RE: City of Decatur WWTP Inspection

AFIN: 04-00052 Permit No.: AR0022292

## OFFICE OF WATER QUALITY INSPECTION REPORT

AFIN: **04-00052** | PERMIT #: **AR0022292** | DATE: **2/2/2018**

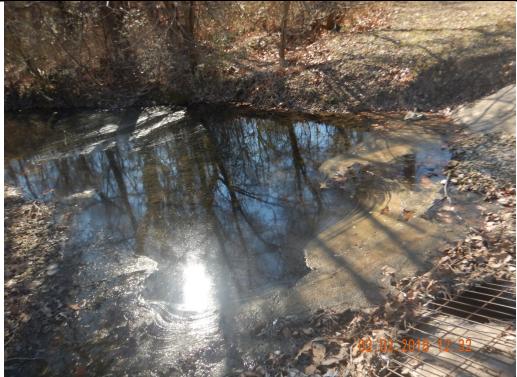
Photographer: Garrett Grimes, District 1 Inspector Date: 02/02/2018 Time: 12:32
Witness: Photo #: 12

Description: Upstream of the WWTP showing the water is not turbid and the previously observed solids are not present (3 of 4).
