RE: Quarterly Inspection conducted on April 12, 2018
AFIN 18-00094
Permit Number 0245-S1-R1

Class 1 Landfill Inspection

Site Name	Crittenden County Class 1 Landfill	County	Crittenden	AFIN	18-00094
Facility Address	1299 Khun Rd. West Memphis, AR 72301	Phone Number	LF: 870-732-4290 Off: 870-732-6580	Permit Number	0245-S1-R1
Permittee Address	Crittenden Co. Judge	E-Mail Address	arredllc@swb.net	PDS #	102502
Date	4/12/2018	Entry Time	1040	Exit Time	1340

Subj: Crittenden Co. Class 1 Landfill – 0245-S1-R1 Q2 2018 – Inspection Report

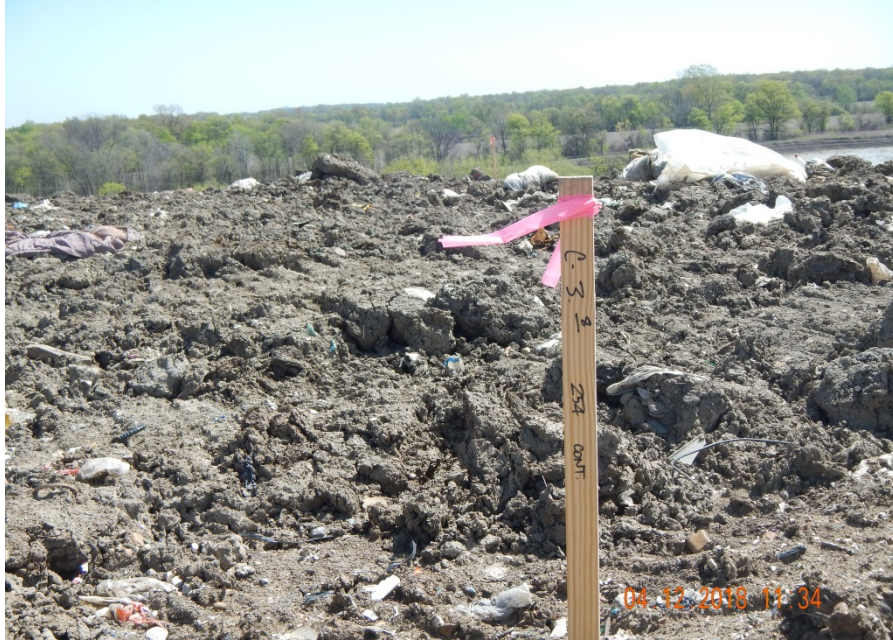
Location	Crittenden Co. Class 1 Landfill	Permit	0245-S1-R1	AFIN	18-00094
Photographer	Tobin Baker, ADEQ Solid Waste Inspector	<i>TB</i>	Witness	N/A	
Photo #	3	Of	6	Date	4/12/2018
Description	View of grade stake, indicating overfill on the top of Cell 3, looking east.

Corrective Action : Noted Allegation 309 (c) was a misunderstanding with Sullivan Survey. See attachment email from Fields & Associates, on the confusion.

Based on this information there is not an overfill conditions as identified at the landfill and alleged by the ADEQ and the grade stakes surveyed by Sullivan Surveying. Attached to this email is Sheet 4A of 20 with the points identified in the survey.

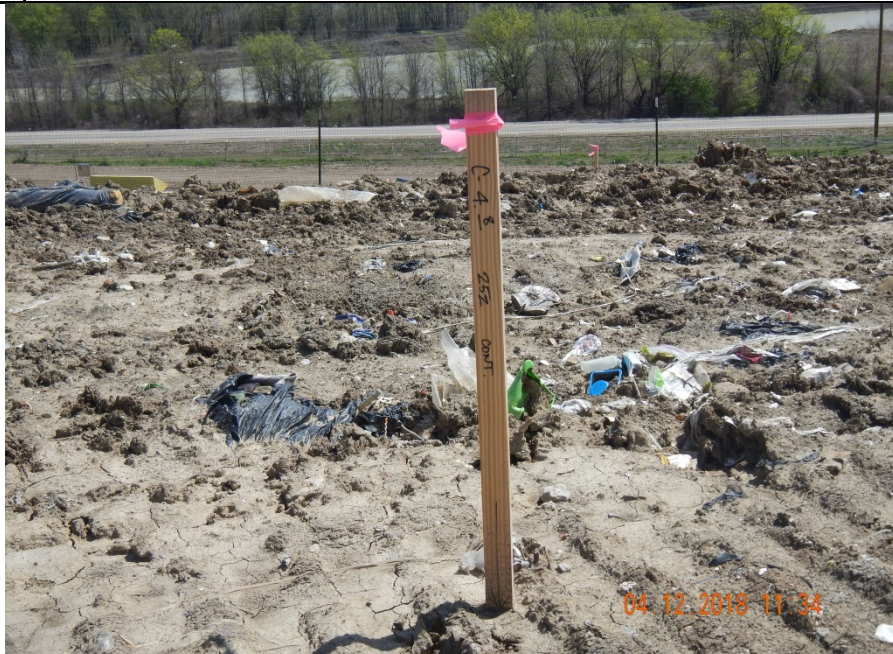
Location	Crittenden Co. Class 1 Landfill	Permit	0245-S1-R1	AFIN	18-00094
Photographer	Tobin Baker, ADEQ Solid Waste Inspector	<i>TB</i>	Witness	N/A	
Photo #	4	Of	6	Date	4/12/2018
Description	View of grade stake indicating overfill on the top of Cell 3, looking east.

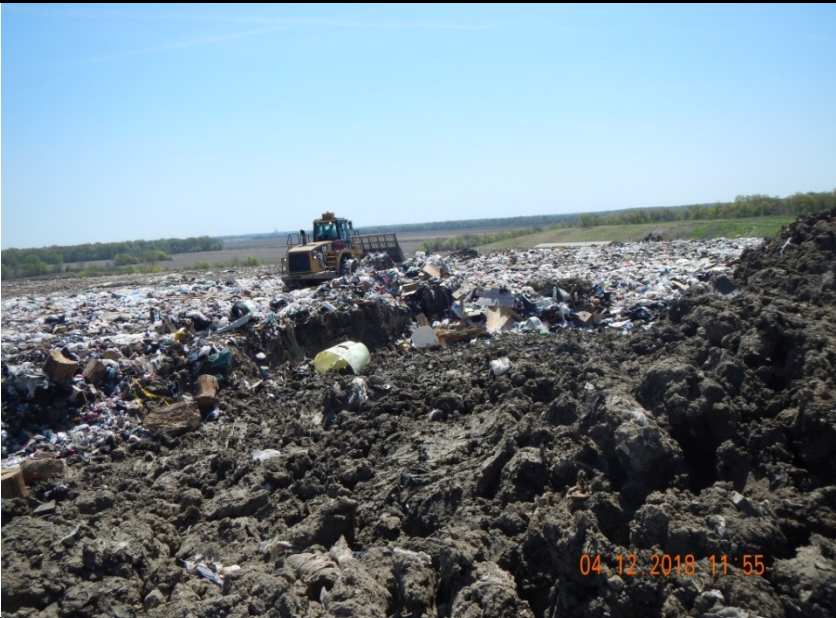
Location	Crittenden Co. Class 1 Landfill				Permit	0245-S1-R1		AFIN	18-00094		
Photographer	Tobin Baker, ADEQ Solid Waste Inspector				<i>Tb</i>	Witness	N/A				
Photo #	5	Of	6		Date	4/12/2018		Time	1155		
Description	View of the active working face, looking east. Active working face was not confined to the smallest practical area.

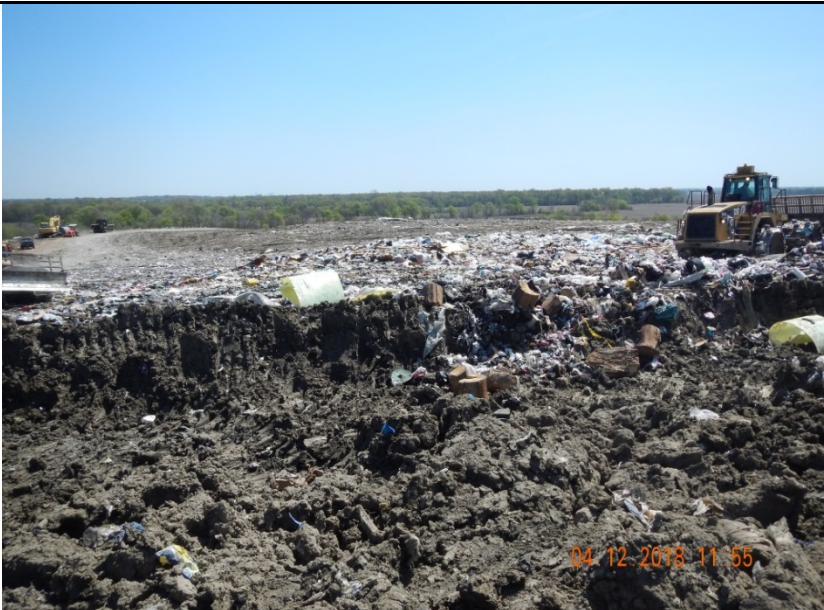
Location	Crittenden Co. Class 1 Landfill				Permit	0245-S1-R1		AFIN	18-00094		
Photographer	Tobin Baker, ADEQ Solid Waste Inspector				<i>Tb</i>	Witness	N/A				
Photo #	6	Of	6		Date	4/12/2018		Time	1155		
Description	Another angle of the active working face. Active working face was not confined to the smallest practical area.
