ADEQ ARKANSAS Department of Environmental Quality		WATER DIVISION INSPECTION REPORT			
		AFIN: 75-00017	PERMIT #: AR0036714	DATE: 3/20/2018	
COUNTY: 75 Yell		PDS #: 102706	MEDIA: WN		
GPS LAT: 35.216738 LONG: -93.162393 LOCATION: Entrance					
FACILITY INFORMATION		INSPECTION INFORMATION			
NAME: Tyson Foods, Inc. LOCATION: 1291 North Hwy 7 CITY: Dardanelle		FACILITY TYPE: 2 - Industrial	INSPECTOR ID#: 36537 T-Joint State/EPA-State Lead		
		FACILITY EVALUATION RATING: 5 - Satisfactory	INSPECTION TYPE: Other		
		DATE(S): 3/20/2018	ENTRY TIME: 09:40	EXIT TIME: 14:00	
				PERMIT EFFECTIVE DATE: 1/1/2015	
				PERMIT EXPIRATION DATE: 12/31/2019	
RESPONSIBLE OFFICIAL					
NAME: / TITLE Kemai Beach / V.P. Small Bird COMPANY: Tyson Foods, Inc. MAILING ADDRESS: 2200 Don Tyson Parkway CITY, STATE, ZIP: Springdale AR 72762 PHONE & EXT: / FAX: 479-229-8750 / 479-229-8791 EMAIL: lance.martin@tyson.com					
FAYETTEVILLE SHALE RELATED: N FAYETTEVILLE SHALE VIOLATIONS: N

Region 6 Compliance Assurance and Enforcement Division
INSPECTION REPORT

Inspection Date(s):	03/20-21/2018		
Media:	Water		
Regulatory Program(s)	NPDES		
Company Name:	Tyson Poultry, Inc.		
Facility Name:	Tyson Poultry, Inc. – D

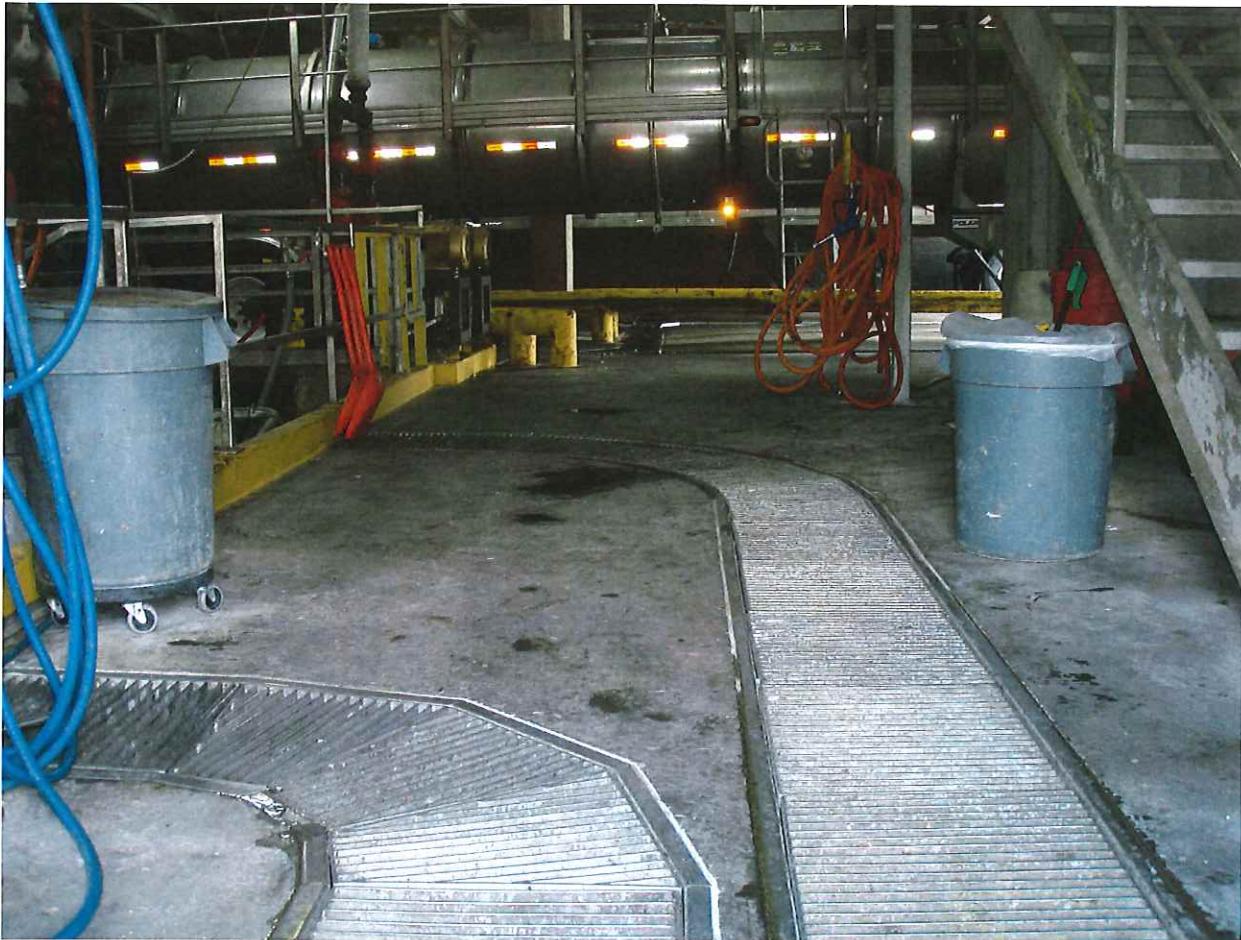
Photo No. 1

Description: Looking west at the drain trenches in the offal building. The trenches lead to the offal screens. A blood tanker was seen in the background. This area was very well maintained.

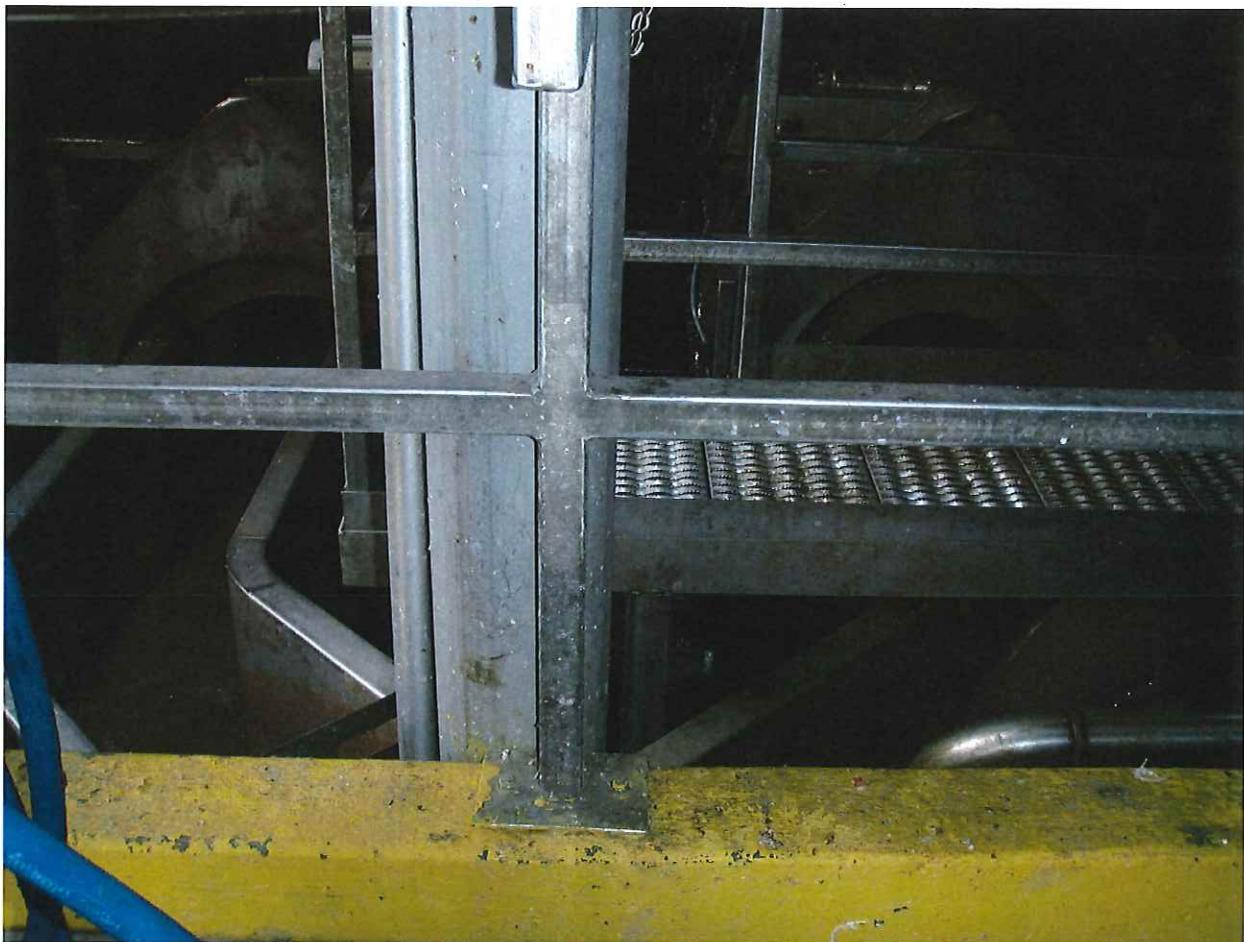
Photo No. 2

Description: Looking south at the drain trenches in the offal building with the rotating screens in the background.

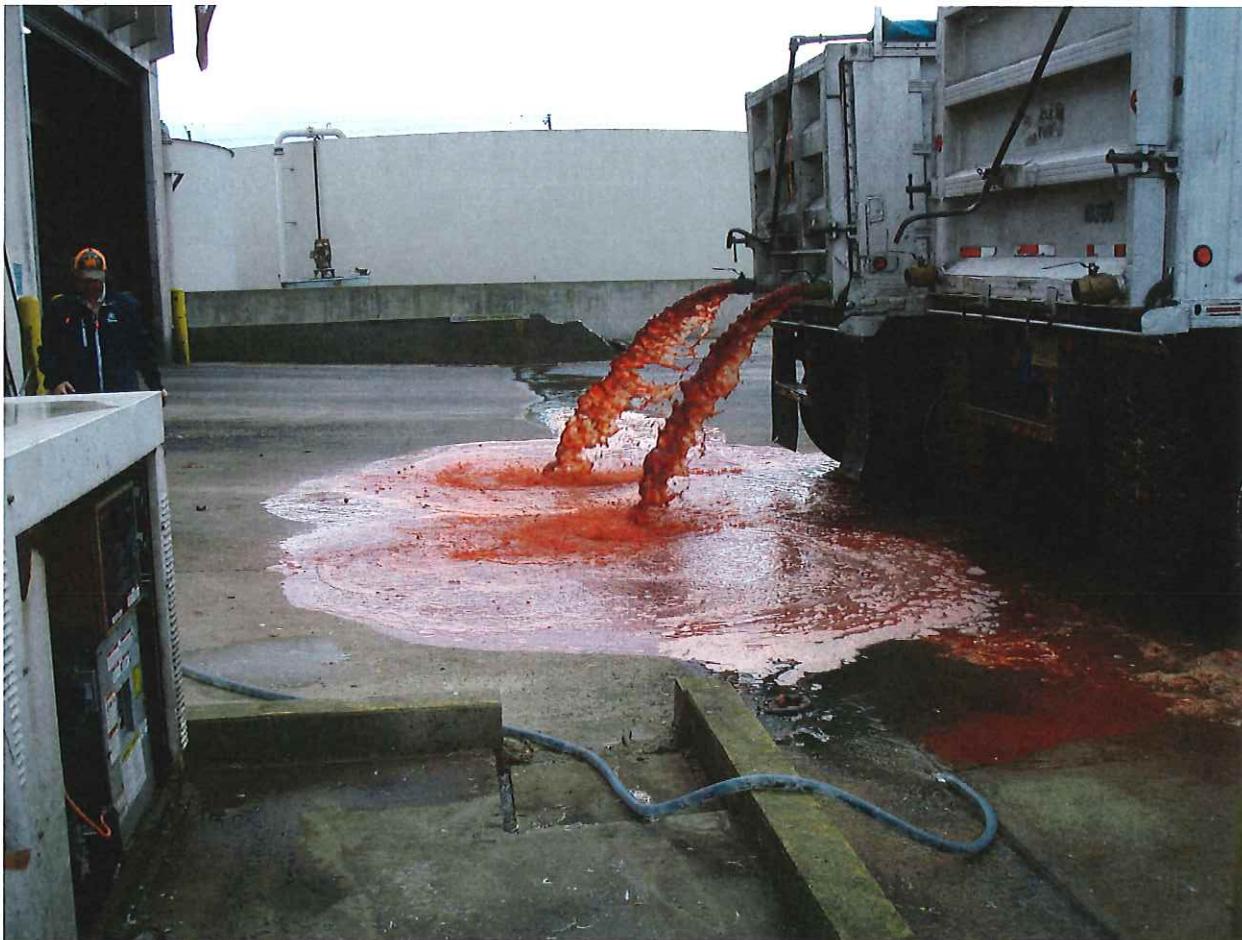
Photo No. 3

Description: Looking west at the offal trucks as they drained liquid and blood into a trench that had a drain recovery pit at the far concrete wall. The drain lead back to the offal screens seen in photo 2. A red dye was added to the offal and blood (a USDA requirement) to prevent its use in food grade products.

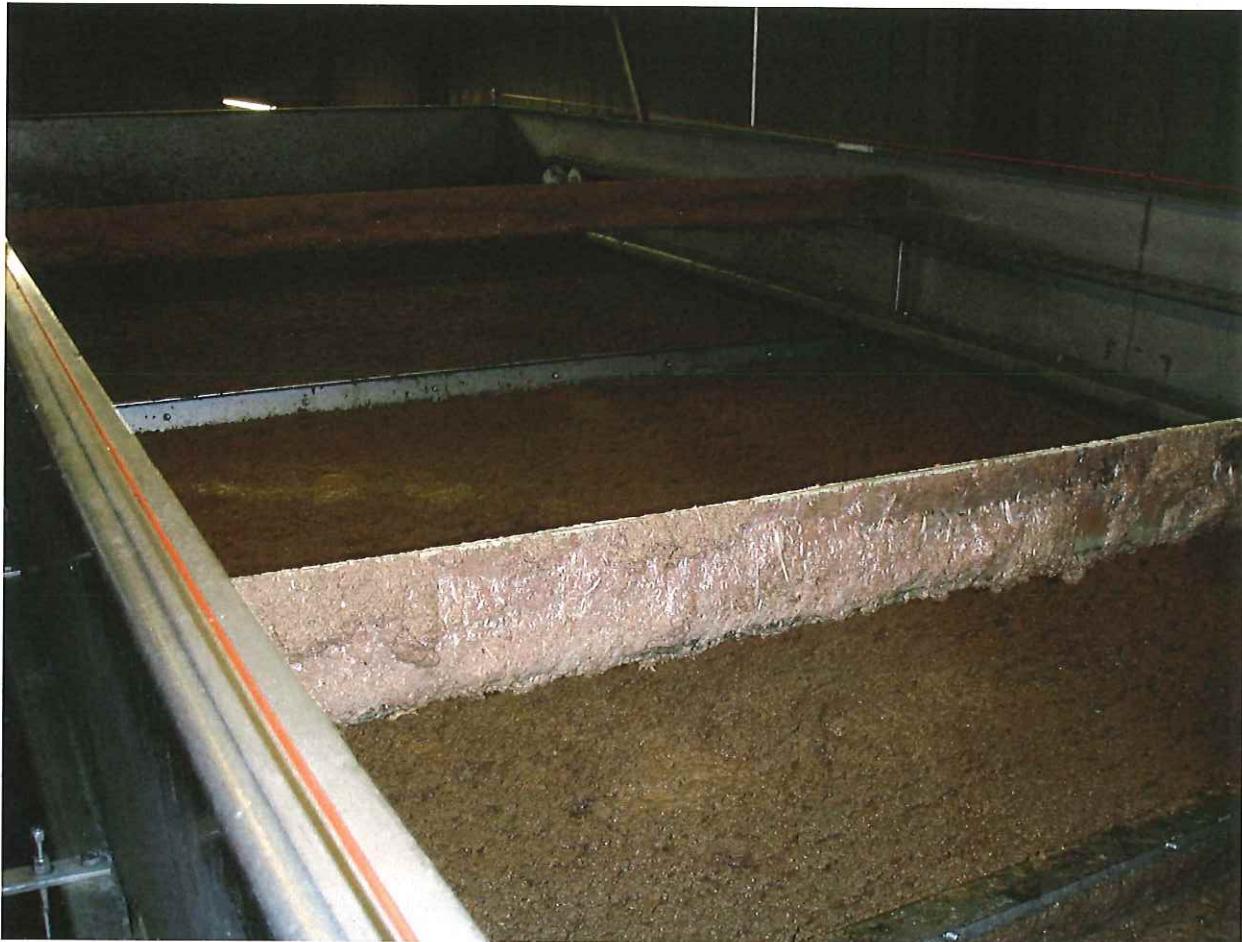
Photo No. 4

Description: Solids coagulation seen on the DAF unit. Excellent solids removal was observed.

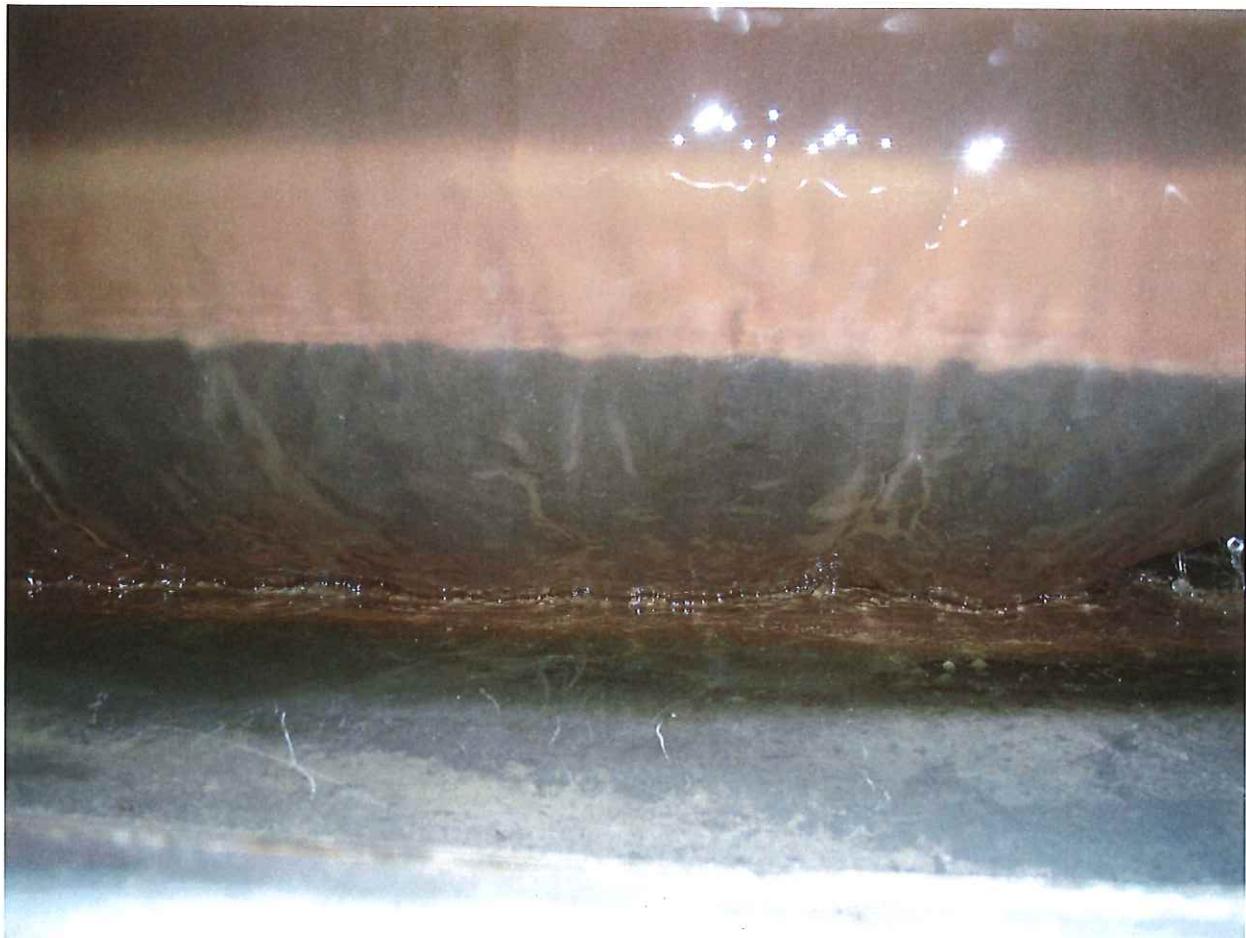
Photo No. 6

Description: Another view of the effluent discharge from the DAF unit. Excellent solids removal was observed.

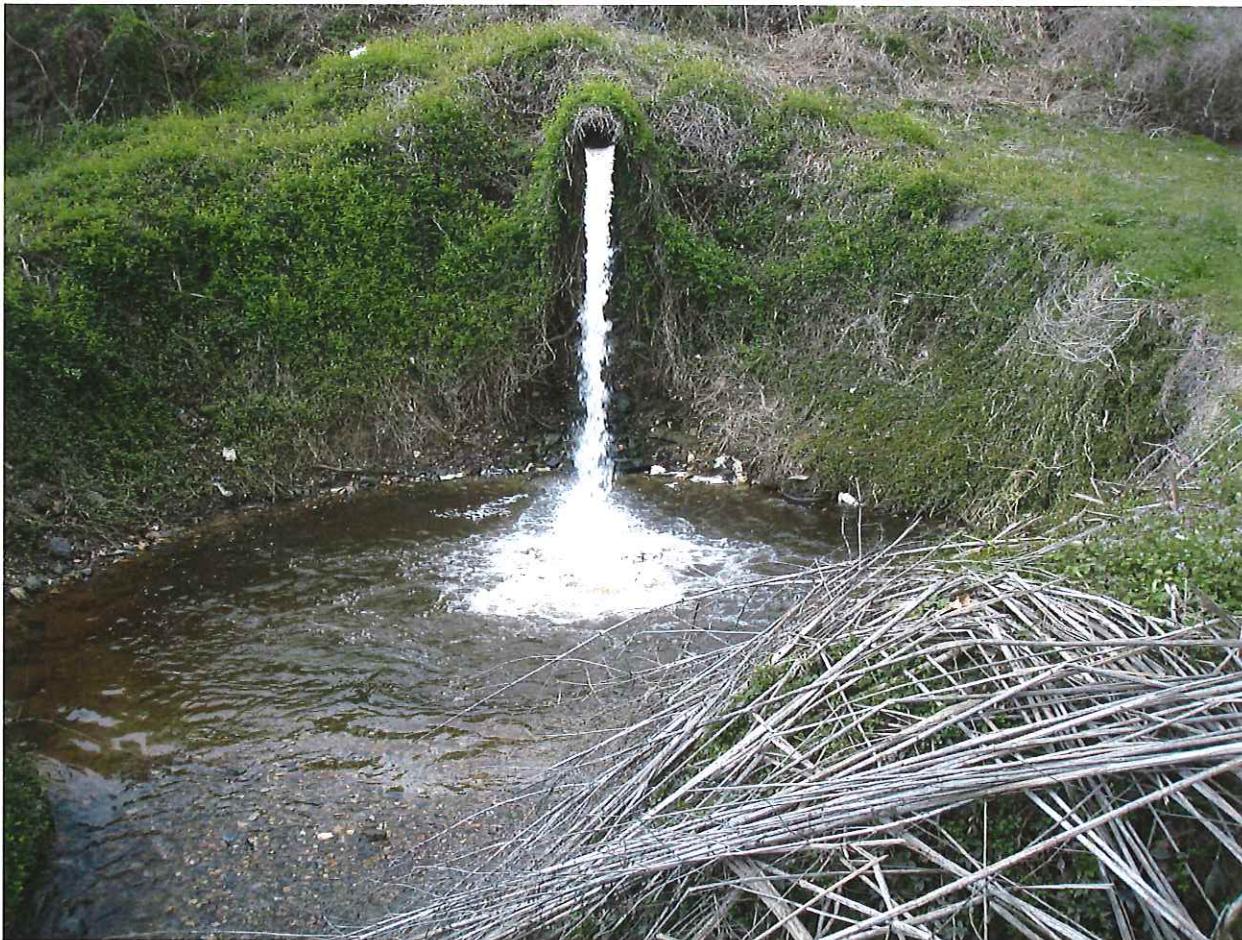
Photo No. 7

The discharge permit issued to Tyson did not mention that plant effluent would discharge thru a city storm sewer to the Arkansas River. However, the plant's 24-hour composite sampler was located following the final treatment unit (aerated chlorine contact basin), in the wastewater discharge line prior to commingling with any city storm water.

Description: The Tyson plant final effluent as it is discharged into a channel leading to the Arkansas River. The effluent discharge runs thru a City of Dardanelle storm drain that runs between the Tyson facility to this point. The photo was looking west.

- 1) The discharge permit issued to Tyson did not mention that plant effluent would discharge thru a city storm sewer to the Arkansas River. The next permit cycle should specify the discharge route more precisely.
- 2) The barometer used to calibrate the DO meter be calibrated annually, or a web source be used to provide the local barometric pressure.

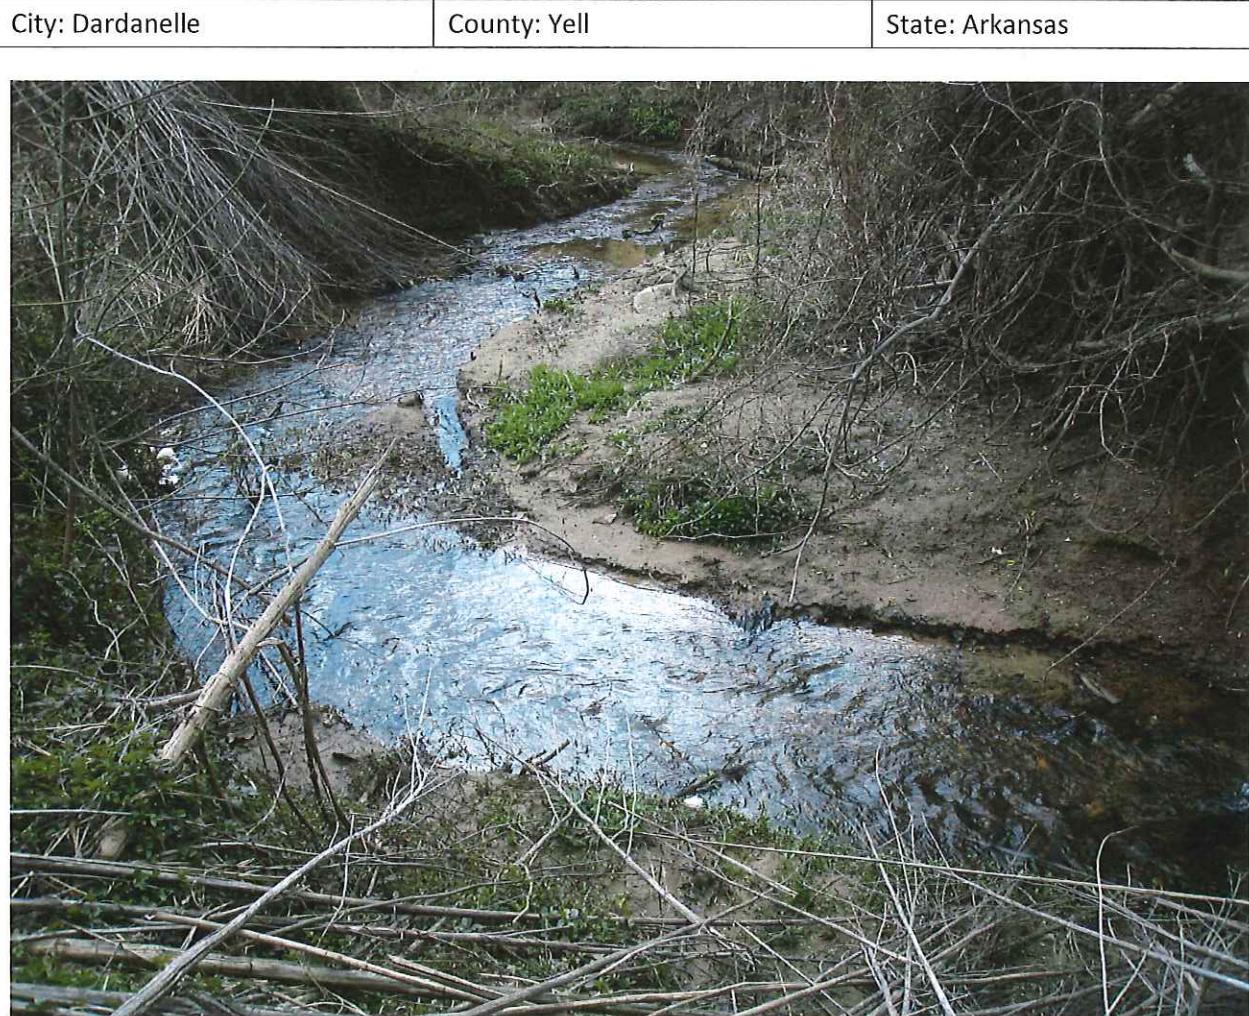
Photo No. 8

The effluent discharged to the Arkansas River was clear, free of any sheen, floatables and foam. Additionally, the channel through which the discharge flowed had a gravel base and was free of any visible plant solids.

Description: The Tyson plant final effluent as it is discharged into a channel leading to the Arkansas River. The stream had a gravel base which did not show any evidence of solids accumulation from the WWTP. This photo, which was looking south, was taken about 50' from the discharge line seen in photo 7.
