RE: City of Eureka Springs WWTP Inspection
AFIN: 08-00036 Permit No.: AR0021865

A R K A N S A S Department of Environmental Quality	WATER DIVISION INSPECTION REPORT				
	AFIN: 08-00036	PERMIT #: AR0021865	DATE: 6/21/2018		
	COUNTY: 08 Carroll	PDS #: 103555	MEDIA: WN		
	GPS LAT: 36.420282 LONG: -93.734920 LOCATION: General Area				
FACILITY INFORMATION		INSPECTION INFORMATION			
NAME: City of Eureka Springs WWTP LOCATION: 100 Highway 23 North CITY: Eureka Springs		FACILITY TYPE: 1 - Municipal INSPECTOR ID#: 120809 S - State FACILITY EVALUATION RATING: *** INSPECTION TYPE: Reconnaissance			
RESPONSIBLE OFFICIAL		DATE(S): 6/21/2018 ENTRY TIME: 10:55 EXIT TIME: 11:45 PERMIT EFFECTIVE DATE: 3/1/2013 PERMIT EXPIRATION DATE: 2/28/2018			
NAME / TITLE: Allen Dwayne / Director of Public Works COMPANY: City of Eureka Springs MAILING ADDRESS: 3174 E. Van Buren CITY, STATE, ZIP: Eureka Springs AR 72632 PHONE & EXT: / FAX: 479-253-8868 / EMAIL: dallen@cityofeurekasprings.org		INSPECTION PARTICIPANTS

Water Division Photographic Evidence Sheet

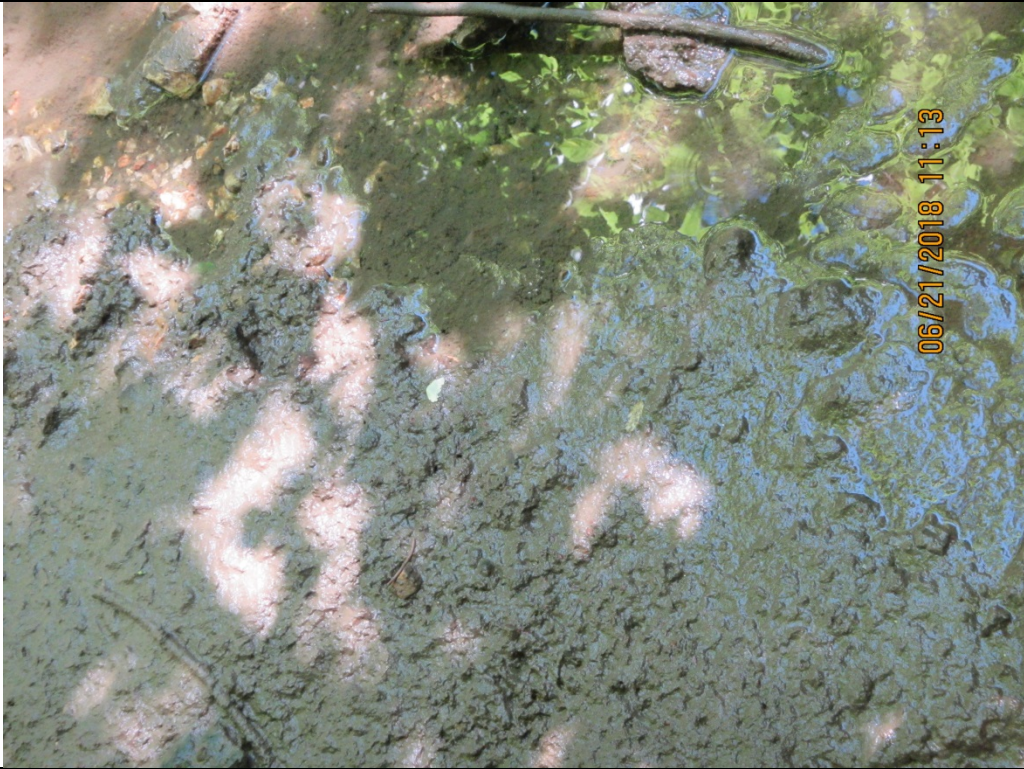
Location:	City of Eureka Springs WWTP, Leatherwood Creek		
Photographer:	Ankush Nautiyal	Date:	06/21/2018
Time:	11:13	Witness:	
Photo #:	1	Description: Sludge deposited on the stream bank

We had our people get in the creek the afternoon of June 21 with shovels and 5-gallon buckets to further investigate the presence of any suspected sludge and to begin the clean-up operation. The clean-up operation involved the gentle removal of any substance which appeared to be sludge, as well as the soil surrounding and below the suspected substance. The suspected sludge and surrounding soil, removed from Leatherwood Creek were disposed of by adding it to the pressed biosolids coming off our belt press and shipped to the landfill for disposal.

Clean-Up of the suspected substance was completed on June 22, 2018. Please see our picture #4 which shows one of the buckets of suspected material removed from Leatherwood Creek during our clean-up operation.

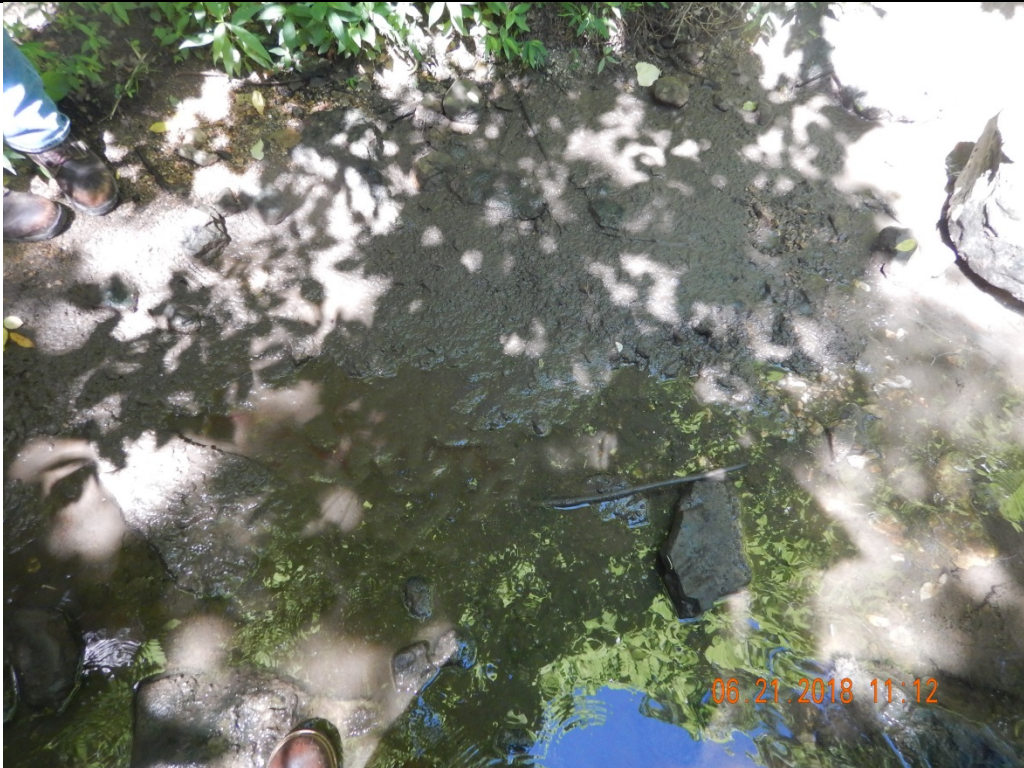
Photographer:	Garrett Grimes	Date:	06/21/2018
Time:	11:12	Witness:	
Photo #:	2	Description: Sludge accumulation on the stream bank

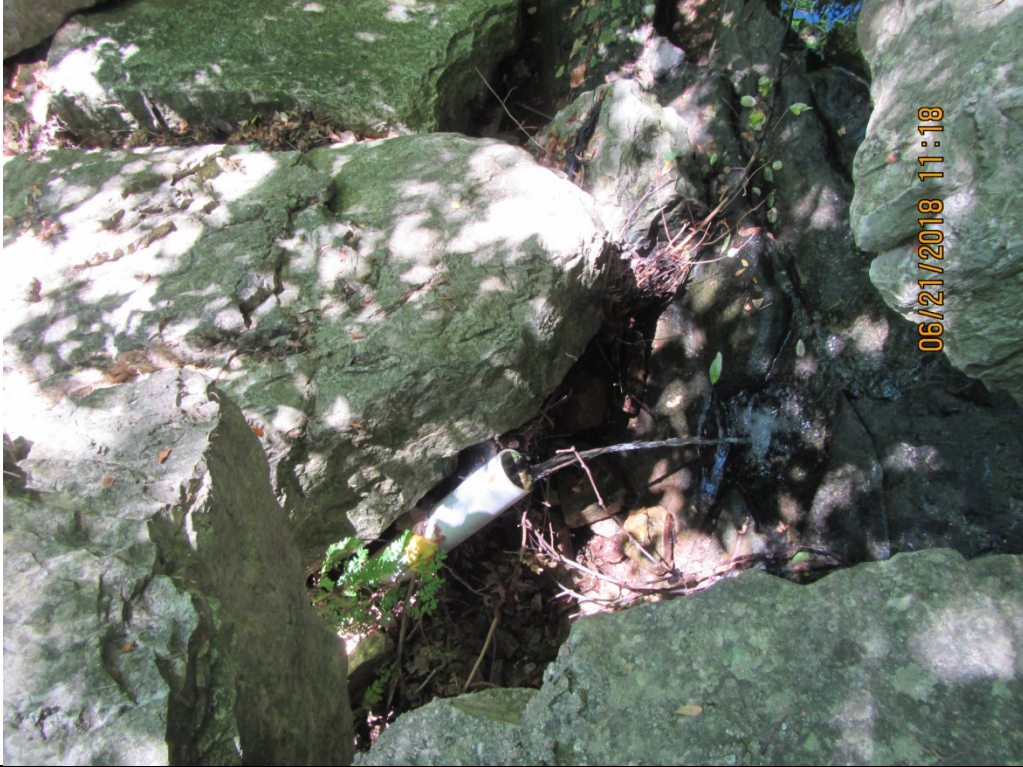
Location:	City of Eureka Springs WWTP		
Photographer:	Ankush Nautiyal	Date:	06/21/2018
Time:	11:18	Photo #:	3
Witness:			
Description:	A pipe coming from the facility was discharging water

Finding #2 - A pipe (not the permitted outfall) was discharging water (see photo #3), Mr. Long was requested to identify the source of this discharge.

This pipe is not on any drawings or plans that we have of the facility, so without digging up the pipe, it is impossible to be certain what it is or where it comes from. We did, however, talk to the only person who was employed by public works department during the construction of the new plant to see if he knew anything about where the pipe came from, or what purpose the pipe might have served. He said that the current grade level surrounding the plant is several feet higher than it was before construction was started, and that the footings for the new structures were actually poured near or below the level of the bottom of Leatherwood Creek, and that the construction company had several drain pipes in use during construction just to keep the groundwater drained away from the construction site, and he couldn't remember if they removed all the drain pipes before backfilling. So, with that being said, it is our best estimation that the pipe in question is left over from the construction of the new treatment facility and was draining groundwater away from the foundation of the treatment facility. We did apply, with glue, a 4-inch cleanout cap on the end of the pipe to stop the flow of water into the creek. We also collected a sample of water exiting from the pipe and tested it in an attempt to determine the source of the water and the test results lead us to believe that the water that was flowing from the pipe was in fact groundwater. This pipe was plugged on July 12, 2018. Please see our Picture #1 which shows this pipe having been capped.

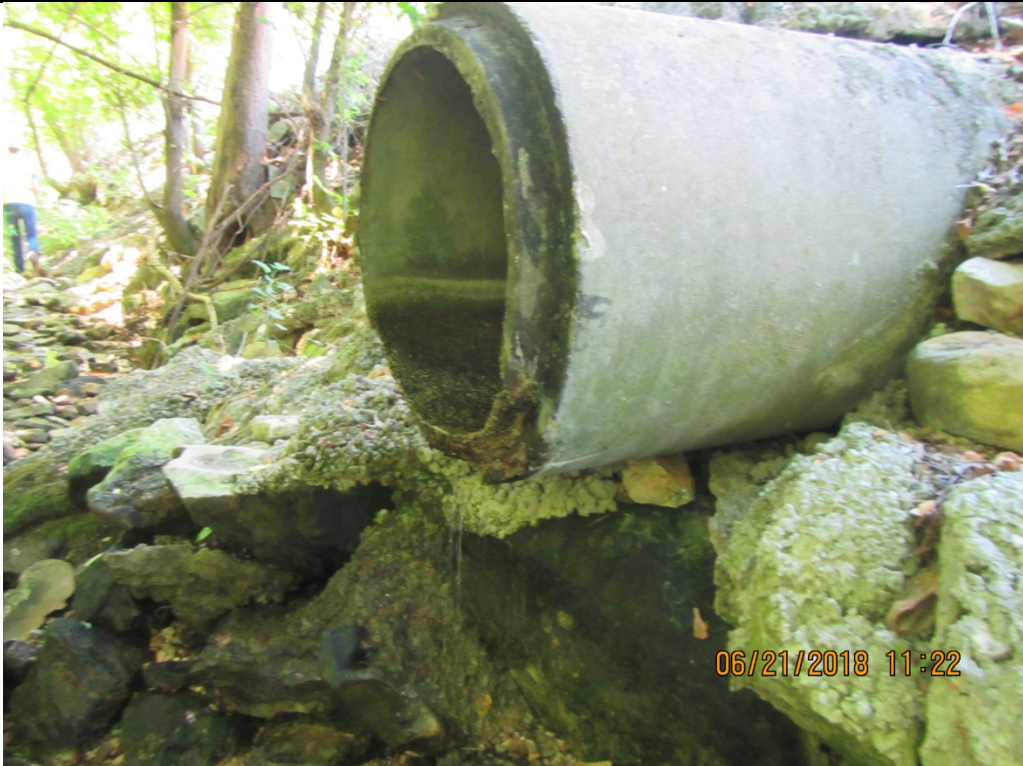
Photographer:	Ankush Nautiyal	Date:	
Time:	11:22	Photo #:	4
Witness:			
Description:	Outfall discharge appeared clear

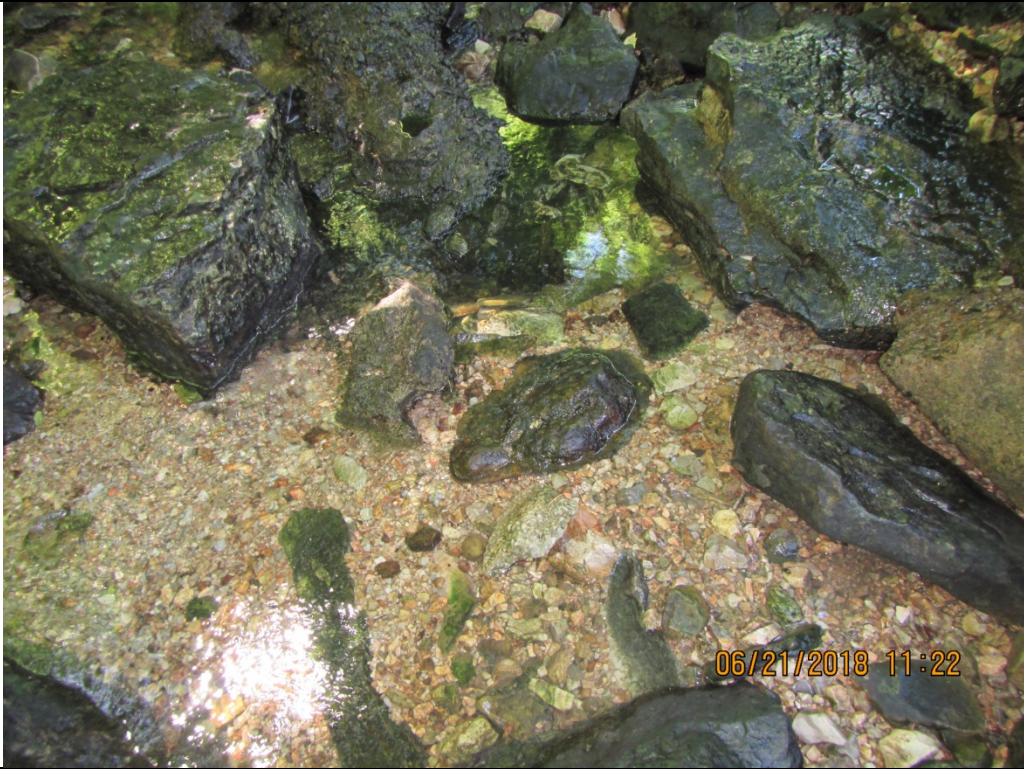
**	SAMPLING	**	SLUDGE HANDLING/DISPOSAL	**	PRETREATMENT
**	OTHER:				
SUMMARY OF FINDINGS					
<p>Upstream from the WWTP, the creek did not show any sludge (See photo # 6). No sludge was noticed near the outfall (See photo #5). However, downstream from the outfall, some deposited material was noticed which appeared to be sludge (See photos #1 and 2). According to Inspector Grimes, the deposited material had Sulphur odor. Since the sludge seemed old and decomposing, it could have been there due to previous upsets. Presence of sludge in the stream is violation of Part I, Section A of the permit which states: There shall be no discharge of distinctly visible solids, scum, or foam of a persistent nature, nor shall there be any formation of slime, bottom deposits, or sludge banks. There shall be no visible sheen due to the presence of oil (Sheen means an iridescent appearance on the surface of the water.</p> <p>Please provide a response for the following concerns:</p> <ol style="list-style-type: none"> 1. A. The facility needs to identify the reasons behind the presence of sludge in the creek. B. The facility needs to take proper steps to prevent re-occurrence of any such events which can result in sludge discharge. C. The facility needs to ensure proper clean up. 2. A pipe (not the permitted outfall) was discharging water (See photo #3), Mr. Long was requested to identify the source of this discharge. 3. Water was seeping out of the ground from multiple locations near the facility (See photo #8). Mr. Long mentioned that a water pipeline passes through that area and is probably leaking. He mentioned that he was not aware about this leakage and will work on getting it fixed. Please describe if the source of this leak was confirmed.

Location:	City of Eureka Springs WWTP, Leatherwood Creek		
Photographer:	Ankush Nautiyal	Date:	06/21/2018
Time:	11:22	Witness:	
Photo #:	5	Description: Stream was clear at the outfall discharge location

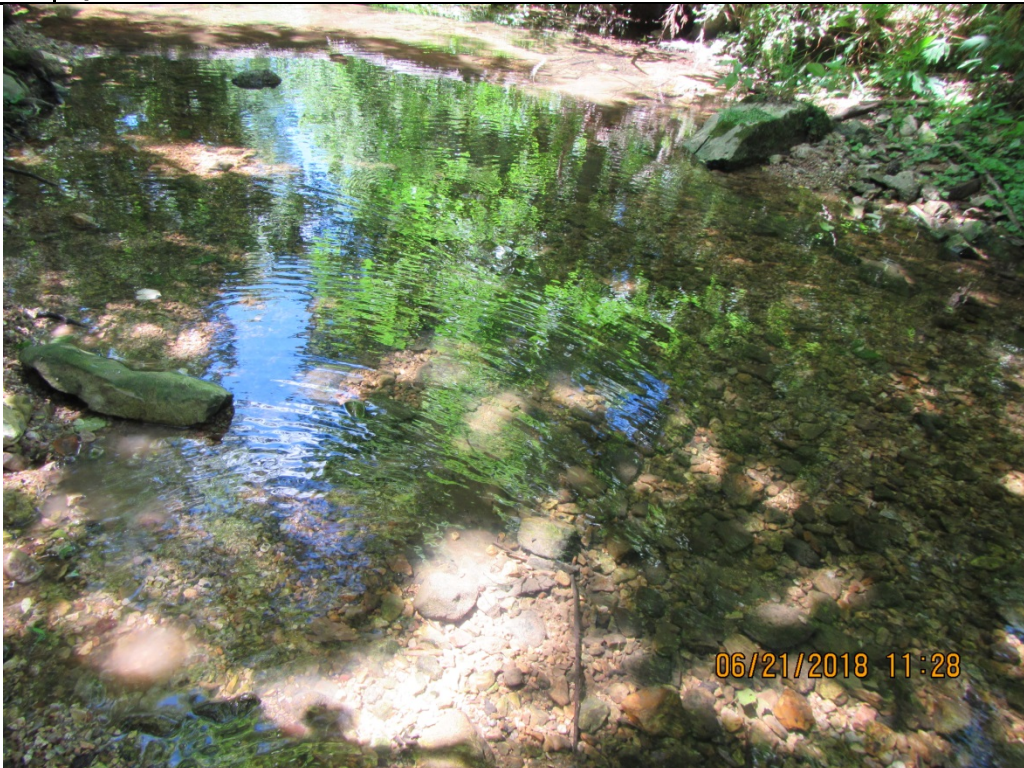
Photographer:	Ankush Nautiyal	Date:	06/21/2018
Time:	11:28	Witness:	
Photo #:	6	Description: Upstream was clear

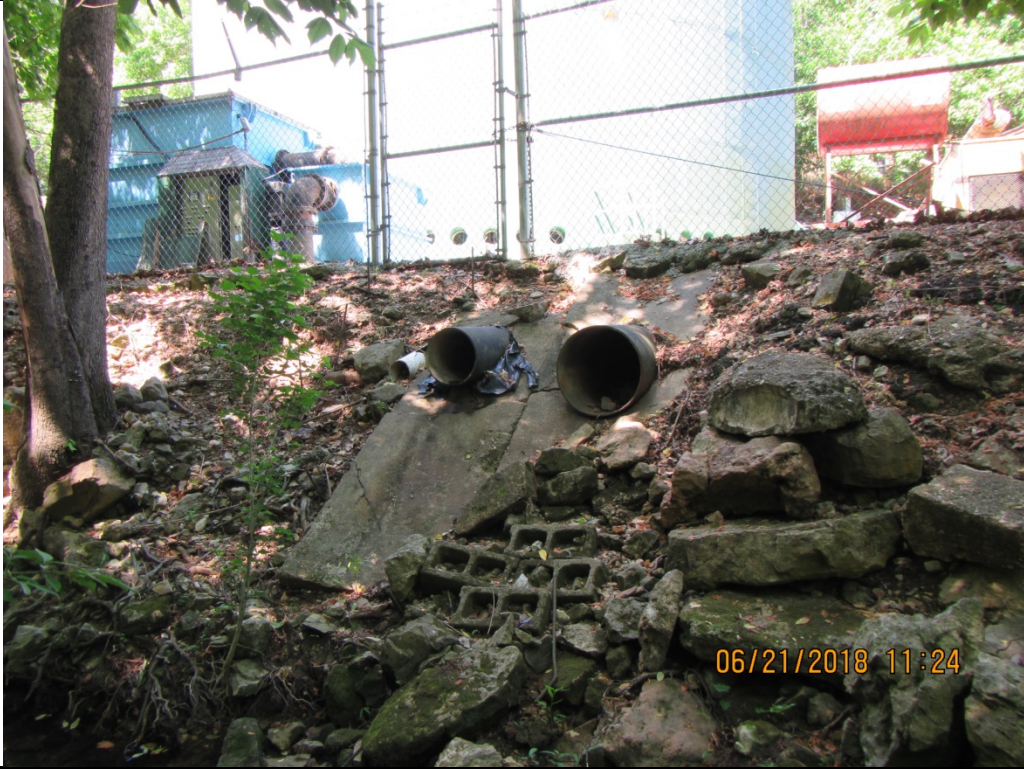
There were multiple pipes with no discharge (See photo # 7). Mr. Long mentioned that those are older pipes for discharge and by-passes, which are no longer in use.

Description: **Extra pipes were present but did not have any discharges. Mr. Long mentioned that they were part of the older treatment part and were not in use anymore**

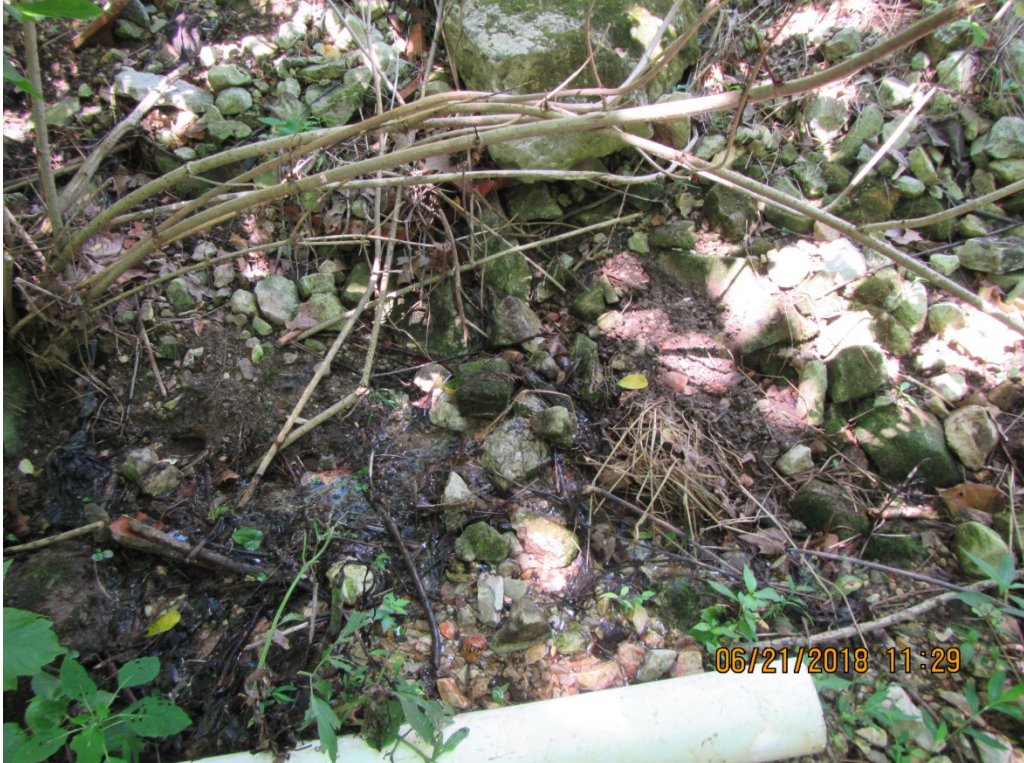
Description: **Water was seeping out of multiple locations. Mr. Long mentioned that a water pipeline passes through that area and is probably leaking**

Finding #3 - Water was seeping out of the ground from multiple locations near the facility (see photo #8). Mr. Long mentioned that a water pipeline passes through that area and is probably leaking. He mentioned that he was not aware of this leakage and will work on getting it fixed. Please describe if the source of this leak was confirmed.

The water that was observed seeping out of the ground was, in fact, coming from a leak in a potable water line. As mentioned during the reconnaissance inspection, we suspected that we had a leak in the water line but had never been able to locate it, and this was, in fact, the leak that we had been searching for. The afternoon of the inspection (June 21, 2018), we went back to the area where water was seeping and collected a sample for analysis and the presence of fluoride was detected in the water, which confirmed that it was a potable water leak. We then closed the water valve coming into the facility, and after a period of a few minutes, the water stopped seeping from the ground, and then when we opened

The leak was located, about fifteen (15) feet away from the edge of the creek at a depth of approximately four (4) feet, near and below the level of the footing for the influent bar screen.

The leak was caused by a longitudinal split in the 2-inch potable water line that services the wastewater treatment plant. The leak was repaired on July 10, 2018. Please see our picture #2, which shows the location of the water leak that was responsible for the water seeping from the ground and our picture #3 which is a picture of the area that was water was seeping from after the leak was identified and repaired.

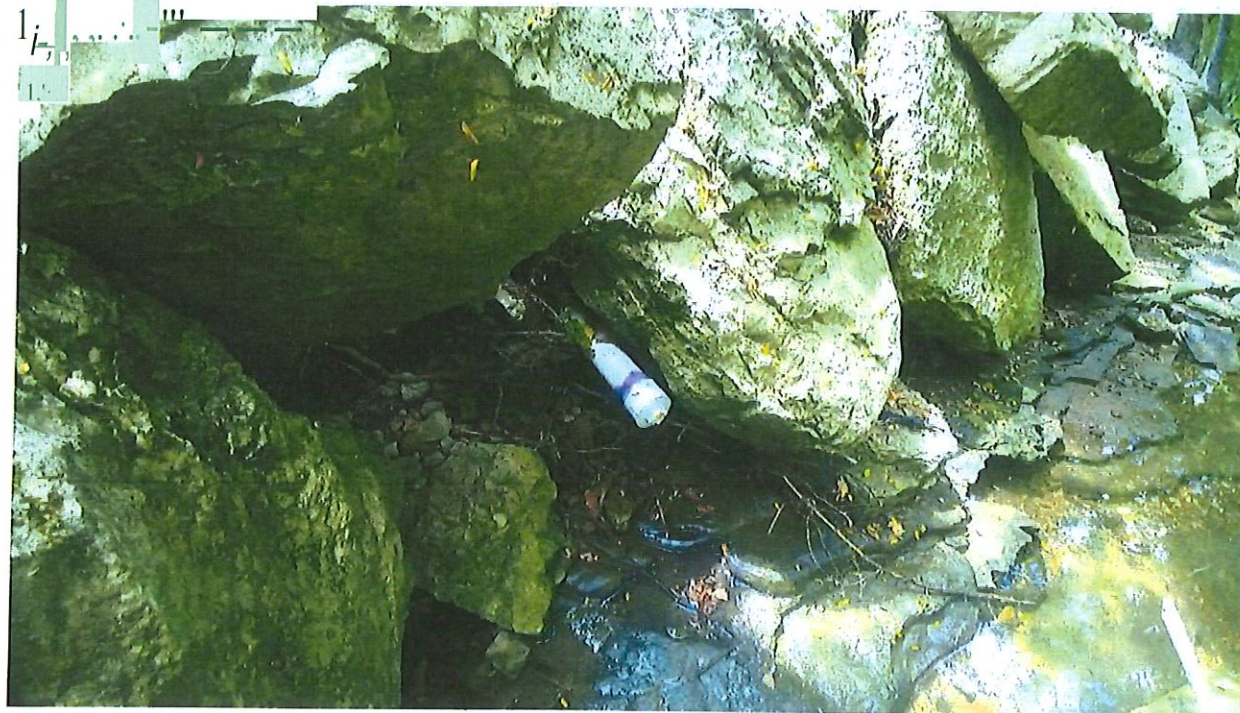
Picture #1

This is a picture of the pipe that was referenced by Ms. Nautiyal as photo #3 which was discharging water.

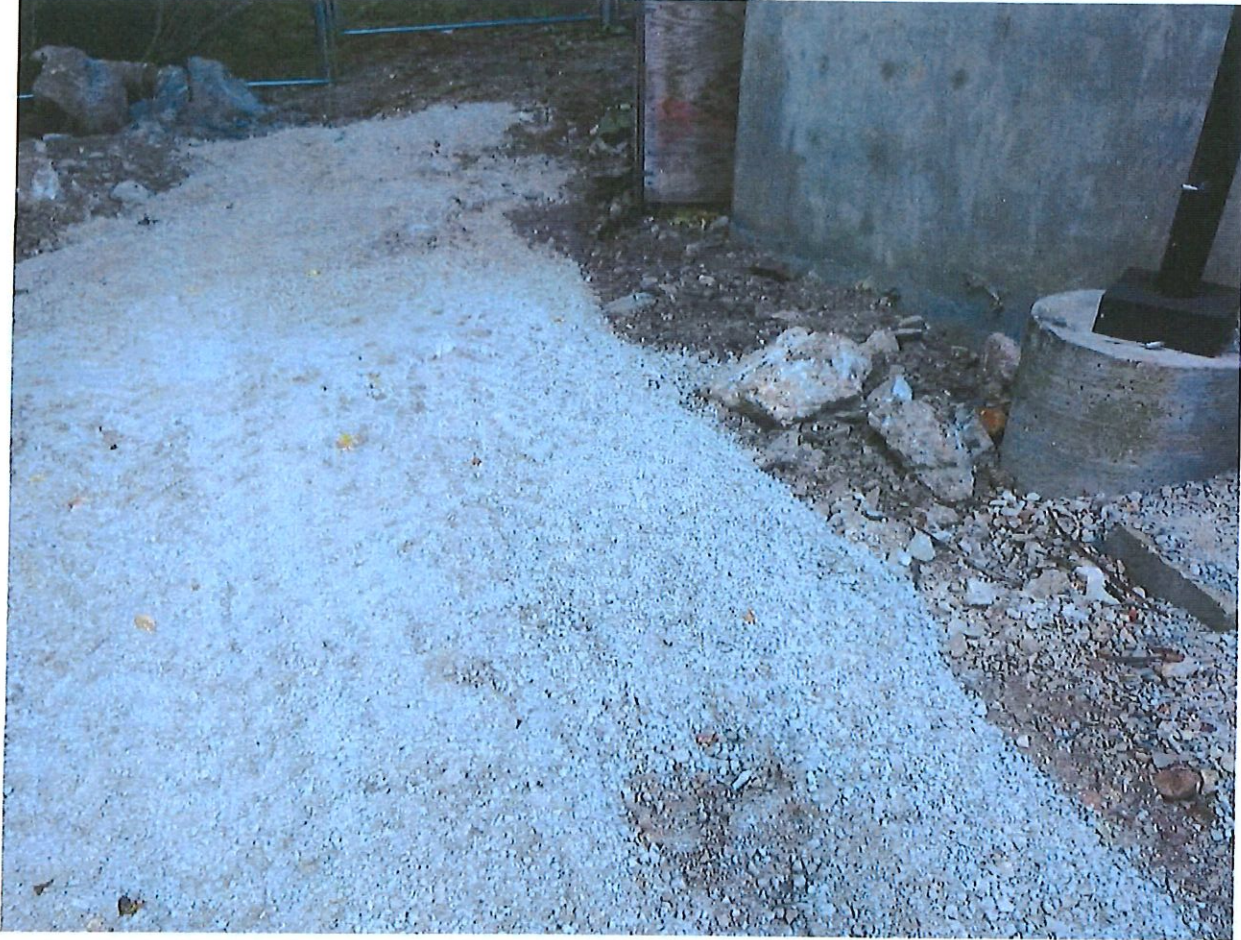
Picture #2

This picture shows the location of the leak that was the source of the seeping water referenced by Ms. Nautiyal in photo #8 which was seeping water from multiple locations.

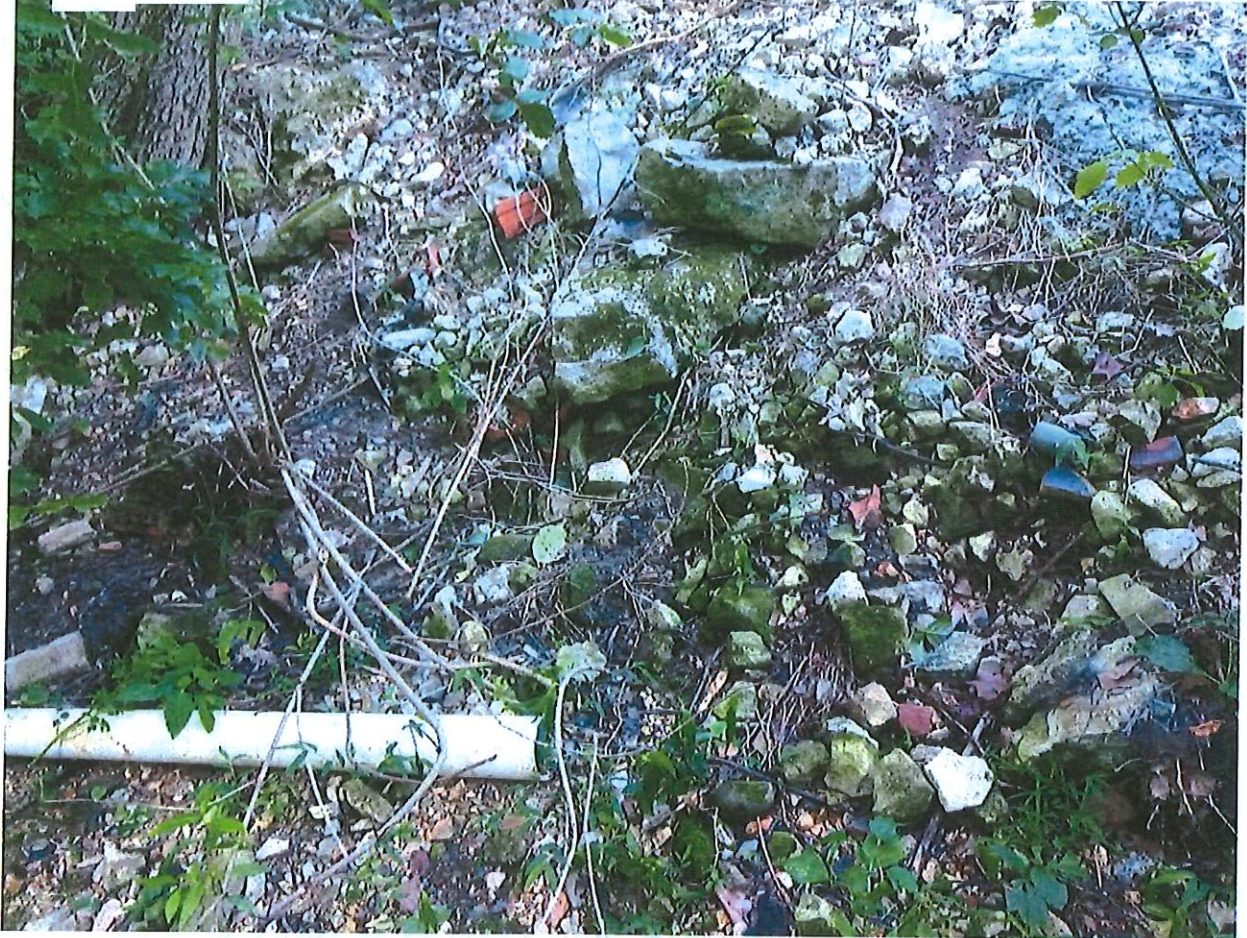
Picture #3

This picture shows the location of the seeping water referenced by Ms. Nautiyal in photo #8 which was seeping water from multiple locations after the leak was located and repaired.

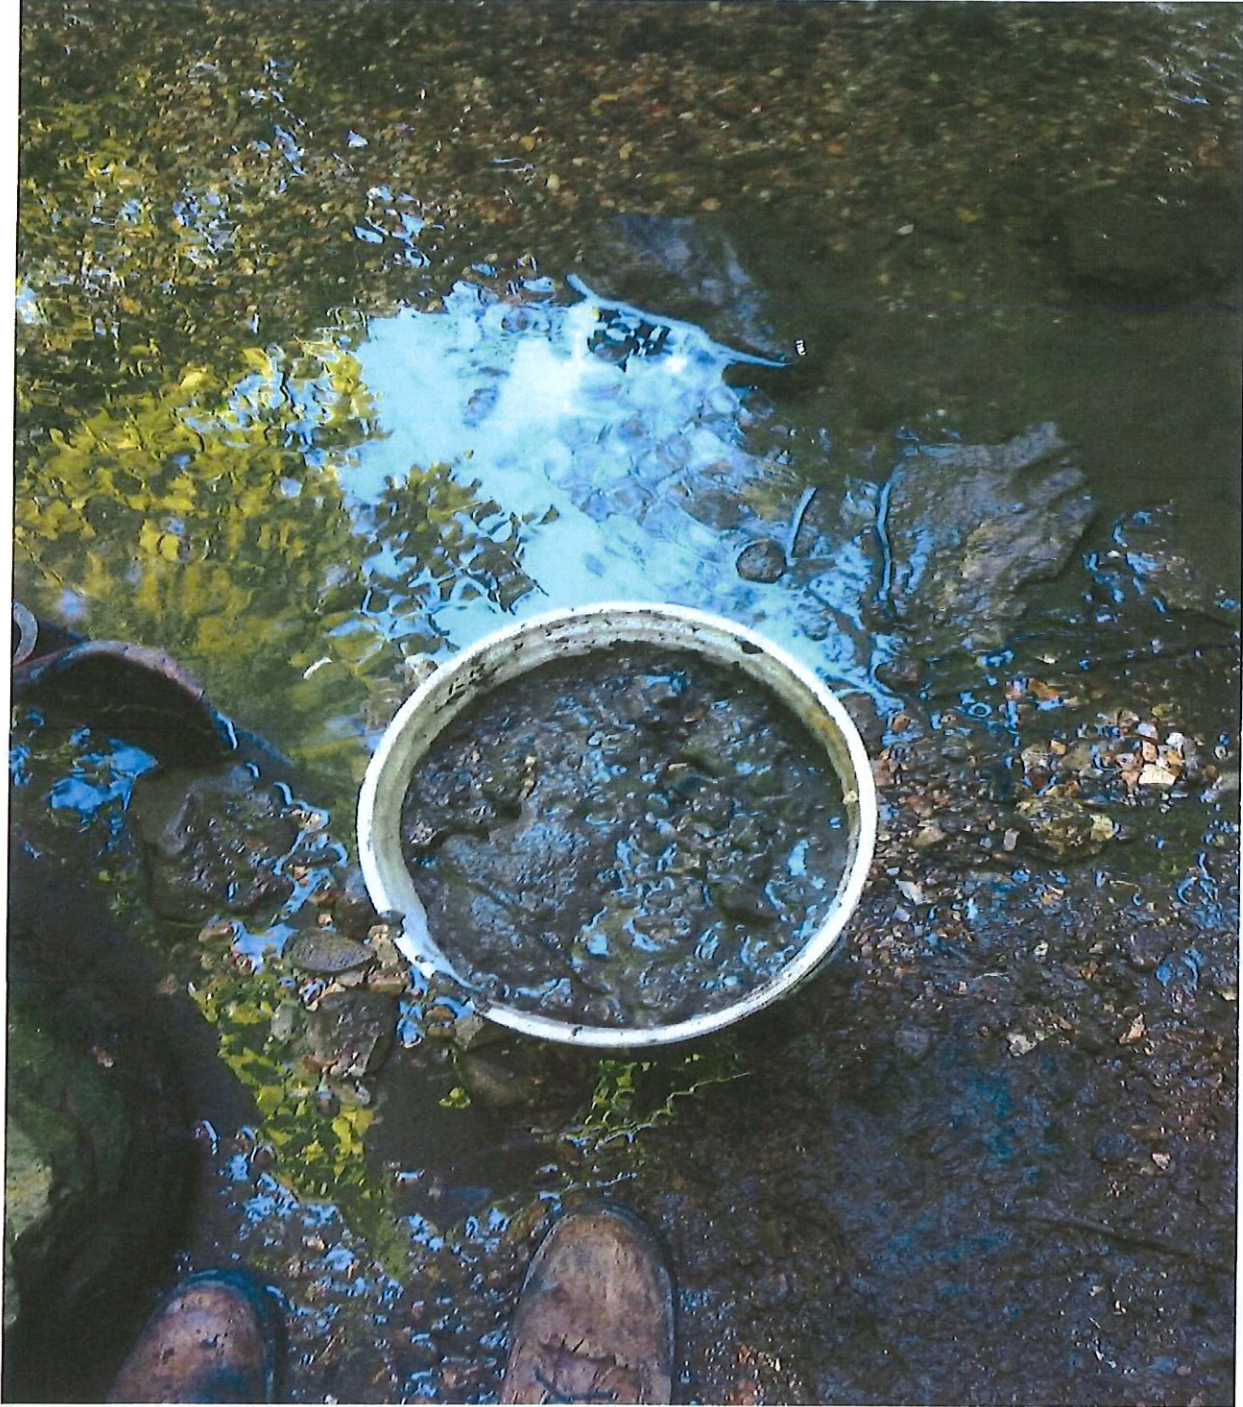
Picture #4

This is a picture of one of the buckets of suspected sludge and potentially contaminated soil and gravel that was removed from Leatherwood Creek during our clean-up of material suspected to be sludge.
