RE: Quarterly Inspection conducted on September 14, 2018
AFIN 03-00051
Permit Number 0249-S1-R2

Arkansas Department of Environmental Quality
Office of Land Resources-Solid Waste Management
Class 1 Landfill Inspection

Site Name	NABORS Class 1 Landfill (Closed)	County	Baxter	AFIN	03-00051
Facility Address	Mountain Home, Hwy 5N to CR16 to site entrance	Phone Number	870-425-3213 870-656-9463	Permit Number	0249-S1-R2
Permittee Address	P.O. Box 1715, Mountain Home, AR, 72602	E-Mail Address		PDS #	104585
Date	9/14/2018	Entry Time	1000	Exit Time	1115

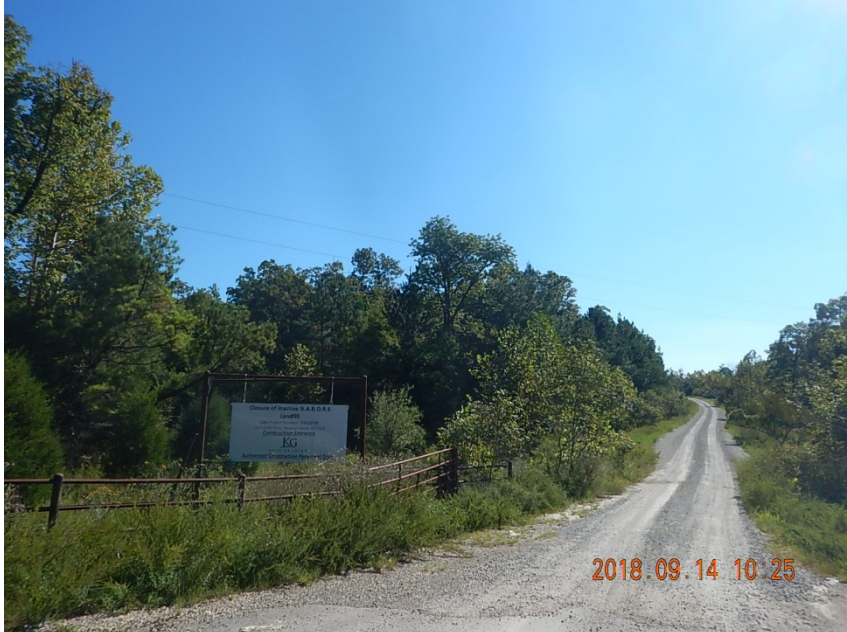
Location	NABORS Class 1			Permit	0249-S1-R2	AFIN	03-00051
Photographer	Darrell Norton, ADEQ Solid Waste Inspector		<i>DN</i>	Witness	N/A		
Photo #	1	Of	6	Date	9/14/2018	Time	1025
Description	A view of the signage and entrance road to the Nabors Landfill.

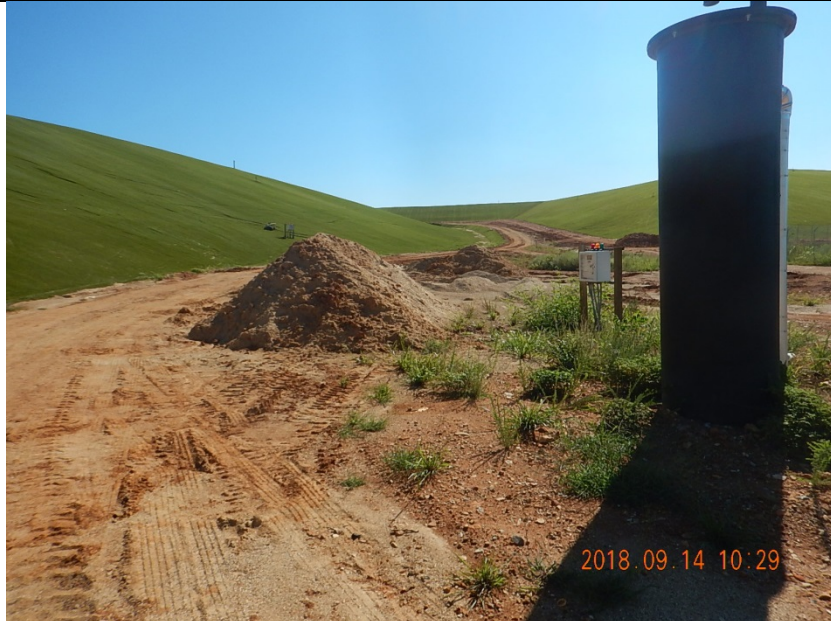
Location	NABORS Class 1			Permit	0249-S1-R2	AFIN	03-00051
Photographer	Darrell Norton, ADEQ Solid Waste Inspector		<i>DN</i>	Witness	N/A		
Photo #	2	Of	6	Date	9/14/2018	Time	1029
Description	A view of the leachate panel east of Area 1-2 with the southwest slope of Area 1-3 visible in the background.

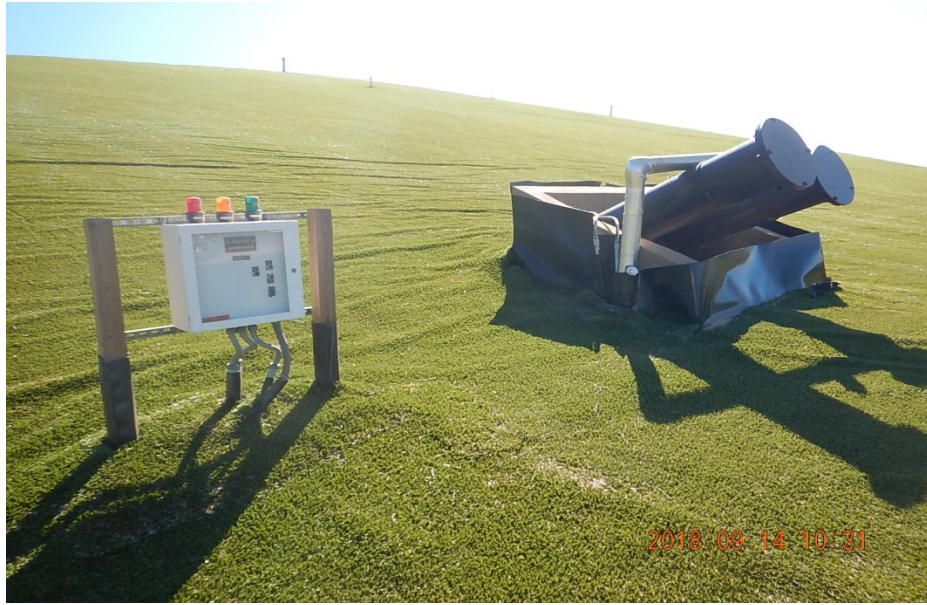
Location	NABORS Class 1			Permit	0249-S1-R2	AFIN	03-00051
Photographer	Darrell Norton, ADEQ Solid Waste Inspector		<i>DN</i>	Witness	N/A		
Photo #	3	Of	6	Date	9/14/2018	Time	1031
Description	A view of the leachate panel and risers on the south slope of Cell 2 in Area 1-3.

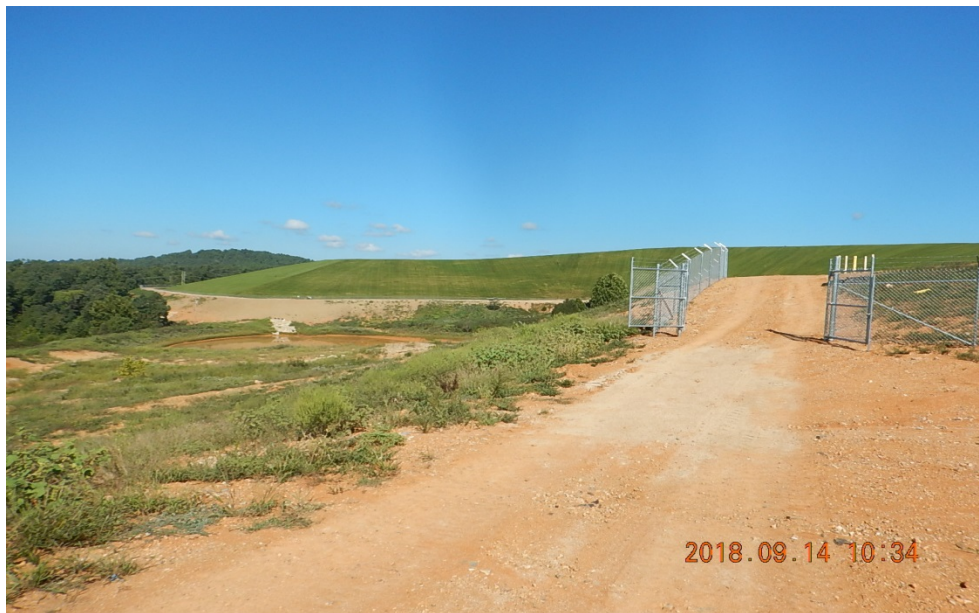
Location	NABORS Class 1			Permit	0249-S1-R2	AFIN	03-00051
Photographer	Darrell Norton, ADEQ Solid Waste Inspector		<i>DN</i>	Witness	N/A		
Photo #	4	Of	6	Date	9/14/2018	Time	1034
Description	A view of the new fenced entrance to the Class 1 site from the Class 4 site. The east slope of Area 1-2 and the sedimentation pond southeast of Area 1-2 are visible.

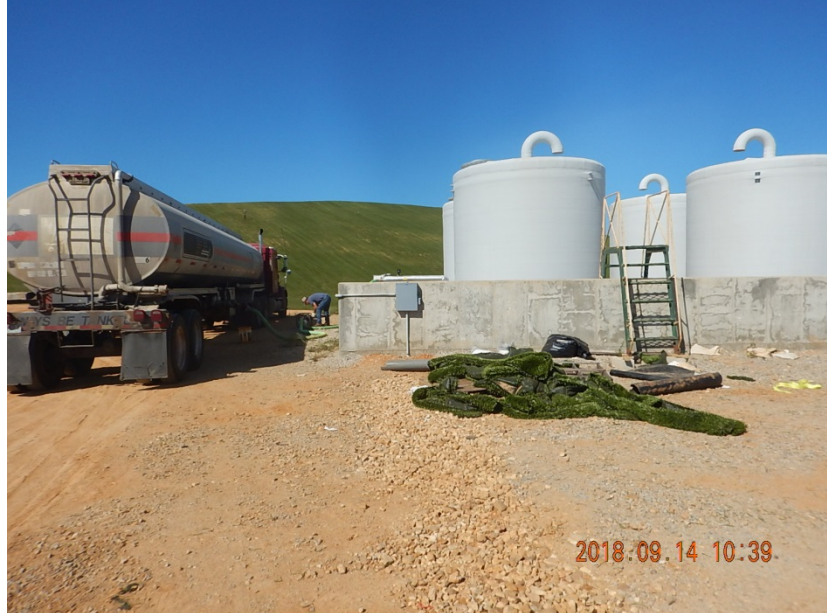
Location	NABORS Class 1			Permit	0249-S1-R2	AFIN	03-00051
Photographer	Darrell Norton, ADEQ Solid Waste Inspector		<i>DN</i>	Witness	N/A		
Photo #	5	Of	6	Date	9/14/2018	Time	1039
Description	A view of the leachate tank farm and secondary containment unit.

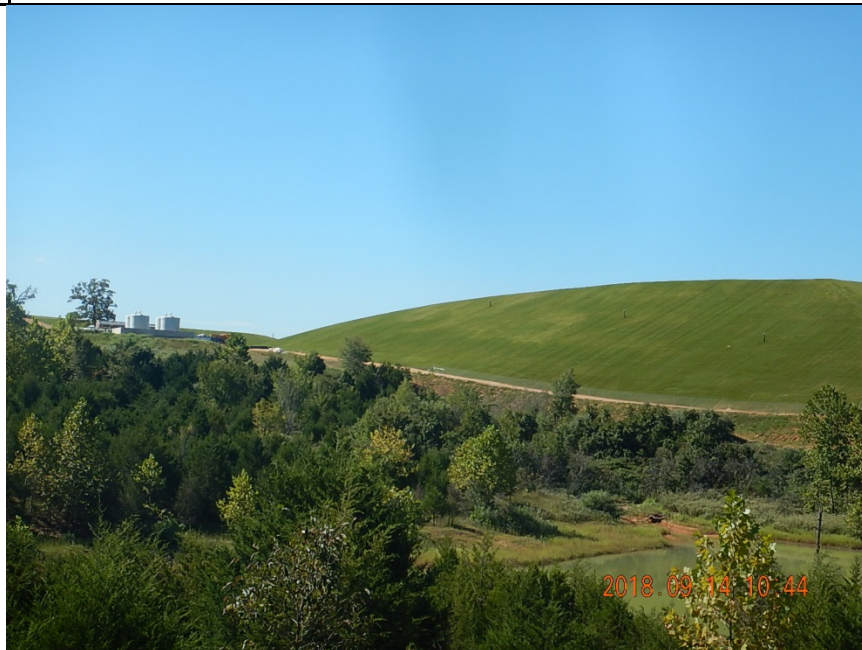
Location	NABORS Class 1			Permit	0249-S1-R2	AFIN	03-00051
Photographer	Darrell Norton, ADEQ Solid Waste Inspector		<i>DN</i>	Witness	N/A		
Photo #	6	Of	6	Date	9/14/2018	Time	1044
Description	A view of the leachate tank farm and north slope of Area 1-2.
