**RE: Quarterly Inspection conducted on February 4, 2019**  
**AFIN 18-00094**  
**Permit Number 0245-S1-R2**

### Class 1 Landfill Inspection

<b>Site Name</b>	Crittenden County Class 1	<b>County</b>	Crittenden	<b>AFIN</b>	18-00094
<b>Facility Address</b>	1299 Khun Rd. West Memphis, AR 72301	<b>Phone Number</b>	LF: 870-732-4290 Off: 870-732-6580	<b>Permit Number</b>	0245-S1-R2
<b>Permittee Address</b>	Crittenden Co. Judge	<b>E-Mail Address</b>	arredllc@swb.net	<b>PDS #</b>	106640
<b>Date</b>	2/4/2019	<b>Entry Time</b>	1300	<b>Exit Time</b>	1515

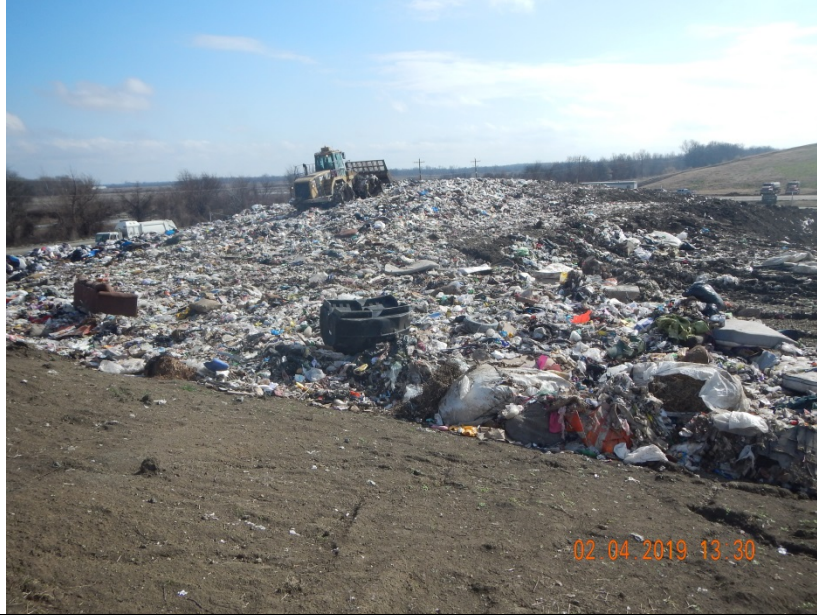
Regulation	Item Description	Comments
411(a)	Operations in accordance with permit documents	
417(c)	Adequate all weather operational roads	
411(c)	Smallest practical area, unloading supervised, single working face	The working face was approximately 150' X 300'. (Refer to Photos #1 & #2.)
411(e)	Salvage operations meet approved conditions	
411(f)(1)	Scavenging of waste prohibited	
411(p)	Proper wet weather repairs	
411(b)	Operations by licensed on-site personnel at all times	
411(d)	Waste spread and compacted as unloaded	
411(g)	Litter control provisions maintained	
414(a)	Disease vectors controlled

<b>Witness</b>	N/A		
<b>Photo #</b>	1	<b>Of</b>	6		<b>Date</b>	2/4/2019	<b>Time</b>	1330
<b>Description</b>	Working face observed with measurements approximately 150' X 300'.

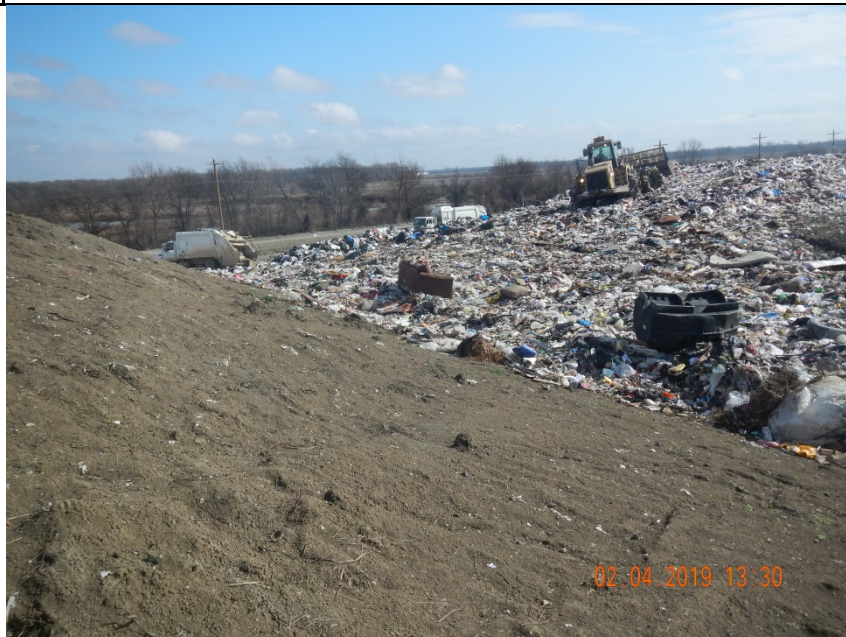
<b>Witness</b>	N/A		
<b>Photo #</b>	2	<b>Of</b>	6		<b>Date</b>	2/4/2019	<b>Time</b>	1330
<b>Description</b>	Working face observed with measurements approximately 150' X 300'.

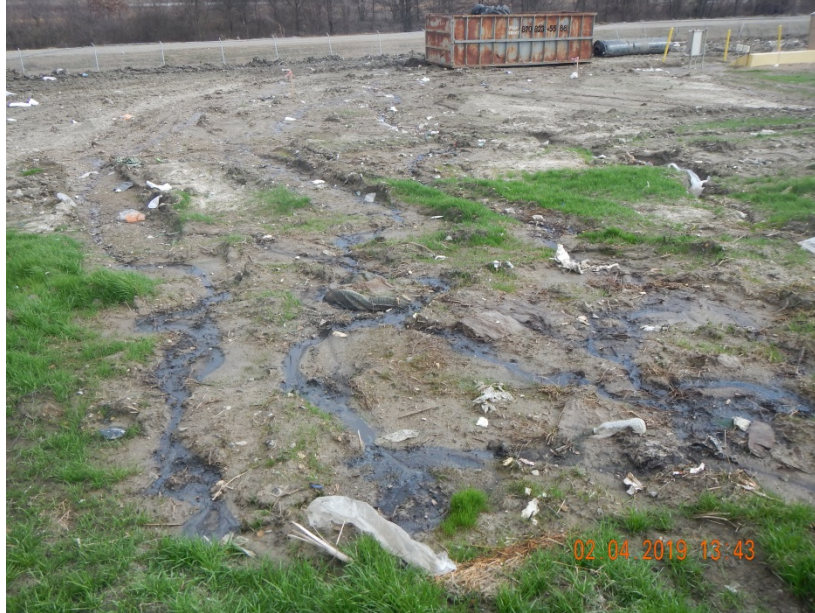
<b>Location</b>	Crittenden Co. Class 1 Landfill			<b>Permit</b>	0245-S1-R2	<b>AFIN</b>	18-00094
<b>Photographer</b>	Tobin Baker, ADEQ Solid Waste Inspector		TB	<b>Witness</b>	N/A		
<b>Photo #</b>	3	<b>Of</b>	6	<b>Date</b>	2/4/2019	<b>Time</b>	1343
<b>Description</b>	Leachate leaks observed on the east slope of Cell 3.

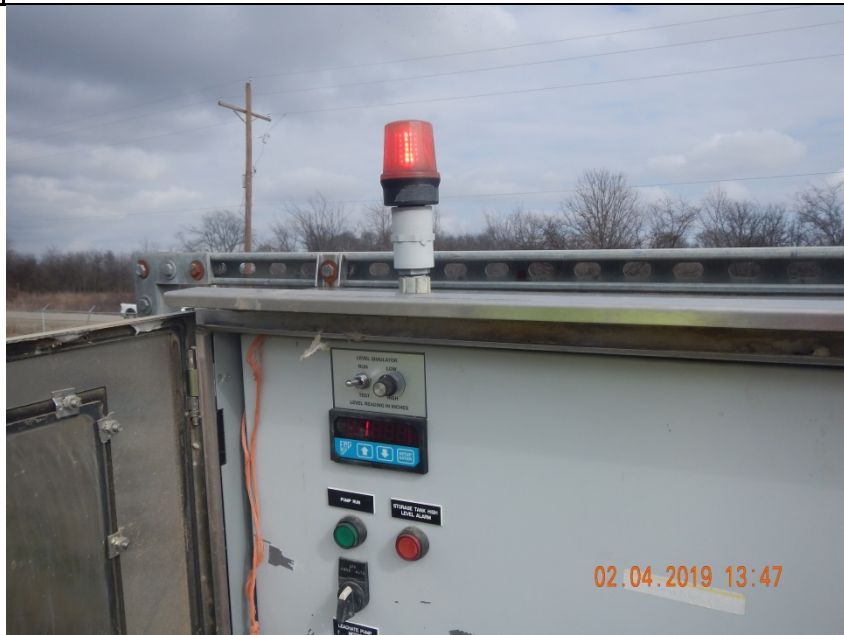
Category 2 (continued)											
	Regulation	Item Description				Comments					
X	427	Surface Water Controls				Standing water observed on interim cover on top of the landfill in Cell 1A. (Refer to Photo #6.)					
	411(h)(1)	Contouring prevents surface water flowing into or through waste									
	418(a)(b)	Run-on/off control system present and adequate									
	411(h)(2)	Surface water control prevents off-site sediment accumulation									
	411(i);427(f)	Adequate maintenance of intermediate/final cover vegetation									
	415	Gas monitoring program									
X	411(o)	Leachate leaks or evidence of leachate seepage				Leachate leaks observed in Cell 1A and on the east slope of Cell 3. (Refer to Photos #3 & #5.)					
	426	Survey controls									
X	429	Leachate collection system				Hi-level alarm light observed flashing at leachate control panel in Cell 2A, which read 102.1". (Refer to Photo #4.)

<b>Location</b>	Crittenden Co. Class 1 Landfill			<b>Permit</b>	0245-S1-R2	<b>AFIN</b>	18-00094
<b>Photographer</b>	Tobin Baker, ADEQ Solid Waste Inspector		TB	<b>Witness</b>	N/A		
<b>Photo #</b>	4	<b>Of</b>	6	<b>Date</b>	2/4/2019	<b>Time</b>	1347
<b>Description</b>	Hi level alarm light observed flashing at leachate pump control panel for Cell 2A.

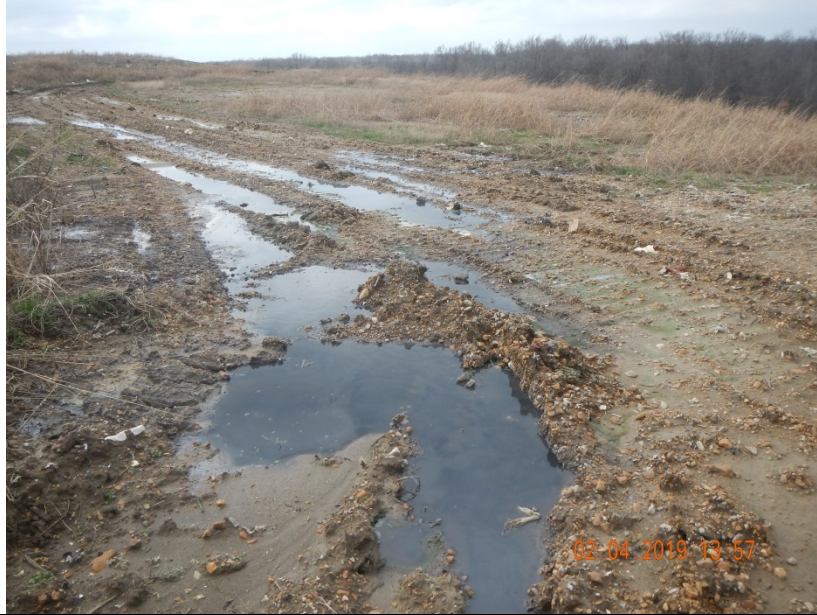
<b>Location</b>	Crittenden Co. Class 1 Landfill			<b>Permit</b>	0245-S1-R2	<b>AFIN</b>	18-00094
<b>Photographer</b>	Tobin Baker, ADEQ Solid Waste Inspector		TB	<b>Witness</b>	N/A		
<b>Photo #</b>	5	<b>Of</b>	6	<b>Date</b>	2/4/2019	<b>Time</b>	1357
<b>Description</b>	Leachate leaks observed in Cell 1A.

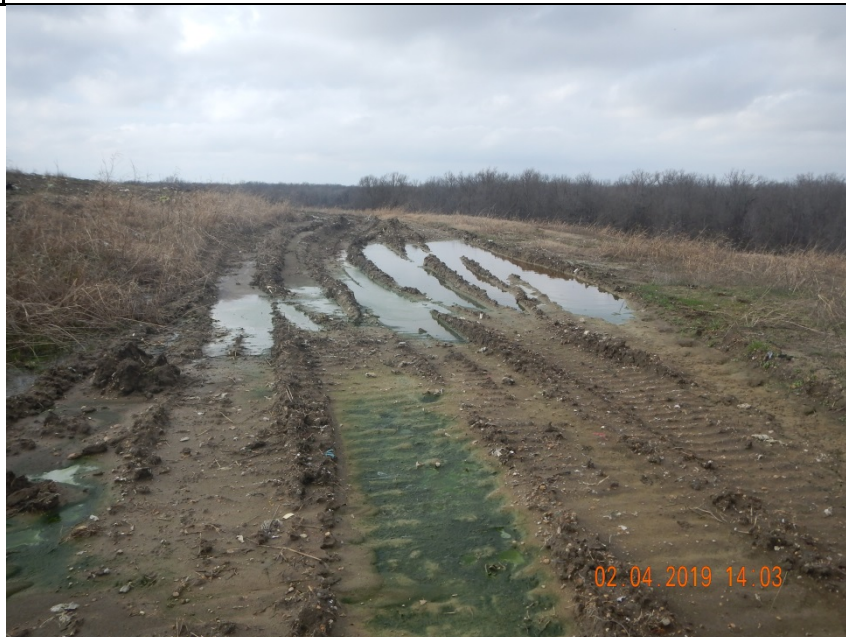
<b>Location</b>	Crittenden Co. Class 1 Landfill			<b>Permit</b>	0245-S1-R2	<b>AFIN</b>	18-00094
<b>Photographer</b>	Tobin Baker, ADEQ Solid Waste Inspector		TB	<b>Witness</b>	N/A		
<b>Photo #</b>	6	<b>Of</b>	6	<b>Date</b>	2/4/2019	<b>Time</b>	1403
<b>Description</b>	Standing water observed on interim cover on top of the landfill in Cell 1A.
