RE: Quarterly Inspection conducted on March 19, 2019
AFIN 03-00051
Permit Number 0249-S1-R2

**Arkansas Department of Environmental Quality
Office of Land Resources-Solid Waste Management
Class 1 Landfill Inspection**

Site Name	NABORS Landfill	County	Baxter	AFIN	03-00051
Facility Address	Mountain Home, Hwy 5N to CR16 to site entrance	Phone Number	870-425-3213 870-656-9463	Permit Number	0249-S1-R2
Permittee Address	P.O. Box 1715, Mountain Home, AR, 72602	E-Mail Address		PDS #	107296
Date	3/19/2019	Entry Time	1040	Exit Time	1140

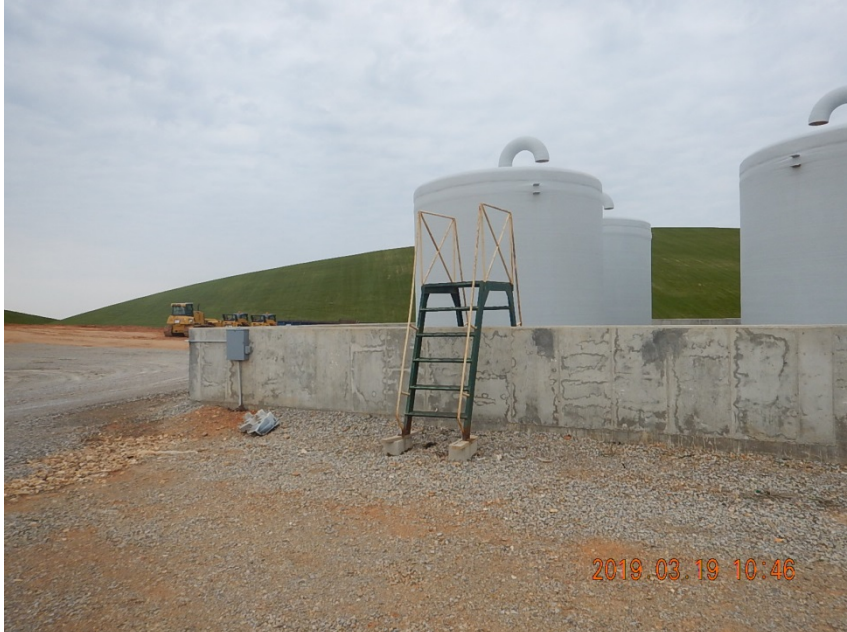
Location	NABORS Class 1			Permit	0249-S1-R2	AFIN	03-00051
Photographer	Darrell Norton, ADEQ Solid Waste Inspector		<i>DN</i>	Witness	N/A		
Photo #	1	Of	4	Date	3/19/2019	Time	1046
Description	A view of the tank farm and secondary containment.

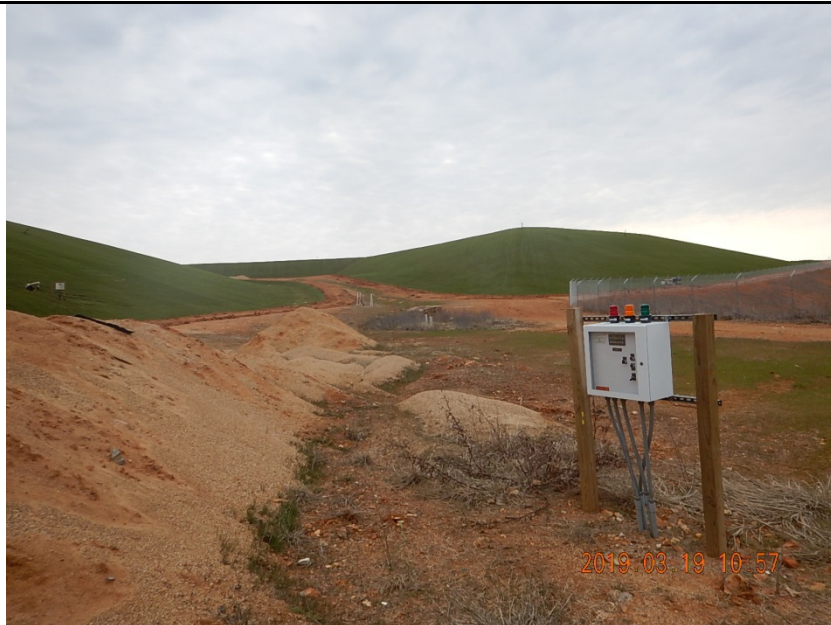
Location	NABORS Class 1			Permit	0249-S1-R2	AFIN	03-00051
Photographer	Darrell Norton, ADEQ Solid Waste Inspector		<i>DN</i>	Witness	N/A		
Photo #	2	Of	4	Date	3/19/2019	Time	1057
Description	A view of the leachate panel and service roads southeast of Area 1-2.

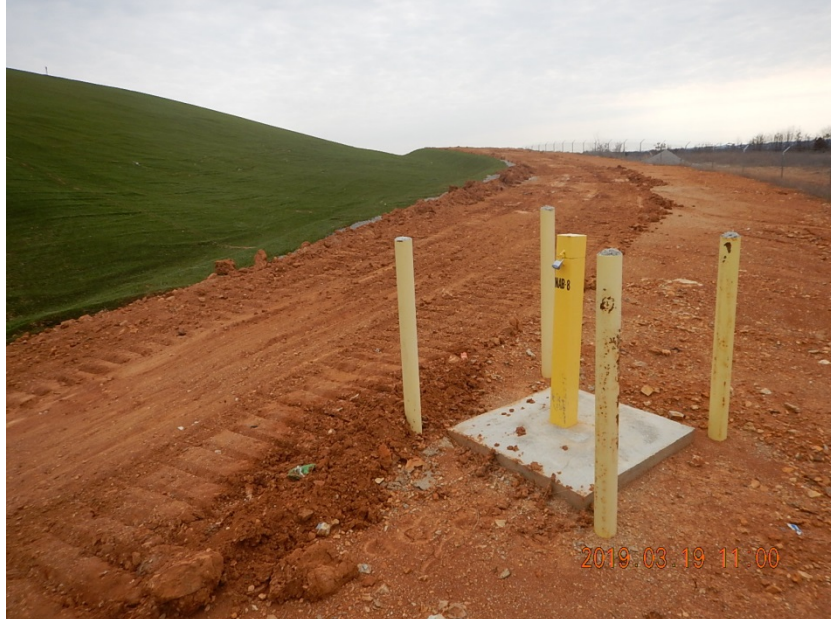
Location	NABORS Class 1			Permit	0249-S1-R2	AFIN	03-00051
Photographer	Darrell Norton, ADEQ Solid Waste Inspector		<i>DN</i>	Witness	N/A		
Photo #	3	Of	4	Date	3/19/2019	Time	1100
Description	A view of monitoring well NAB-8, south of Area 1-3.

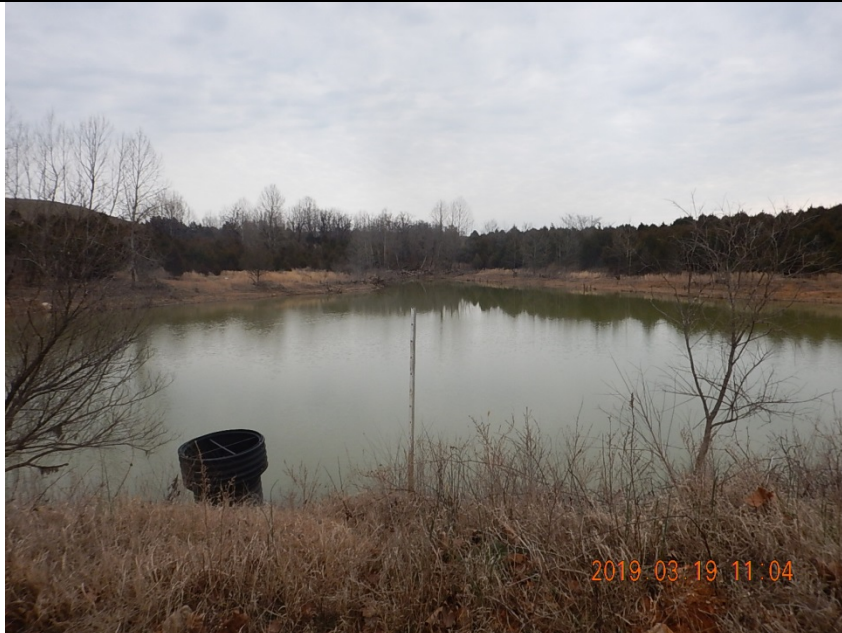
Location	NABORS Class 1			Permit	0249-S1-R2	AFIN	03-00051
Photographer	Darrell Norton, ADEQ Solid Waste Inspector		<i>DN</i>	Witness	N/A		
Photo #	4	Of	4	Date	3/19/2019	Time	1104
Description	A view of the sedimentation basin north of Area 1-2.
