RE: Quarterly Inspection conducted on May 16, 2019
AFIN 63-00155
Permit Number 0261-S1-R3

Arkansas Department of Environmental Quality
Office of Land Resources – Solid Waste Management
Class 1 Landfill Inspection

Site Name	BFI Waste Systems of Arkansas, LLC.- Class 1	County	Saline	AFIN	63-00155
Facility Address	18511 W. Sardis Road, Bauxite, AR 72011	Phone Number	870-946-5583 Heath 501-602-8440 Robert	Permit Number	0261-S1-R3
Permittee Address	18511 W. Sardis Road, Bauxite, AR 72011	E-Mail Address	Hlockley@republicservices.com	PDS #	108077
Date	5/16/2019	Entry Time	0840	Exit Time	1126

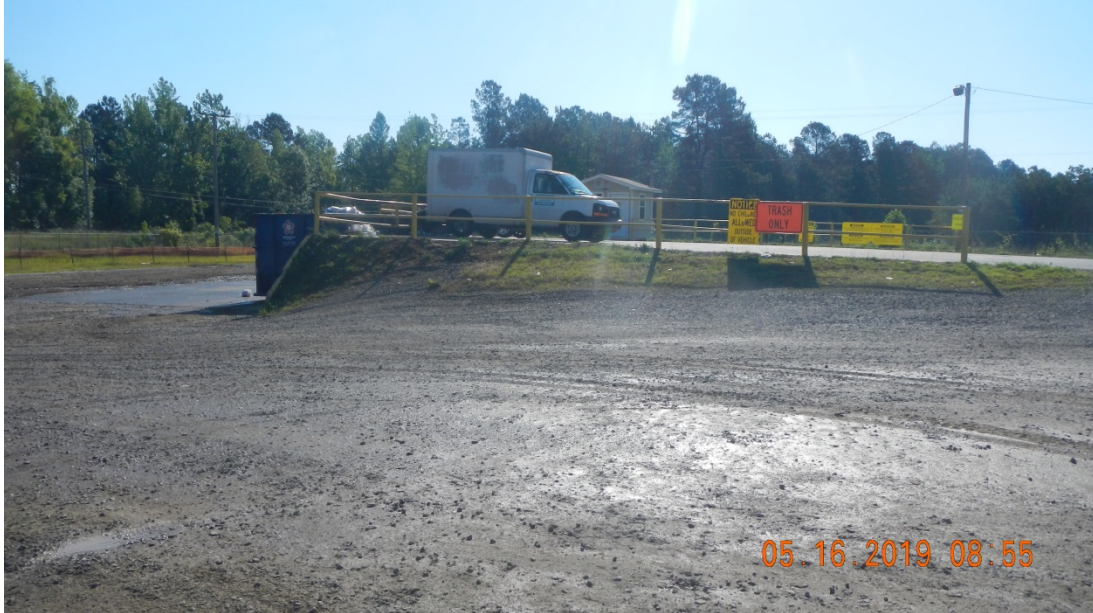
Location	BFI Waste Systems of Arkansas, LLC			Permit	0261-S1-R3	AFIN	63-00155
Photographer	Kim Davenport, ADEQ Solid Waste Inspector		<i>KD</i>	Witness	Robert Sanchez, Operator		
Photo #	1	Of	8	Date	5/16/2019	Time	0855
Description	Northeast view of the convenience area with new signage and litter fencing observed.

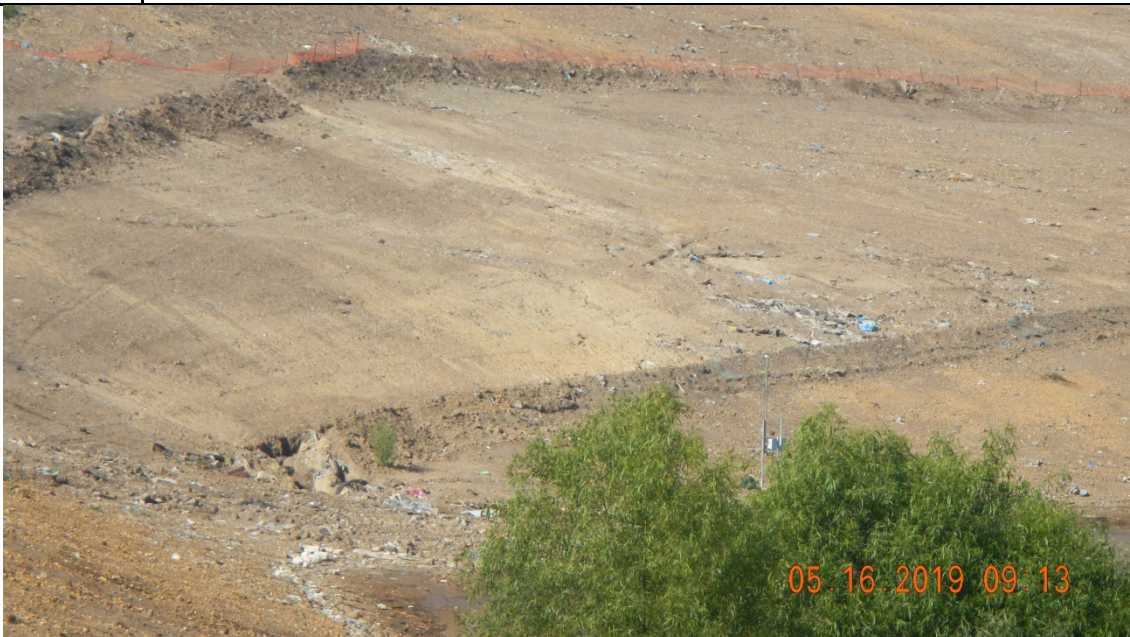
Location	BFI Waste Systems of Arkansas, LLC			Permit	0261-S1-R3	AFIN	63-00155
Photographer	Kim Davenport, ADEQ Solid Waste Inspector		<i>KD</i>	Witness	Robert Sanchez, Operator		
Photo #	2	Of	8	Date	5/16/2019	Time	0913
Description	Northeast slope of the landfill with litter fence and berm observed.

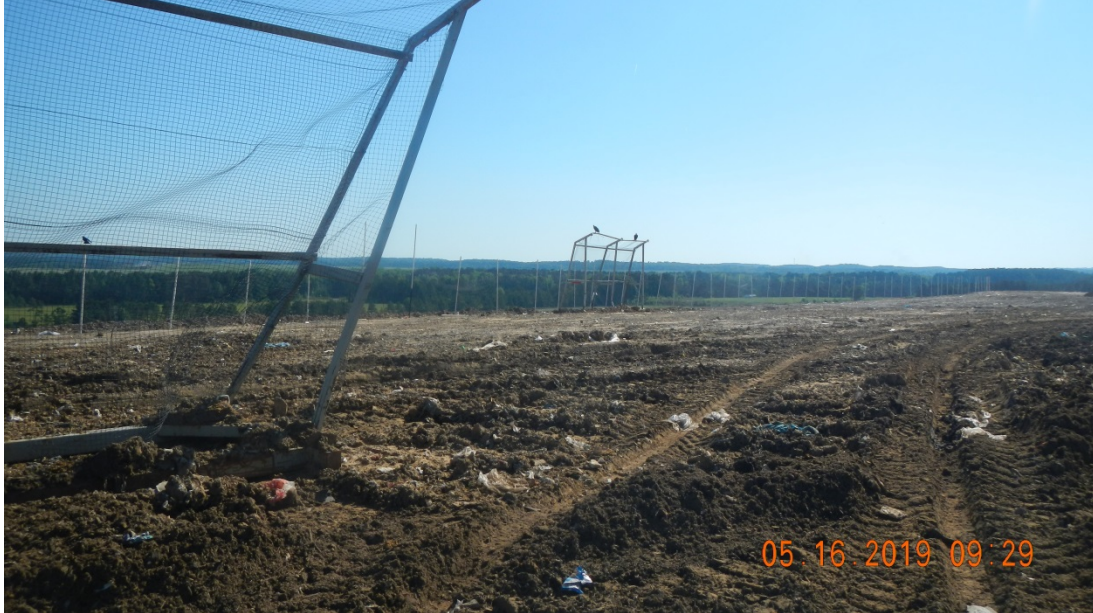
Location	BFI Waste Systems of Arkansas, LLC			Permit	0261-S1-R3	AFIN	63-00155
Photographer	Kim Davenport, ADEQ Solid Waste Inspector		<i>KD</i>	Witness	Robert Sanchez, Operator		
Photo #	3	Of	8	Date	5/16/2019	Time	0929
Description	Northeast view of the primary and secondary litter fencing observed near the working face.

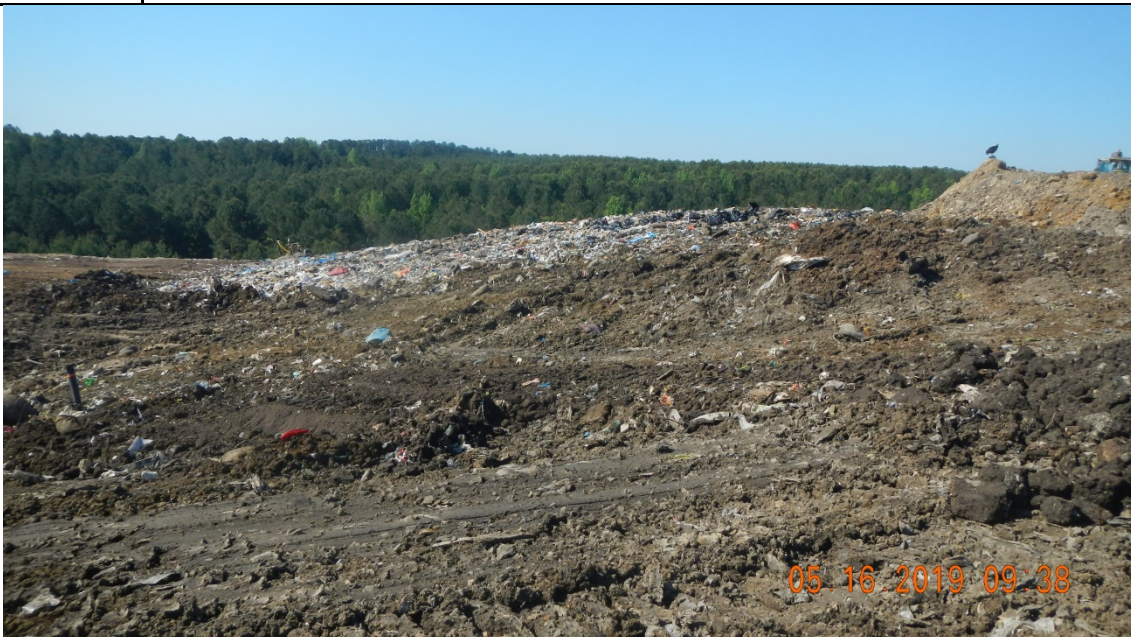
Location	BFI Waste Systems of Arkansas, LLC			Permit	0261-S1-R3	AFIN	63-00155
Photographer	Kim Davenport, ADEQ Solid Waste Inspector		<i>KD</i>	Witness	Robert Sanchez, Operator		
Photo #	4	Of	8	Date	5/16/2019	Time	0938
Description	Southern view of the working face in Cell 2.

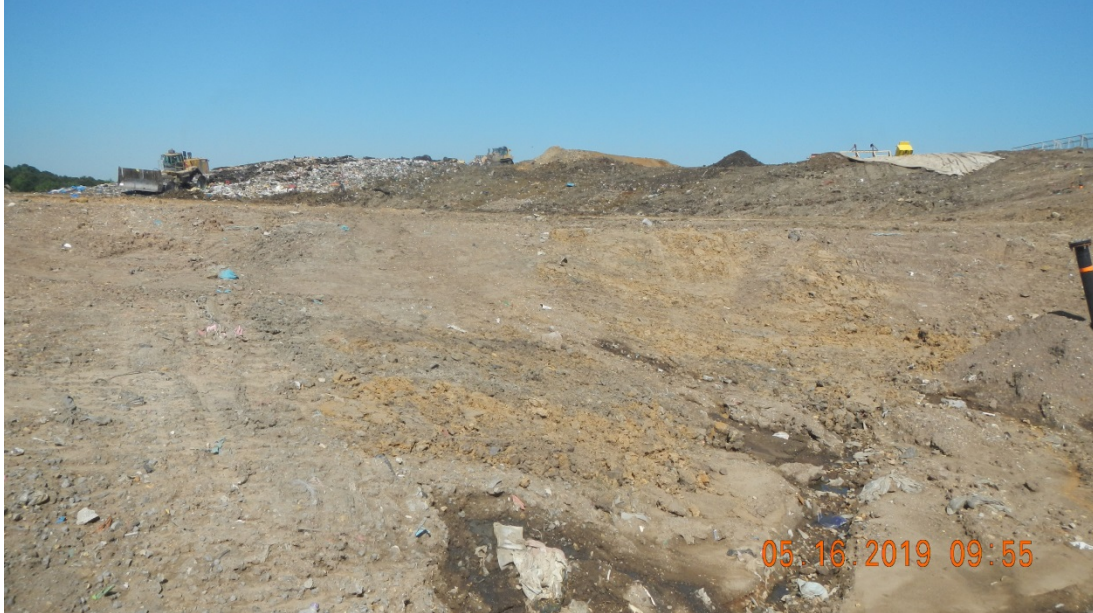
Regulation	Item Description	Comments
	427	Surface Water Controls	
	411(h)(1)	Contouring prevents surface water flowing into or through waste	
	418(a)(b)	Run-on/off control system present and adequate	
	411(h)(2)	Surface water control prevents off-site sediment accumulation	
	411(i);427(f)	Adequate maintenance of intermediate/final cover vegetation	
	415	Gas monitoring program	An area of gas release (bubbling) observed at Cell 2, Zones 2 & 3. (Refer to Photo #8.) Refer to the Office of Air Quality.
X	411(o)	Leachate leaks or evidence of leachate seepage	Leachate observed in Cell 2, Zones 1 & 2, and entering storm water drain before emerging and pooling at Cell 2, Zones 3 & 4. (Refer to Photos #5 - #8.)
	426	Survey controls	
	429	Leachate collection system	
	420	Liquid Restrictions

Location	BFI Waste Systems of Arkansas, LLC				Permit	0261-S1-R3	AFIN	63-00155
Photographer	Kim Davenport, ADEQ Solid Waste Inspector		<i>KD</i>		Witness	Robert Sanchez, Operator		
Photo #	5	Of	8		Date	5/16/2019	Time	0955
Description	Leachate leak observed at Cell 2, Zones 1 & 2.

Good eveninin Kim,
We have made repairs to seep, gas collection system and continue to monitor for seeps and bubbling. We continue to pick litter continiously and continue to take measures to prevent uncontrolled windblown liter. If any questions or concerns please let me know.

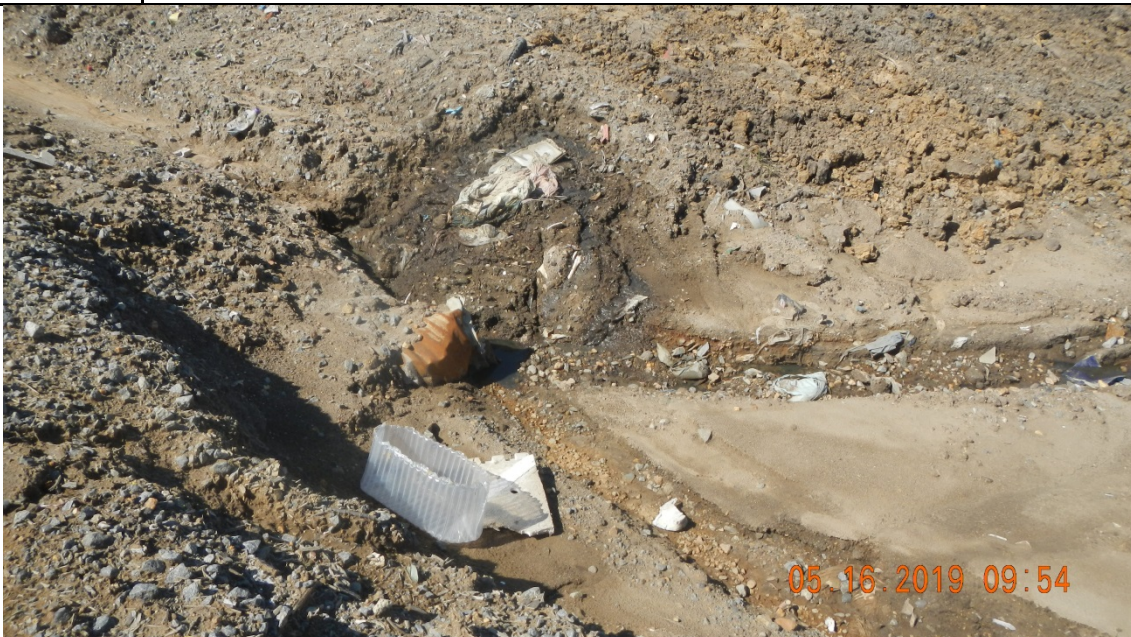
Location	BFI Waste Systems of Arkansas, LLC				Permit	0261-S1-R3	AFIN	63-00155
Photographer	Kim Davenport, ADEQ Solid Waste Inspector		<i>KD</i>		Witness	Robert Sanchez, Operator		
Photo #	6	Of	8		Date	5/16/2019	Time	0954
Description	Leachate shown in Photo #5 observed entering the storm drain culvert.

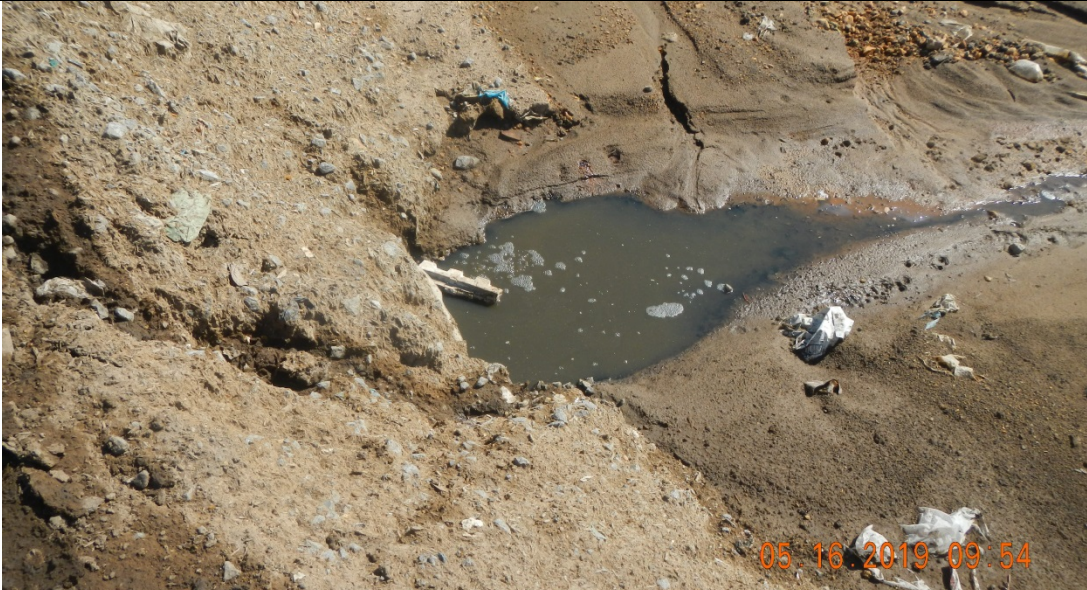
Location	BFI Waste Systems of Arkansas, LLC			Permit	0261-S1-R3	AFIN	63-00155
Photographer	Kim Davenport, ADEQ Solid Waste Inspector		<i>KD</i>	Witness	Robert Sanchez, Operator		
Photo #	7	Of	8	Date	5/16/2019	Time	0955
Description	Leachate shown in Photos #5 & #6 emerges from the storm drain culvert in Cell 2, Zones 3 & 4, and pools in this area.

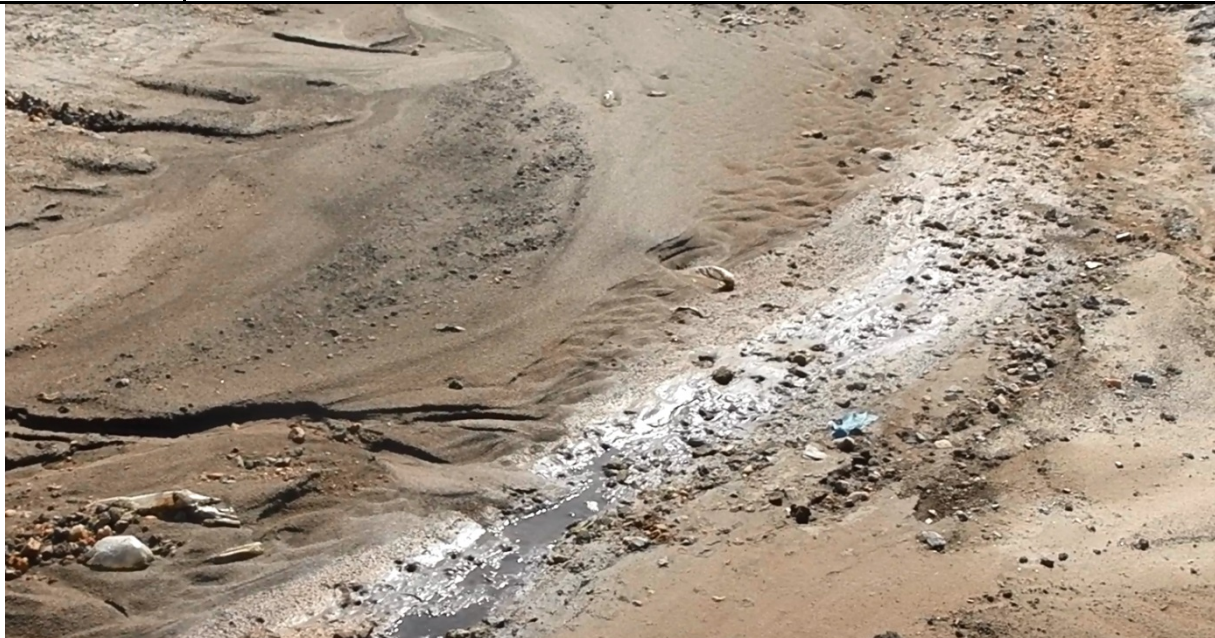
Location	BFI Waste Systems of Arkansas, LLC			Permit	0261-S1-R3	AFIN	63-00155
Photographer	Kim Davenport, ADEQ Solid Waste Inspector		<i>KD</i>	Witness	Robert Sanchez, Operator		
Photo #	8	Of	8	Date	5/16/2019	Time	0955
Description	This screen shot is taken from a short video to show bubbling and pooling leachate observed in Cell 2, Zones 2 & 3.
