ARKANSAS
Department of Environmental Quality

OFFICE OF WATER QUALITY INSPECTION REPORT

NAME:
LRWRA - Cameron V&M

This Industrial User inspection of Cameron Valve and Measurement was conducted as part of the Pretreatment Compliance Inspection of the Little Rock Water Reclamation Authority's pretreatment program.

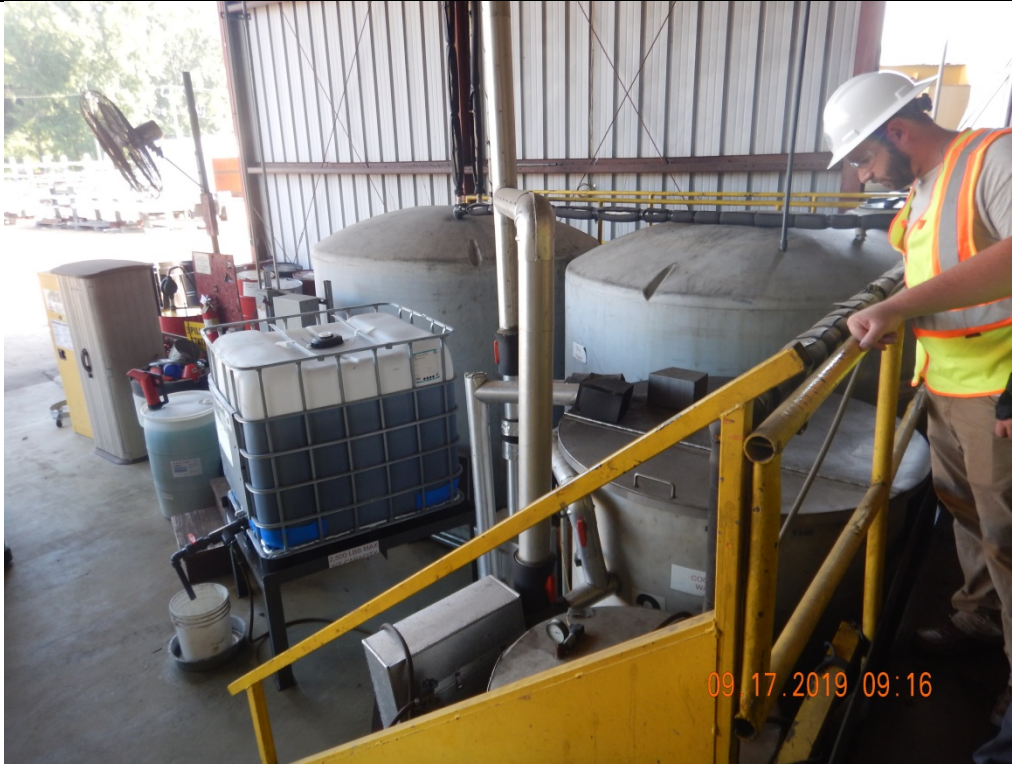
All process wastewater is stored in tanks and disposed of by Heritage Crystal Clean. No process wastewater is discharged to the sanitary sewer. The storage tanks capacities are 2,500 gallons each. The storage tanks and other fluid storage containers such as totes and barrels are contained within secondary containment and under cover and not exposed to rainfall. The floor of the secondary containment area has also been treated so no fluids can seep into it. There is a sump pump within secondary containment that will pump any spilled fluids back into the holding tanks in case of a spill. All floor drains in the facility have been sealed. Spill kits are located throughout the facility and any fluid storage containers within the production area are on secondary containment structures.

Location:	LRWRA - Cameron V&M		
Photographer:	Jason Bolenbaugh	Date:	9/17/2019
Time:	09:16	Photo #:	1
Witness:			
Description:	View of process water storage tanks (2 – 25,000 gallon) in the background within secondary containment and under cover.

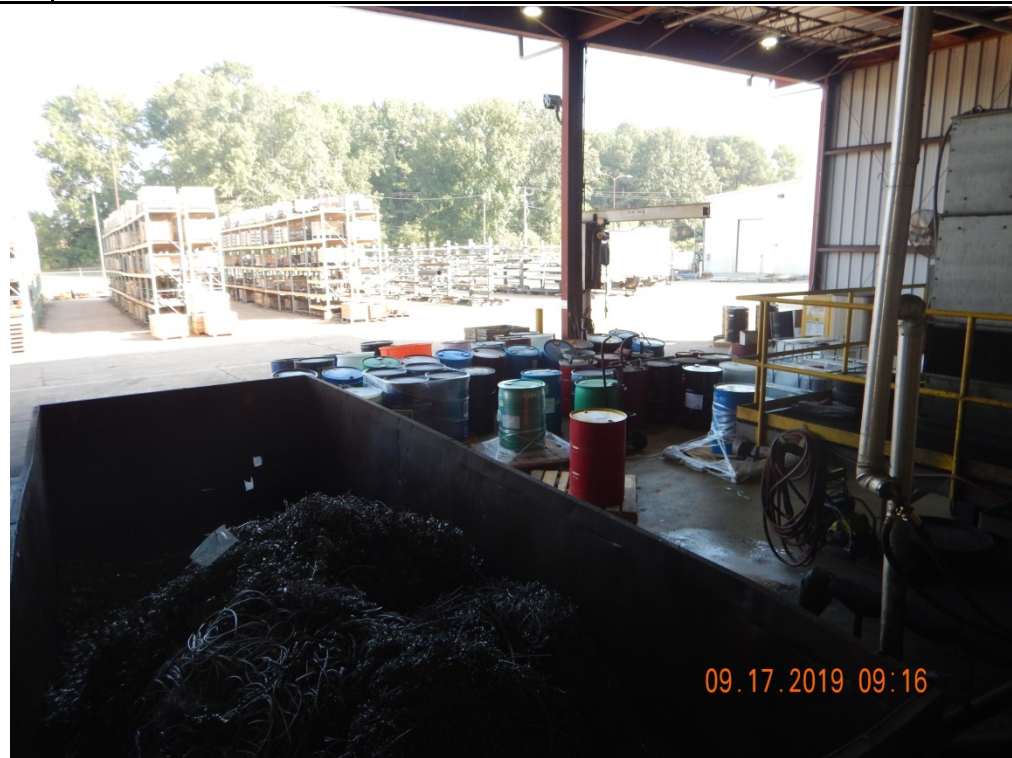
Photographer:	Jason Bolenbaugh	Date:	9/17/2019
Time:	09:16	Photo #:	2
Witness:			
Description:	Another view of stored fluid containers and solids storage within secondary containment and under cover.

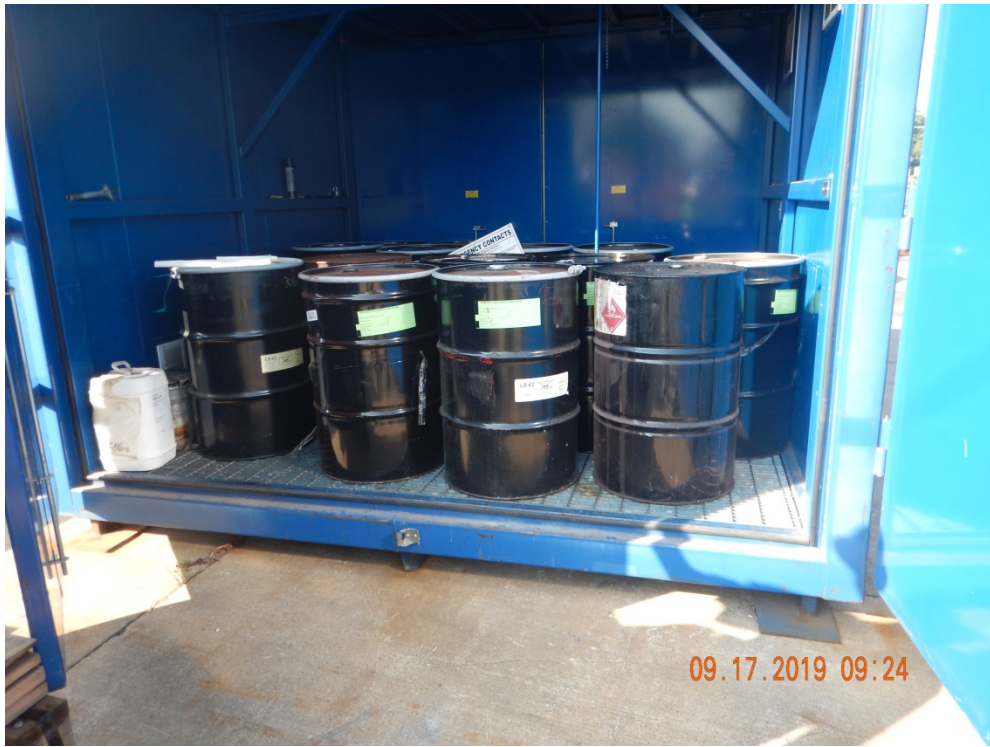
Hazardous waste is stored on site and is disposed of by Rineco on a monthly basis. Hazardous waste is stored in a container on the north side of the facility. There were approximately ten 55-gallon drums stored in the container. A minor concern of this location was if a drum was to be spilled, the material could flow off-site before the spill response team could respond. The facility maintains a spill response team and they conduct biannual drills.

Office of Water Quality Photographic Evidence Sheet			
Location:	LRWRA - Cameron V&M		
Photographer:	Jason Bolenbaugh	Date:	9/17/2019
Time:	09:24	Witness:	
Photo #:	3	Description:	Hazardous waste storage unit.

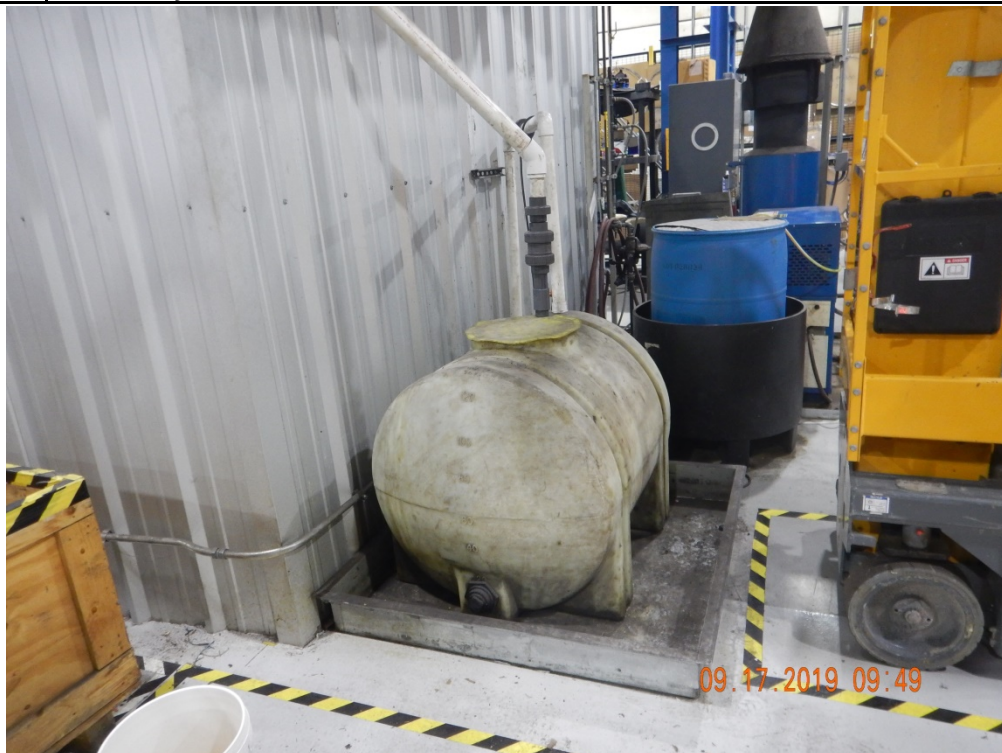
All coolant from machining processes is sent to the holding tanks. The parts washing units have recirculation tanks to reuse water. No washing activities are conducted in paint booths and only a first coat primer is painted on the parts. Parts are typically painted at other contracted locations.

Photographer:	Jason Bolenbaugh	Date:	9/17/2019
Time:	09:49	Witness:	
Photo #:	4	Description:	Water reuse circulation tank at the painting facility. All fluid containers within secondary containment.

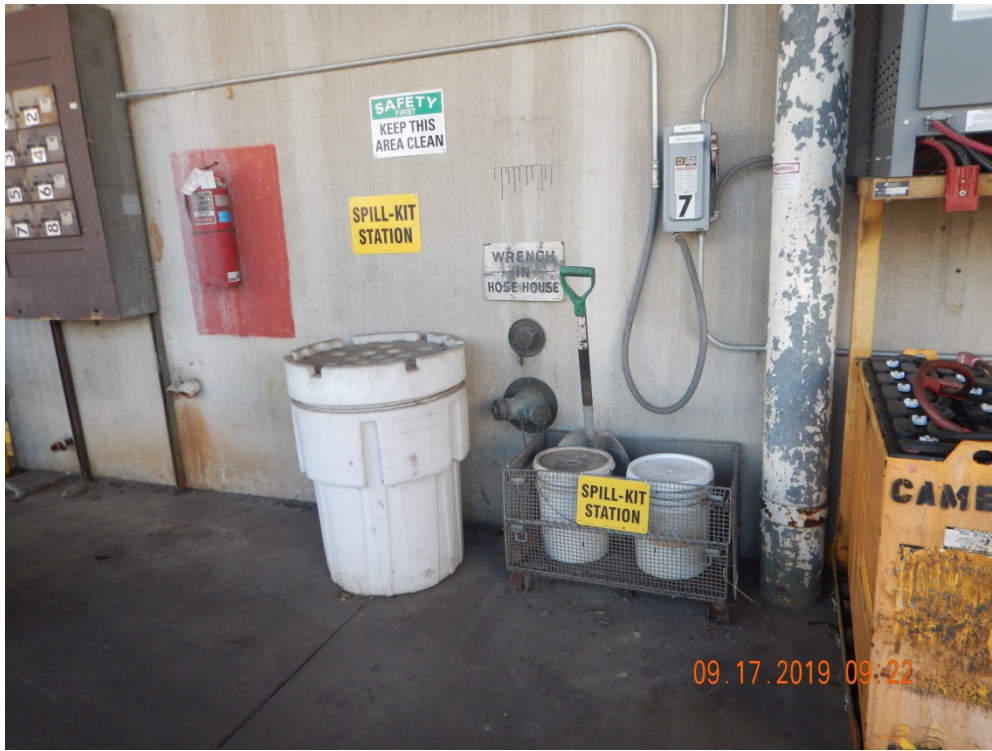
Location:	LRWRA - Cameron V&M		
Photographer:	Jason Bolenbaugh	Date:	9/17/2019
Time:	09:22	Witness:	
Photo #:	5	Description:	Spill kit station and materials near the process water storage tank area.

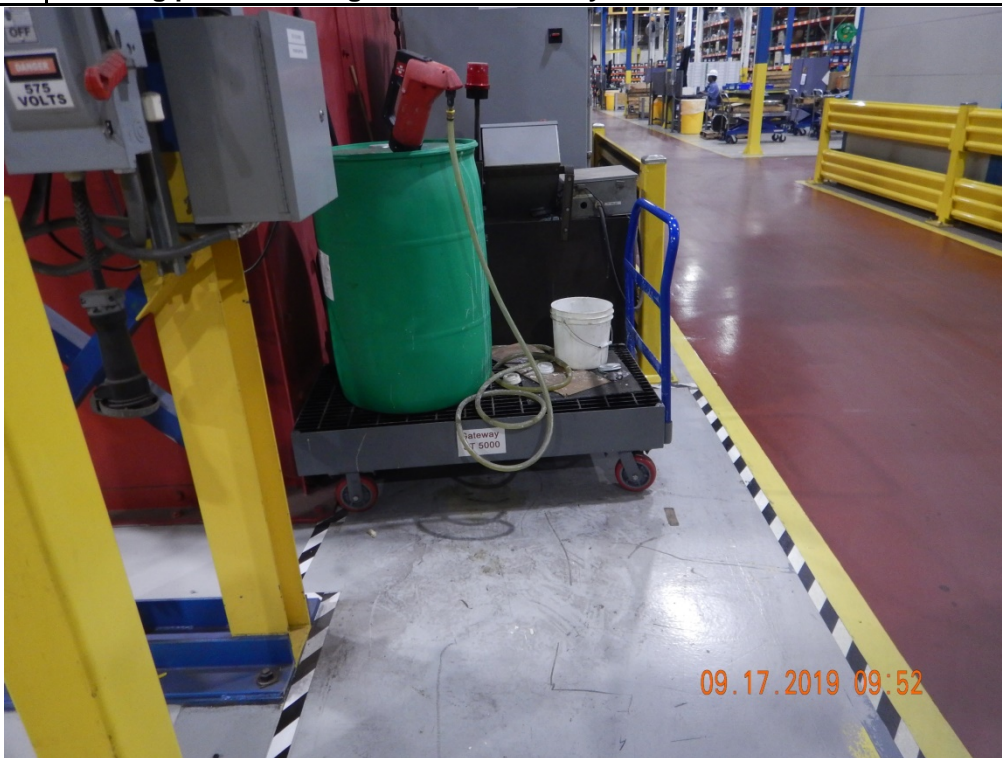
Photographer:	Jason Bolenbaugh	Date:	9/17/2019
Time:	09:52	Witness:	
Photo #:	6	Description:	Cleaning product storage within secondary containment.

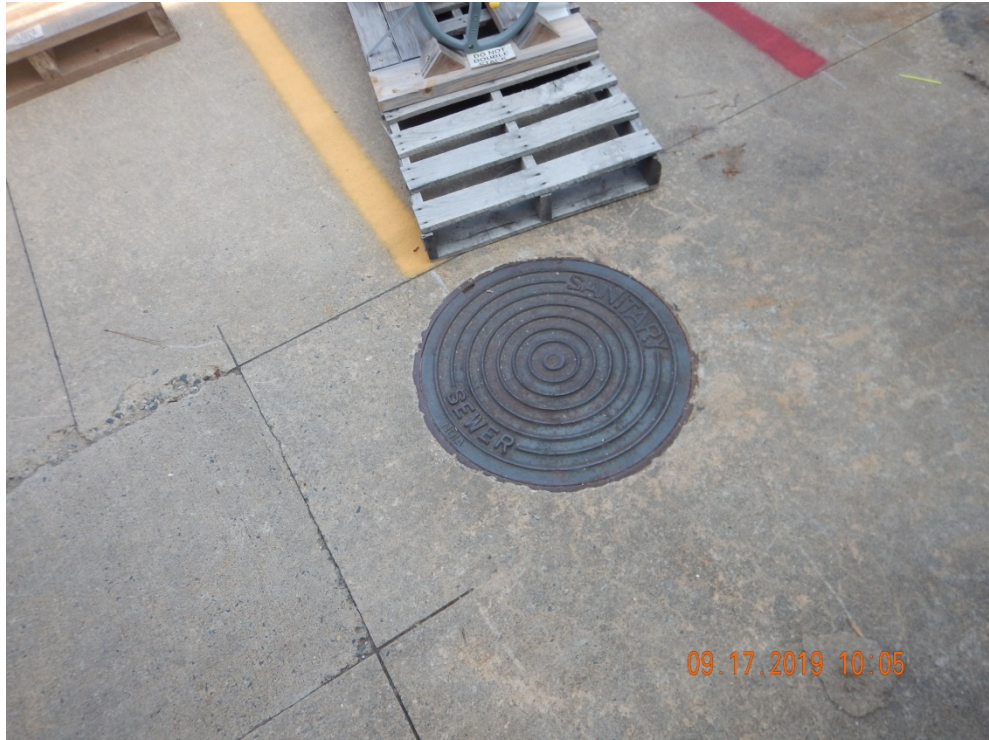
The sampling location is a manhole on the northeast side of the building in which the cooling tower blowdown is tested.

Location:	LRWRA - Cameron V&M		
Photographer:	Jason Bolenbaugh	Date:	9/17/2019
Witness:		Time:	10:05
		Photo #:	7
Description:	Outfall sampling location of cooling tower water that discharges to sanitary sewer.
