## OFFICE OF WATER QUALITY INSPECTION REPORT

NAME:  
**LRWRA - Little Rock Quick Rice**

This Industrial User inspection of Little Rock Quick Rice was conducted as part of the Pretreatment Compliance Inspection of the Little Rock Water Reclamation Authority's pretreatment program. The inspection of Little Rock Quick Rice will be tracked under the above reference NPDES permit number.

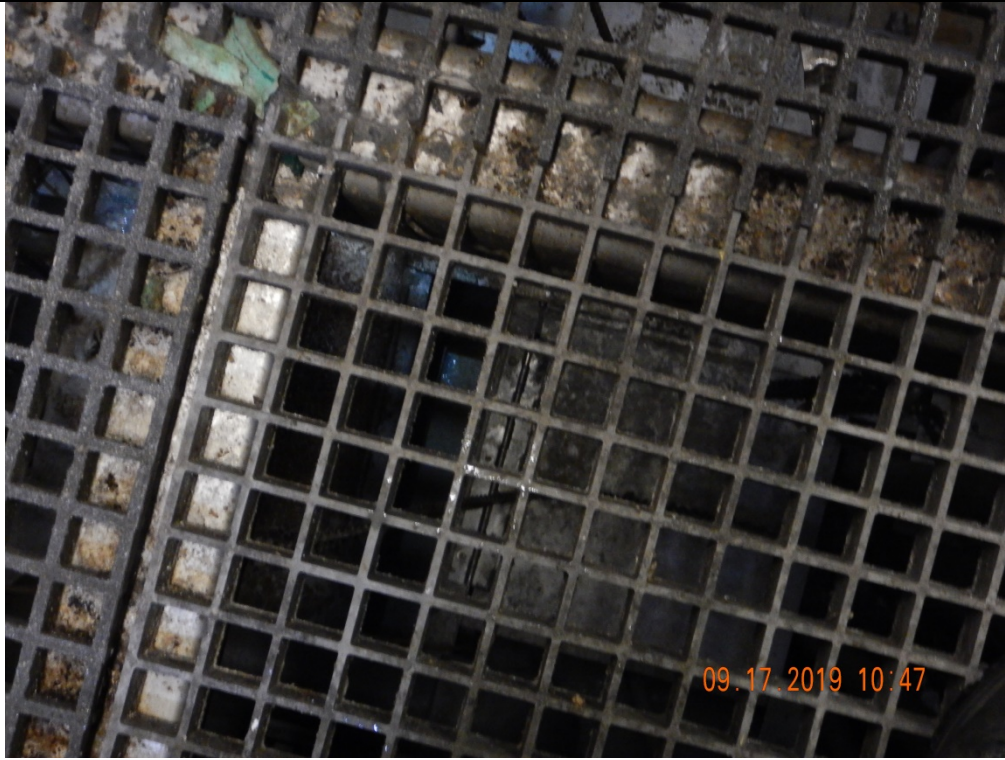
Location:	LRWRA - Little Rock Quick Rice				
Photographer:	Jason Bolenbaugh	Date:	9/17/2019	Time:	10:47
Witness:				Photo #:	1
Description:	Below the grates is a pit that contains storage containers for process wastewater and other wastewater. No visual inspection was made from the pit area.

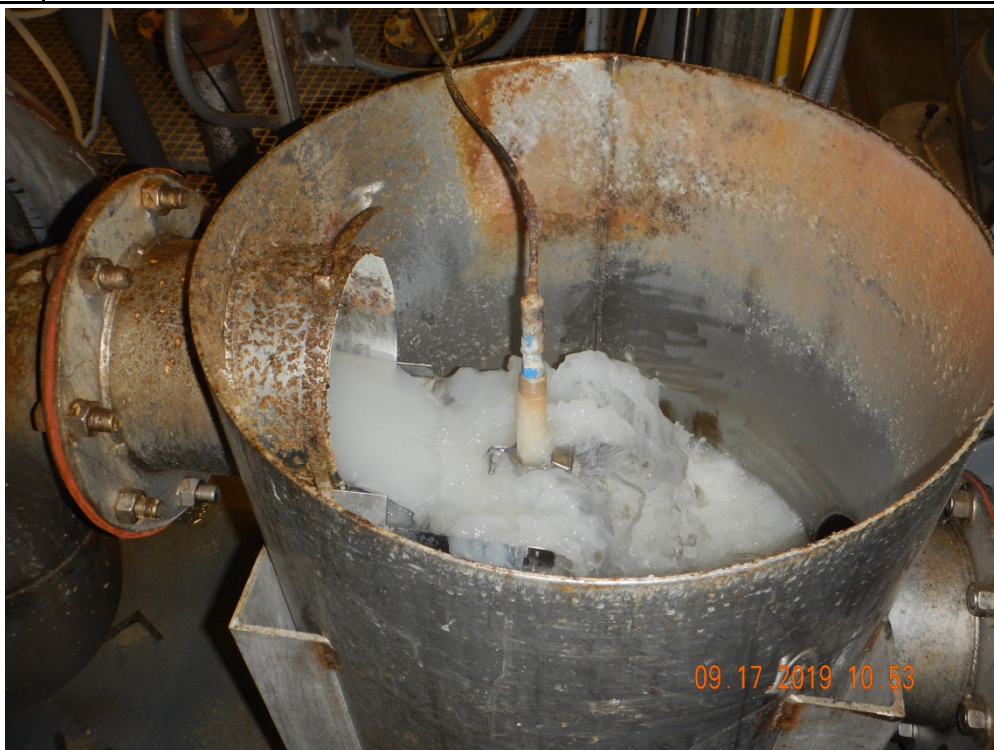
Photographer:	Jason Bolenbaugh	Date:	9/17/2019	Time:	10:53
Witness:				Photo #:	2
Description:	pH monitoring point of process wastewater.

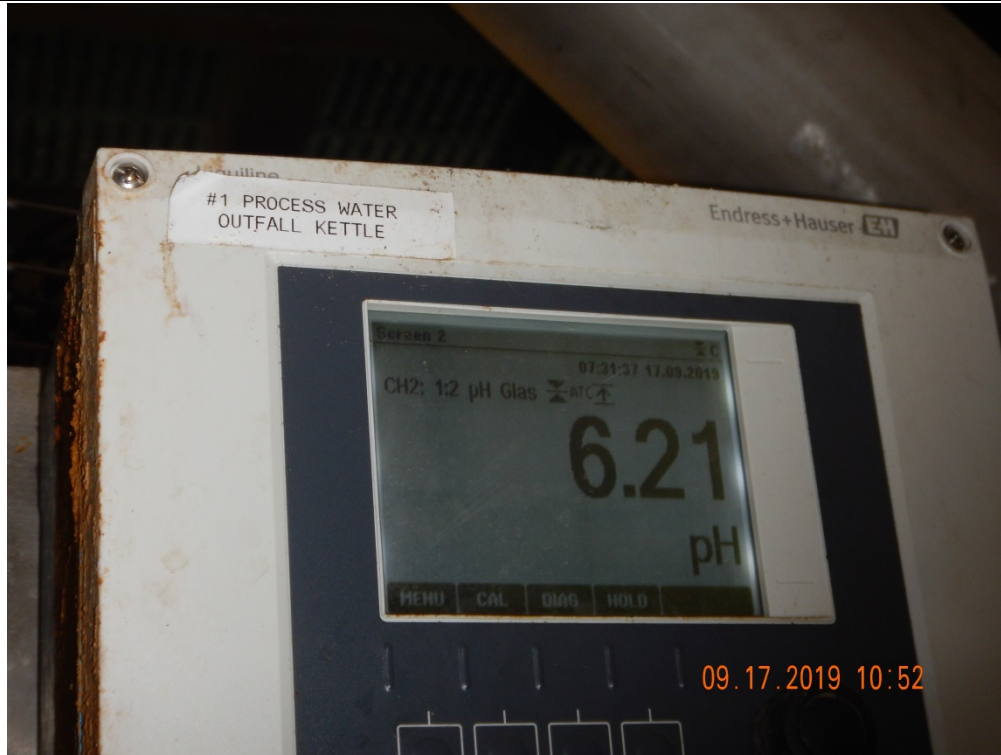
Location:	LRWRA - Little Rock Quick Rice		
Photographer:	Jason Bolenbaugh	Date:	9/17/2019
Time:	10:52	Witness:	
Photo #:	3	Description:	pH reading of process wastewater.

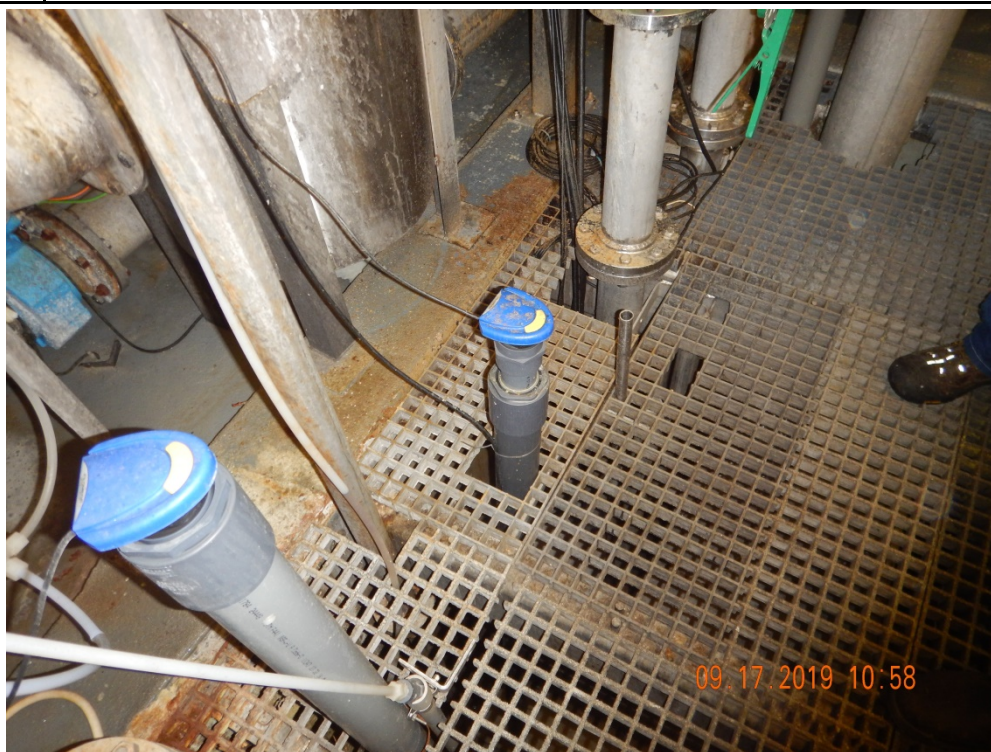
Photographer:	Jason Bolenbaugh	Date:	9/17/2019
Time:	10:58	Witness:	
Photo #:	4	Description:	Sensor that monitors the depth of water that can accumulate in the pit. This sensor works but the warning was ignored by staff.

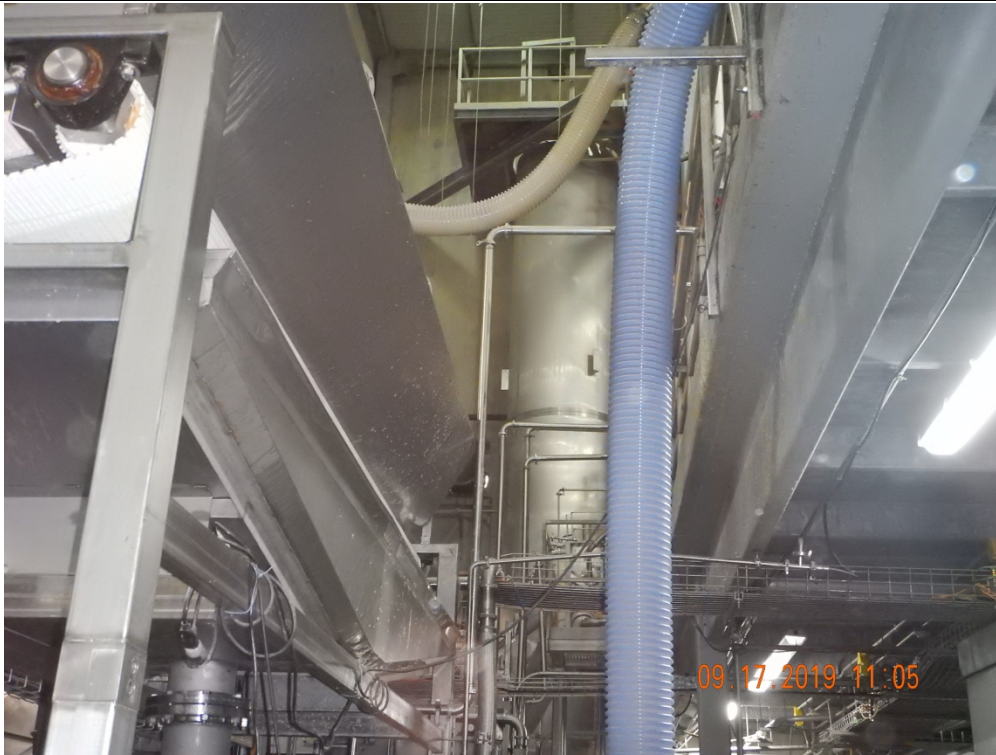
Location:	<b>LRWRA - Little Rock Quick Rice</b>		
Photographer:	<b>Jason Bolenbaugh</b>	Date:	<b>9/17/2019</b>
Time:	<b>11:05</b>	Witness:	
Photo #:	<b>5</b>	Description: <b>New installation of recirculation tank.</b>

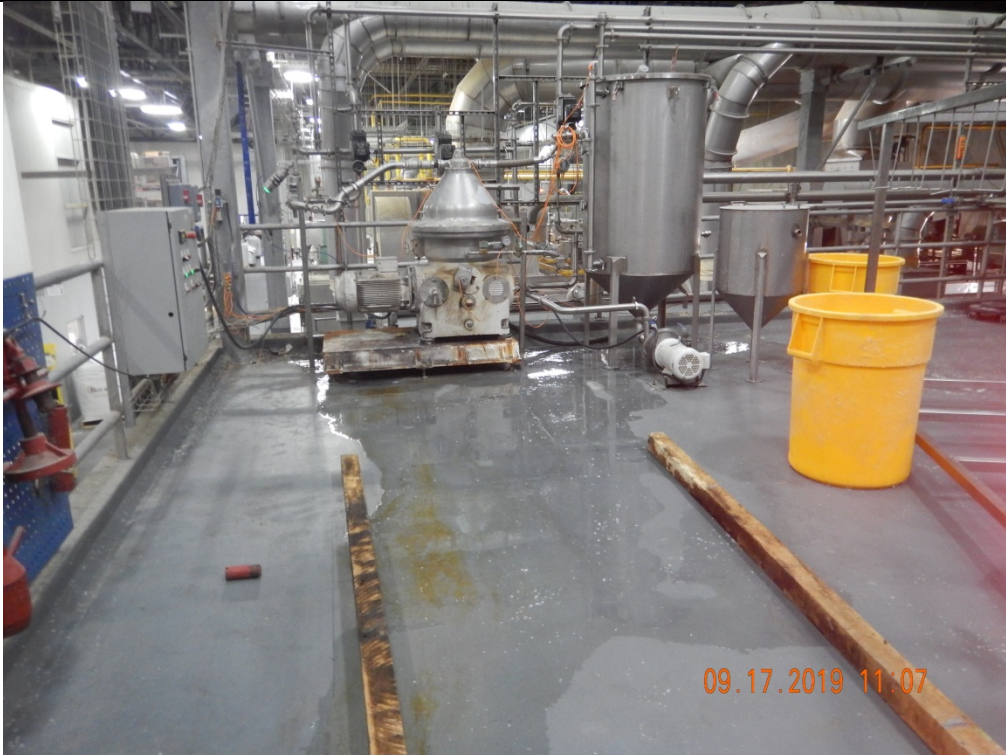
Photographer:	<b>Jason Bolenbaugh</b>	Date:	<b>9/17/2019</b>
Time:	<b>11:07</b>	Witness:	
Photo #:	<b>6</b>	Description: <b>Existing centrifuge. The facility is preparing to install a new one.</b>

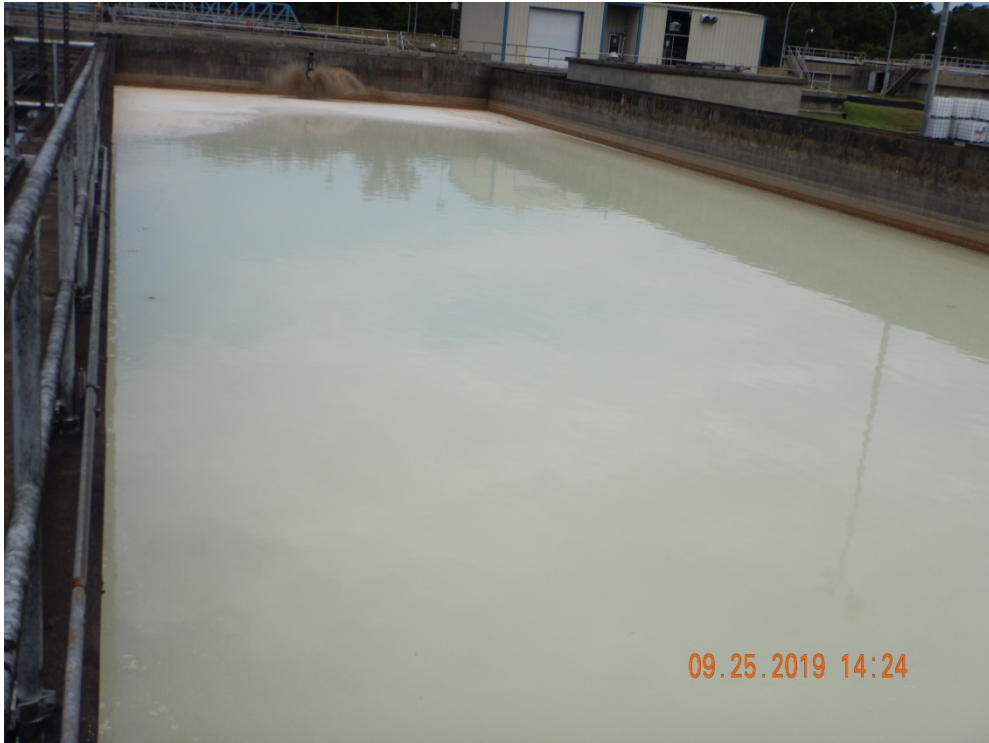
On Monday, September 16, 2019, the staff at the Fourche Creek Water Reclamation Facility determined Little Rock Quick Rice was discharging process wastewater directly to the headworks of the treatment plant rather than to the designated EQ basin. Upon investigation by treatment personnel it was determined Little Rock Quick Rice had experienced an overflow due to a pump failure that occurred on September 13. The failure caused process wastewater to overflow into the storage pit which filled to a level that allowed process water to discharge into the tank that holds domestic wastewater and caused the discharge to the headworks of the WRF. A level sensor is in place that monitors water levels within the storage pit and will send an alarm notice to the control room of the facility. The level sensor was functioning during the discharge to the domestic wastewater line and an alarm was sent to the facility's control room, however, the alarm was ignored by facility staff. The facility's inability to report the spill and discharge to the domestic wastewater collection system is in violation of Part II, Section D, Condition 1 of the pretreatment program's issued permit. LRWRA is currently working on enforcement action at this time.

Location:	<b>LRWRA - Little Rock Quick Rice</b>		
Photographer:	<b>Jason Bolenbaugh</b>	Date:	<b>9/25/2019</b>
Time:	<b>14:24</b>	Witness:	
Photo #:	<b>7</b>	Description:	<b>EQ basin located at the Fourche Creek Water Reclamation Facility that receives only process wastewater from the Little Rock Quick Rice facility.</b>
