**RE: Quarterly Inspection conducted on November 5, 2019**  
**AFIN 16-00923**  
**Permit Number 0254-S1-R4**

**Arkansas Division of Environmental Quality  
Office of Land Resources - Solid Waste Management  
Class 1 Landfill Inspection**

| <b>Site Name</b> | Legacy Landfill | <b>County</b> | Craighead | <b>AFIN</b> | 16-00199 |

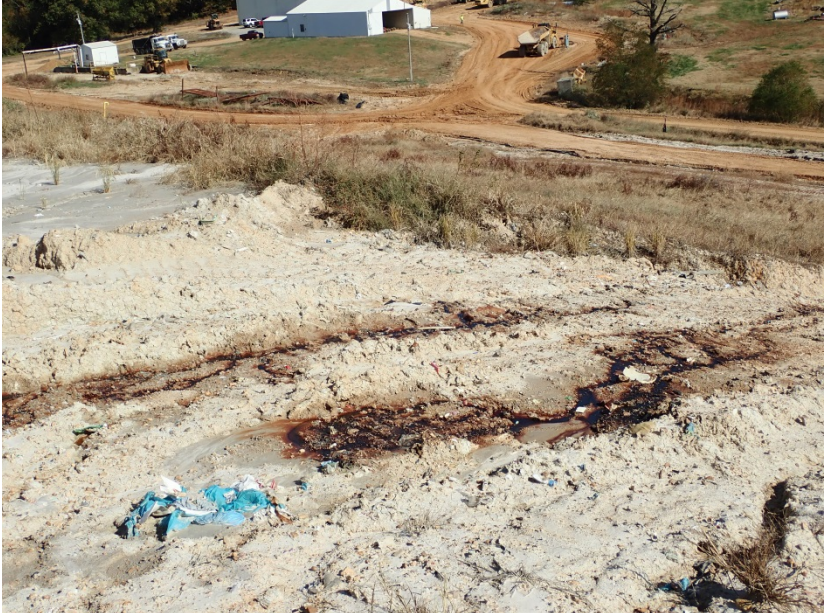
| <b>Photo #</b> | 1 | <b>Of</b> | 2 | | <b>Date</b> | 11/5/2019 | <b>Time</b> | 1118 |

| Category 2 (continued) | | | | | | | | | | | | | | |
|---|---|---|---|---|---|---|---|---|---|---|---|---|---|---|
| X | 411(o) | Leachate leaks or evidence of leachate seepage | | | | | | Leachate leaks observed on the east slope of Cell 3. (Refer to Photo #1.) | | | | | | |

| <b>Description</b> | Leachate leaks observed on the east slope of Cell 3. | | | | | | | |

**Response:** Due to extremely wet conditions our repairs were delayed; however, the erosion was repaired on December 12, 2019. (See CCSWDA Photo #1).

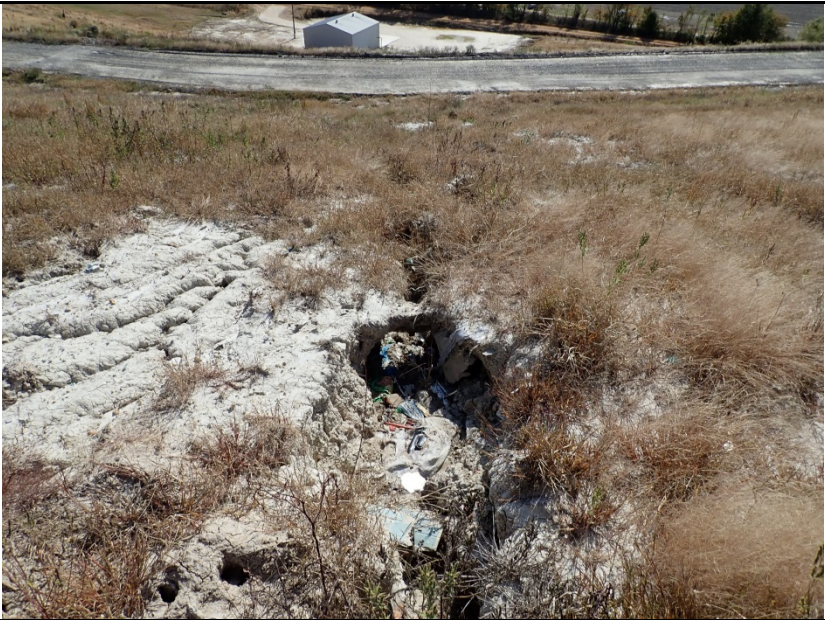
| <b>Photo #</b> | 2 | <b>Of</b> | 2 | | <b>Date</b> | 11/5/2019 | <b>Time</b> | 1129 |

| Category 2 (continued) | | | | | | | | | | | | | | |
|---|---|---|---|---|---|---|---|---|---|---|---|---|---|---|
| X | 411(o) | Erosion or other cover defects resulting in exposed refuse | | | | | | Erosion with exposed waste observed on the south slope of Cell 4 Unit 2 by 360 elevation bench road. (Refer to Photo #2.) | | | | | | |

| <b>Description</b> | Erosion with exposed waste observed on the south slope of Cell 4 Unit 2 by 360 elevation bench road. | | | | | | | |

**Response:** Due to extremely wet conditions our repairs were delayed; however, the erosion was repaired on December 12, 2019. (See CCSWDA Photo #2).

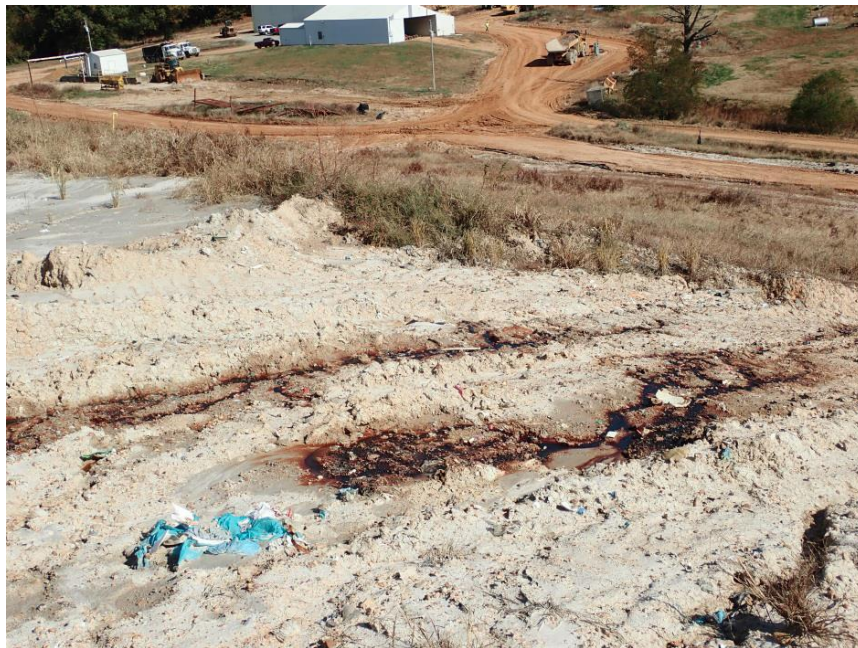
ADEQ Photo #1

Comments: Leachate leaks observed on the east slope of Cell 3. (Refer to Photo #1.)

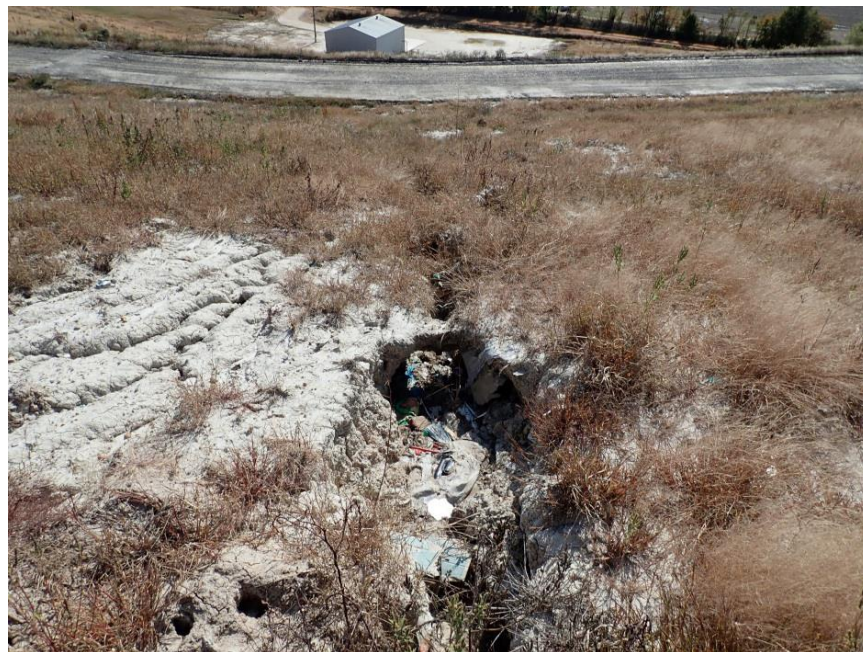
ADEQ Photo #2

Comments: Erosion with exposed waste observed on the south slope of Cell 4 Unit 2 by 360 elevation bench road. (Refer to Photo #2.)
