**RE: Quarterly Inspection conducted on November 25, 2019**  
**AFIN 03-00051**  
**Permit Number 0249-S1-R2**

**Division of Environmental Quality  
Office of Land Resources - Solid Waste Management  
Class 1 Landfill Inspection**

| <b>Site Name</b> | NABORS Class 1 Landfill | <b>County</b> | Baxter | <b>AFIN</b> | 03-00051 |

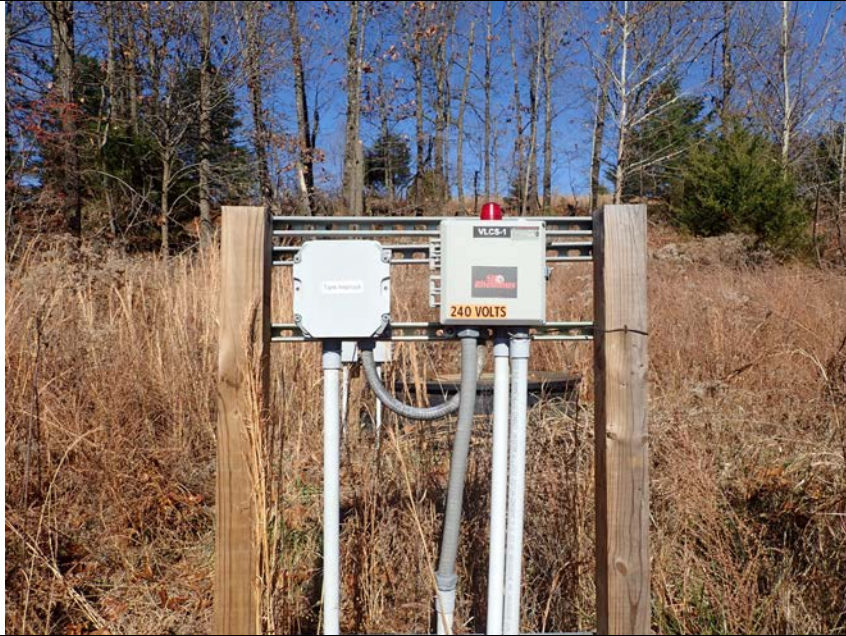
| <b>Photo #</b> | 1 | <b>Of</b> | 6 | <b>Date</b> | 11/25/2019 | <b>Time</b> | 1144 |

| Regulation | Item Description | Comments |
|---|---|--|
| 429 | Leachate collection system | Alarm light activated on VLCS-1. (Refer to Photo #1.) Secondary containment unit valve leak observed. (Refer to Photo #3.) |

| <b>Description</b> | Observed VLCS -1 with active alarm. | | | | | | |

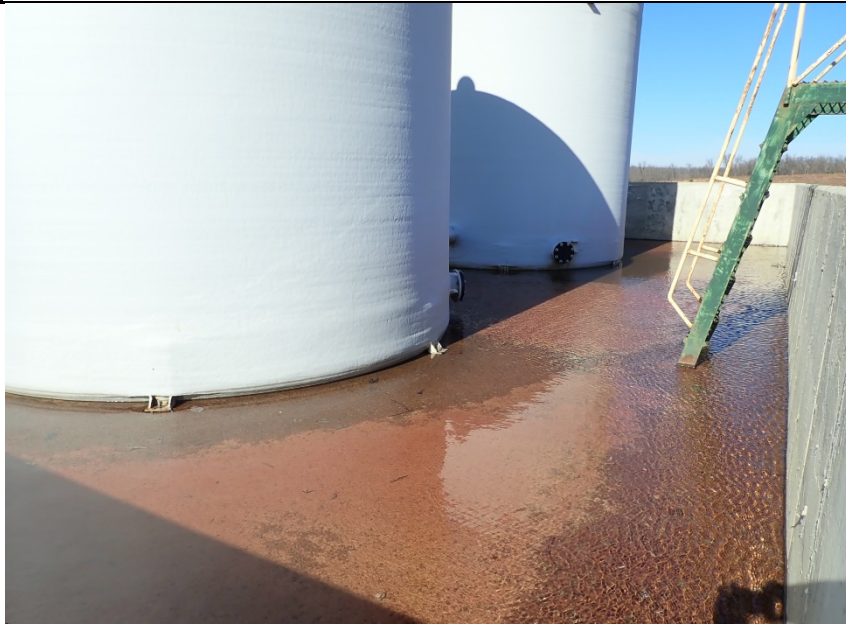
| <b>Photo #</b> | 2 | <b>Of</b> | 6 | <b>Date</b> | 11/25/2019 | <b>Time</b> | 1202 |

| <b>Description</b> | Tank farm and secondary containment unit. | | | | | | |

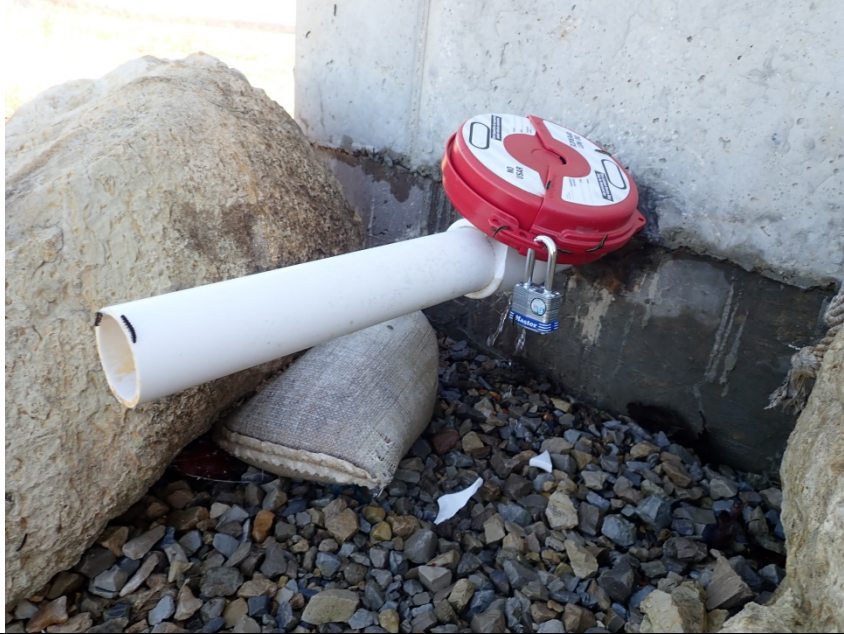
| <b>Photo #</b> | 3 | <b>Of</b> | 6 | <b>Date</b> | 11/25/2019 | <b>Time</b> | 1204 |

| <b>Description</b> | Observed leak at secondary containment valve. | | | | | | |

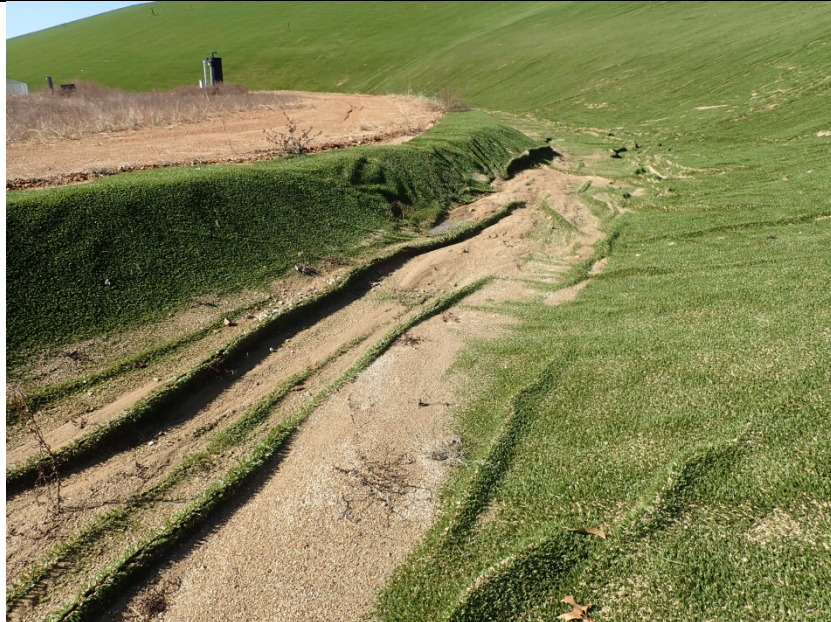
| <b>Photo #</b> | 4 | <b>Of</b> | 6 | <b>Date</b> | 11/25/2019 | <b>Time</b> | 1210 |

| <b>Description</b> | Area of the cover system, just west of LCS-4, on the south slope of Area 1-2. | | | | | | |

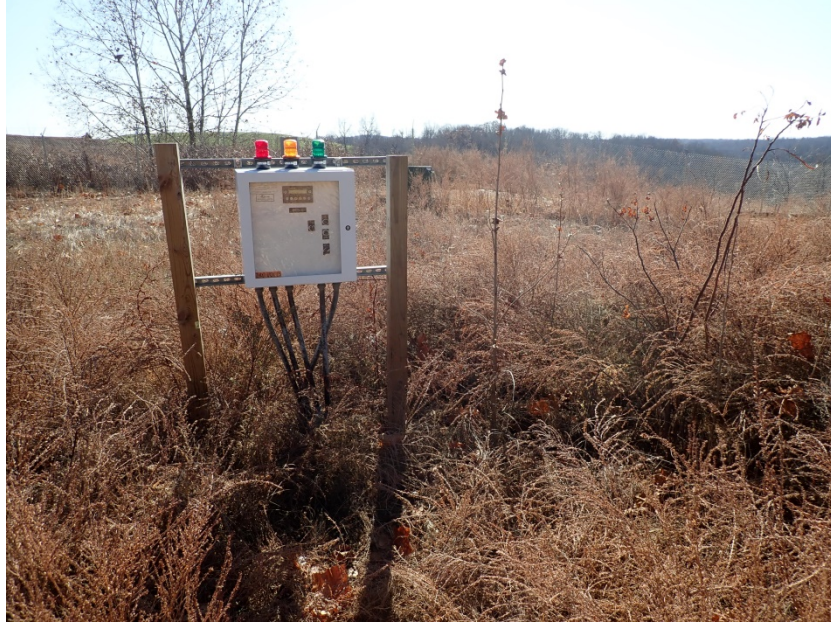
| <b>Photo #</b> | 5 | <b>Of</b> | 6 | <b>Date</b> | 11/25/2019 | <b>Time</b> | 1211 |

| <b>Description</b> | LCS-3 control panel. | | | | | | |

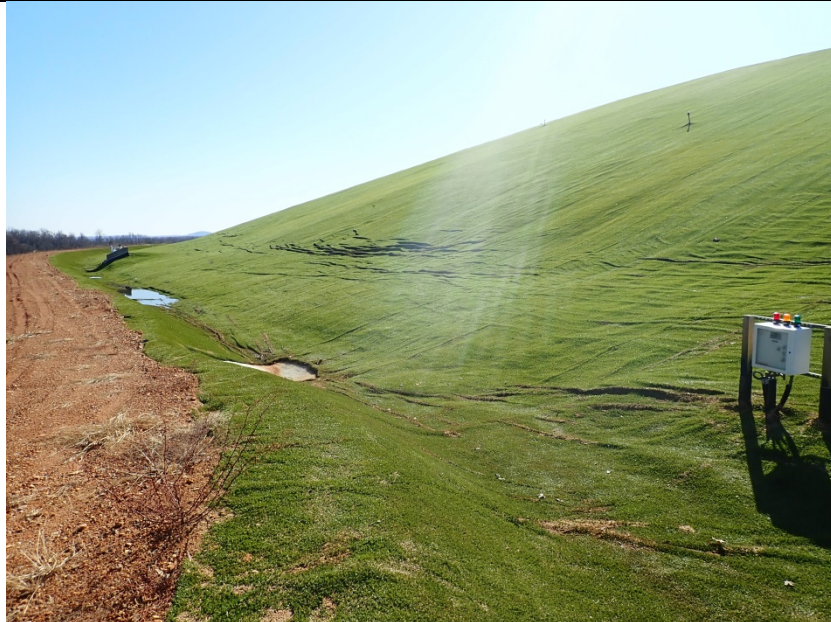
| <b>Photo #</b> | 6 | <b>Of</b> | 6 | <b>Date</b> | 11/25/2019 | <b>Time</b> | 1247 |

| <b>Description</b> | Road and cover system, south of LCS-6. | | | | | | |
