**RE: Quarterly Inspection conducted on December 4, 2019**  
**AFIN 63-00155**  
**Permit Number 0261-S1-R3**

**Division of Environmental Quality**  
**Office of Land Resources - Solid Waste Management**  
**Class 1 Landfill Inspection**

<b>Site Name</b>	BFI Waste Systems of Arkansas, LLC.	<b>County</b>	Saline	<b>AFIN</b>	63-00155
<b>Facility Address</b>	18511 W. Sardis Road, Bauxite, AR 72011	<b>Phone Number</b>	870-946-5583 Heath 501-602-8440 Robert	<b>Permit Number</b>	0261-S1-R3
<b>Permittee Address</b>	18511 W. Sardis Road, Bauxite, AR 72011	<b>E-Mail Address</b>	hlockley@republicservices.com	<b>PDS #</b>	110356
<b>Date</b>	12/4/2019	<b>Entry Time</b>	1030	<b>Exit Time</b>	1150

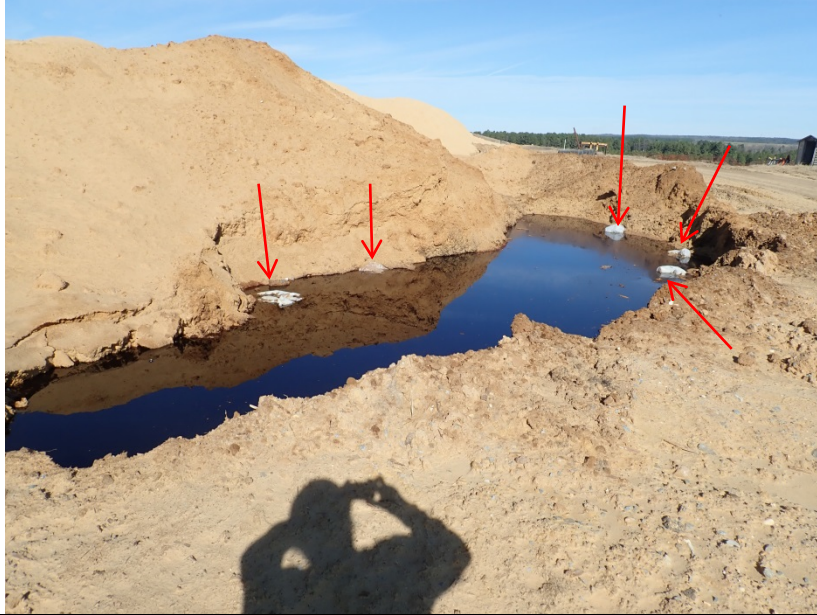
<b>Location</b>	BFI Waste Systems of Arkansas, LLC				<b>Permit</b>	0261-S1-R3	<b>AFIN</b>	63-00155	
<b>Photographer</b>	Kim Davenport, Inspector			<i>KD</i>	<b>Witness</b>	N/A			
<b>Photo #</b>	1	<b>Of</b>	10		<b>Date</b>	12/4/2019		<b>Time</b>	1140
<b>Description</b>	Leachate observed pooling near the sawdust pile at the bulking pit. Solid waste (red arrows) visible in the pool.

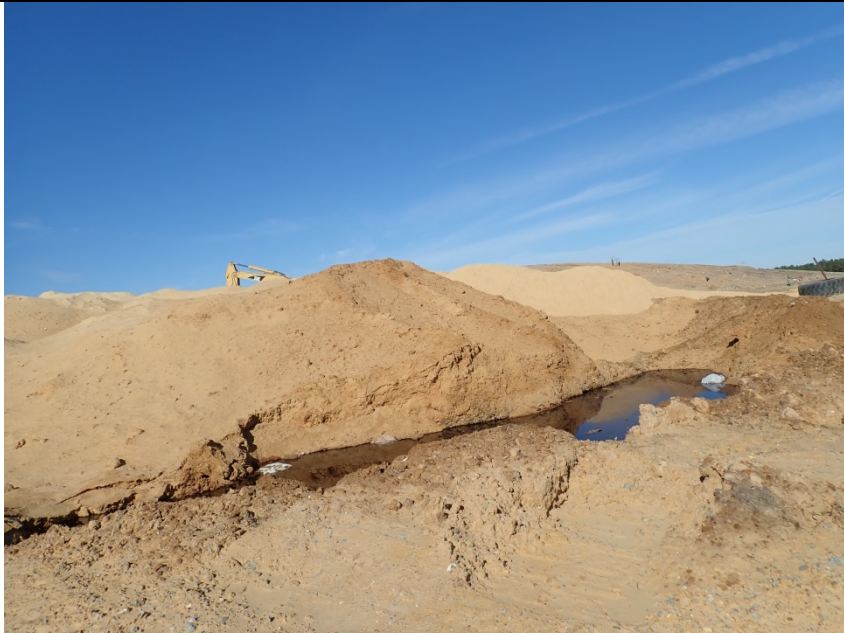
<b>Location</b>	BFI Waste Systems of Arkansas, LLC				<b>Permit</b>	0261-S1-R3	<b>AFIN</b>	63-00155	
<b>Photographer</b>	Kim Davenport, Inspector			<i>KD</i>	<b>Witness</b>	N/A			
<b>Photo #</b>	2	<b>Of</b>	10		<b>Date</b>	12/4/2019		<b>Time</b>	1140
<b>Description</b>	Another view of the leachate shown in Photo #1. The bulking pit is located in the background.

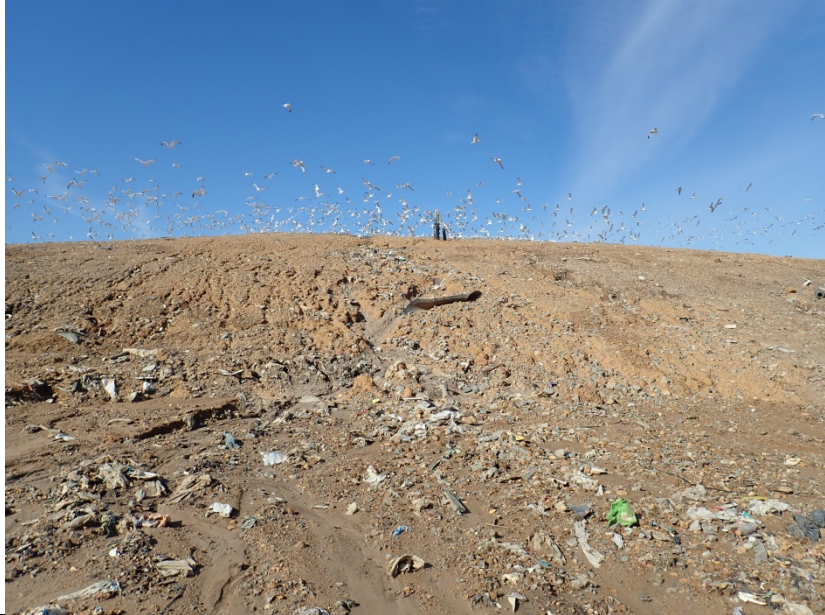
<b>Location</b>	BFI Waste Systems of Arkansas, LLC				<b>Permit</b>	0261-S1-R3	<b>AFIN</b>	63-00155
<b>Photographer</b>	Kim Davenport, Inspector			<i>KD</i>	<b>Witness</b>	N/A		
<b>Photo #</b>	5	<b>Of</b>	10		<b>Date</b>	12/4/2019	<b>Time</b>	1110
<b>Description</b>	Exposed waste observed at Cell 3.

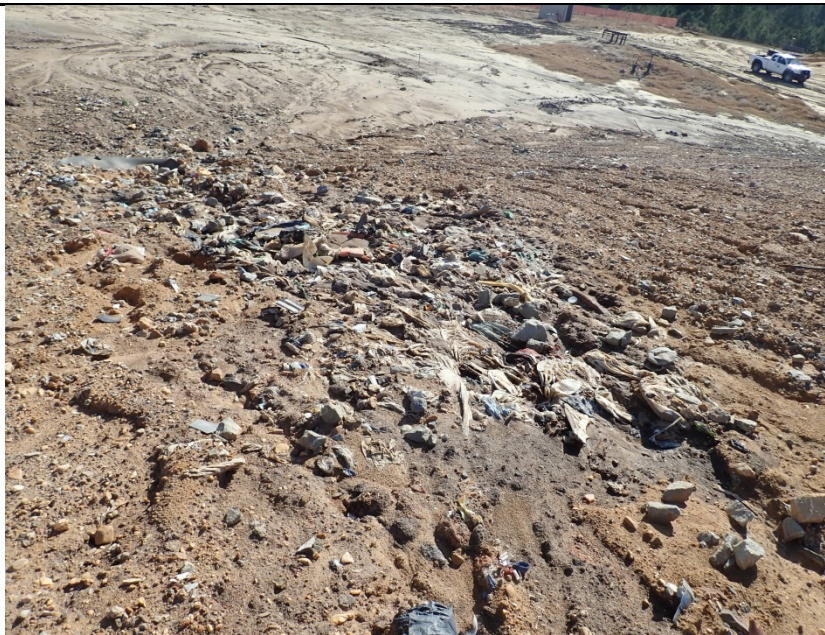
<b>Location</b>	BFI Waste Systems of Arkansas, LLC				<b>Permit</b>	0261-S1-R3	<b>AFIN</b>	63-00155
<b>Photographer</b>	Kim Davenport, Inspector			<i>KD</i>	<b>Witness</b>	N/A		
<b>Photo #</b>	6	<b>Of</b>	10		<b>Date</b>	12/4/2019	<b>Time</b>	1112
<b>Description</b>	Exposed waste observed at Cell 3.

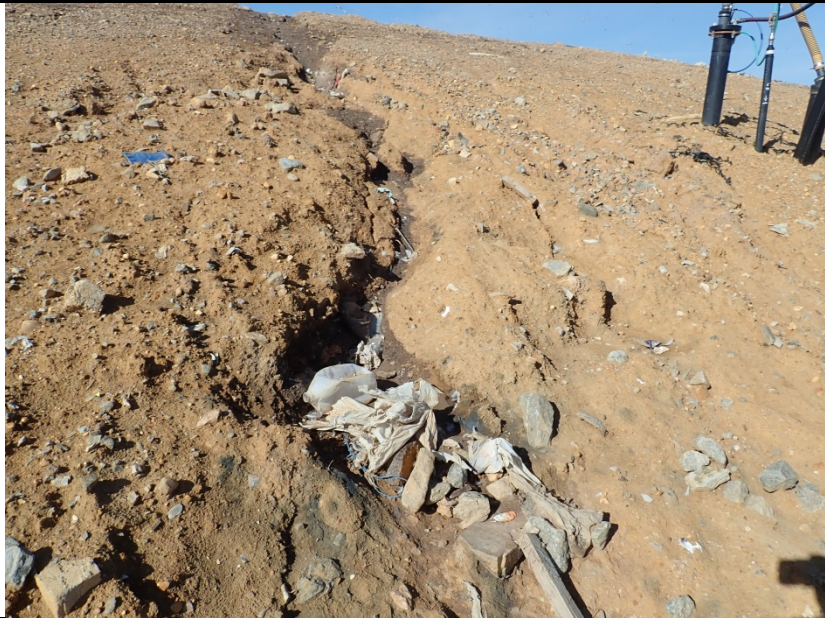
<b>Location</b>	BFI Waste Systems of Arkansas, LLC				<b>Permit</b>	0261-S1-R3	<b>AFIN</b>	63-00155
<b>Photographer</b>	Kim Davenport, Inspector			<i>KD</i>	<b>Witness</b>	N/A		
<b>Photo #</b>	7	<b>Of</b>	10		<b>Date</b>	12/4/2019	<b>Time</b>	1112
<b>Description</b>	Exposed waste observed at Cell 3.

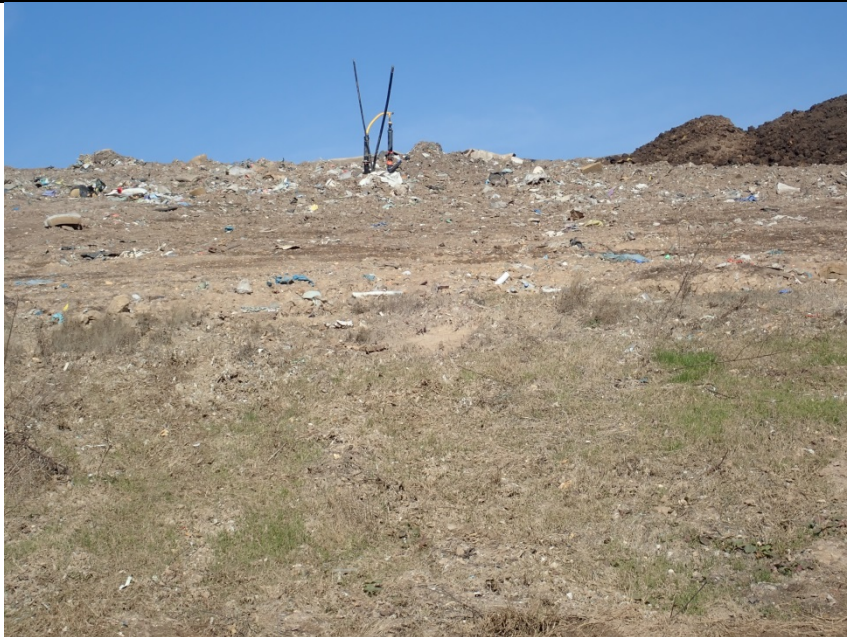
<b>Location</b>	BFI Waste Systems of Arkansas, LLC				<b>Permit</b>	0261-S1-R3	<b>AFIN</b>	63-00155
<b>Photographer</b>	Kim Davenport, Inspector			<i>KD</i>	<b>Witness</b>	N/A		
<b>Photo #</b>	8	<b>Of</b>	10		<b>Date</b>	12/4/2019	<b>Time</b>	1144
<b>Description</b>	Exposed waste observed along the southern slope of the landfill at a gas repair site.

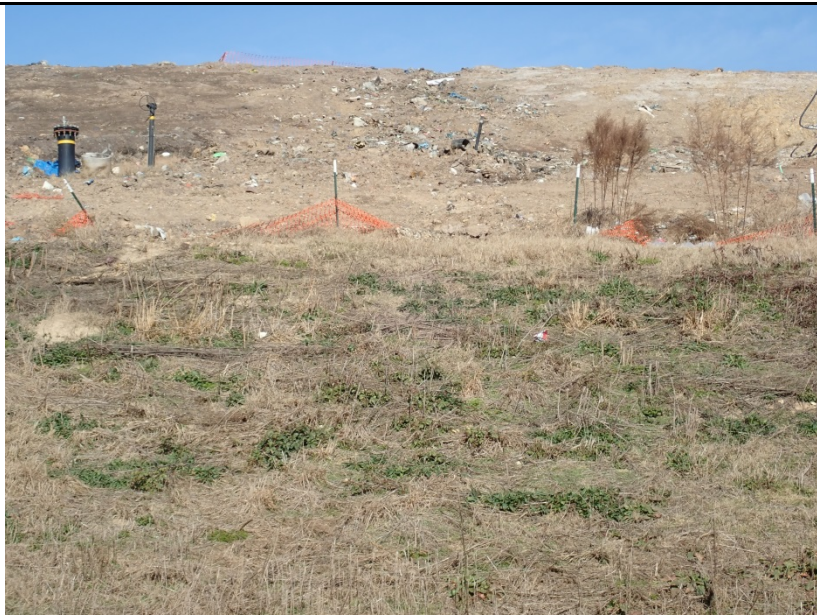
<b>Location</b>	BFI Waste Systems of Arkansas, LLC				<b>Permit</b>	0261-S1-R3	<b>AFIN</b>	63-00155
<b>Photographer</b>	Kim Davenport, Inspector		<i>KD</i>		<b>Witness</b>	N/A		
<b>Photo #</b>	9	<b>Of</b>	10		<b>Date</b>	12/4/2019	<b>Time</b>	1143
<b>Description</b>	Exposed waste observed along the southern slope of the landfill at a gas repair site.

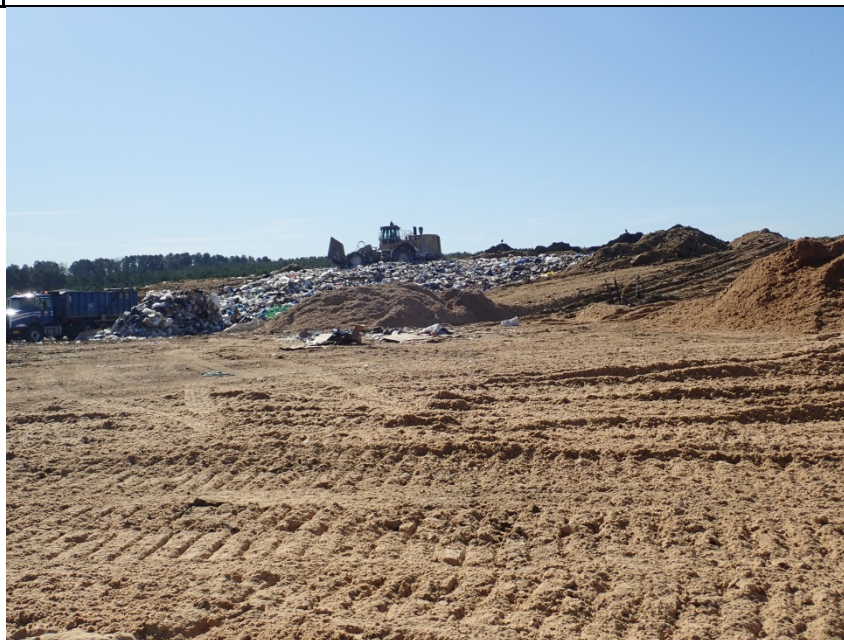
<b>Location</b>	BFI Waste Systems of Arkansas, LLC				<b>Permit</b>	0261-S1-R3	<b>AFIN</b>	63-00155
<b>Photographer</b>	Kim Davenport, Inspector		<i>KD</i>		<b>Witness</b>	N/A		
<b>Photo #</b>	10	<b>Of</b>	10		<b>Date</b>	12/4/2019	<b>Time</b>	1122
<b>Description</b>	View of the working face observed at Cell 4.
