RE: Quarterly Inspection conducted on December 11, 2019
AFIN 32-00042
Permit Number 0200-S3N-R2

**Division of Environmental Quality
Office of Land Resources - Solid Waste Management
Class 3 Landfill Inspection**

Site Name	Entergy- Independence Plant	County	Independence	AFIN	32-00042
Facility Address	555 Point Ferry , Newark, AR 72562	Phone Number	870-799-8761 Entergy 870-799-3565	Permit Number	0200-S3N-R2
Permittee Address	555 Point Ferry , Newark, AR 72562	E-Mail Address	krichmond@headwaters.com		PDS # 110483
Date	12/11/2019	Entry Time	0940	Exit Time	1130

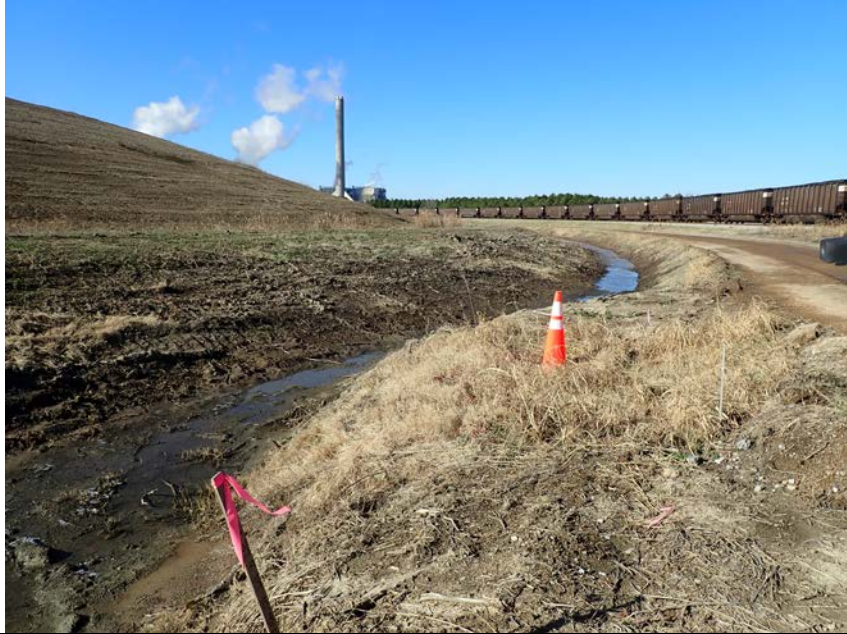
Location	Entergy-Independence Plant			Permit	0200-S3N-R2	AFIN	32-00042
Photographer	Darrell Norton , Inspector		<i>DN</i>	Witness	Anthony Wilson, Facility Operator		
Photo #	1	Of	6	Date	12/11/2019	Time	1010
Description	Storm water ditches observed graded near decommissioned 704S.

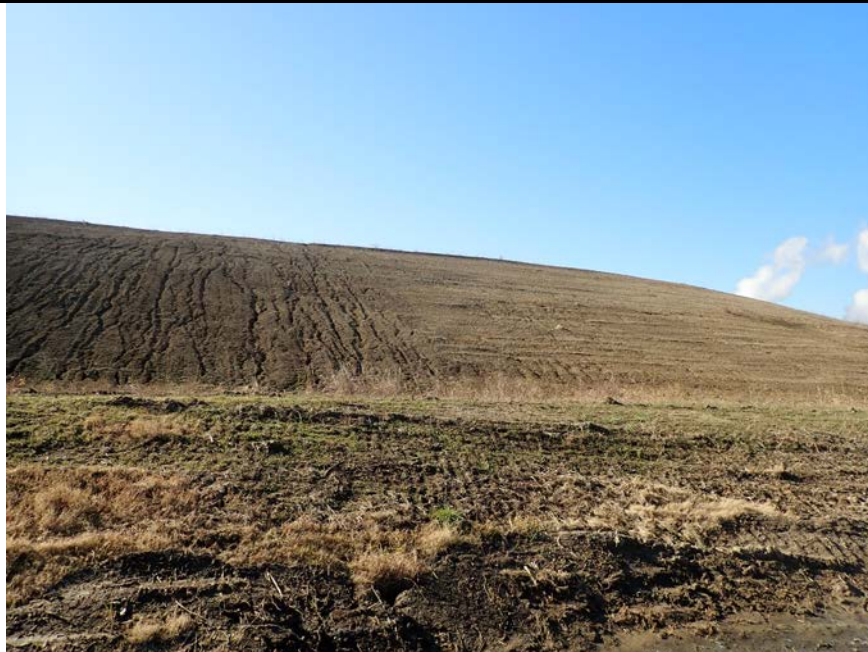
Location	Entergy-Independence Plant			Permit	0200-S3N-R2	AFIN	32-00042
Photographer	Darrell Norton, Inspector		<i>DN</i>	Witness	Anthony Wilson, Facility Operator		
Photo #	2	Of	6	Date	12/11/2019	Time	1010
Description	Slope stabilization (with tracking) observed on the north slope of cell 14.

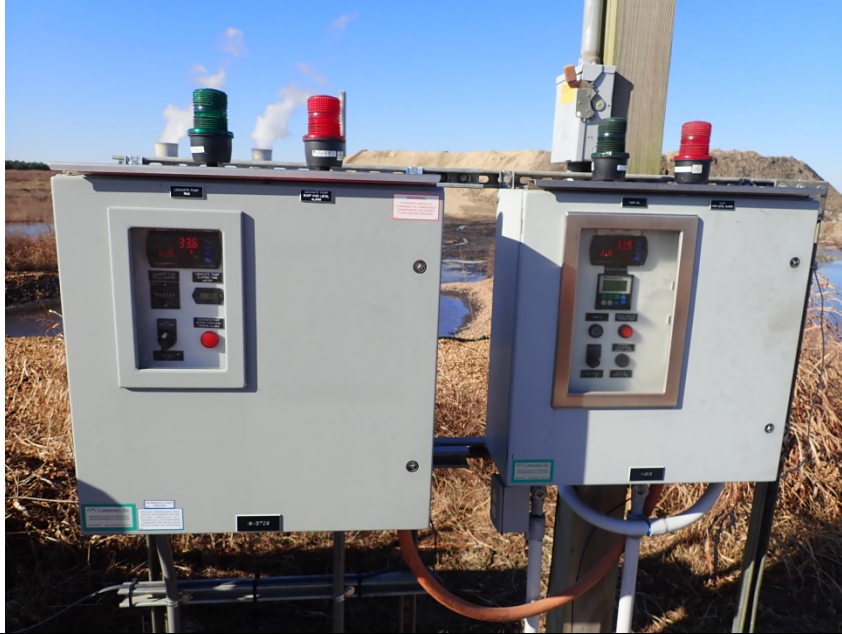
Location	Entergy-Independence Plant			Permit	0200-S3N-R2	AFIN	32-00042
Photographer	Darrell Norton , Inspector		<i>DN</i>	Witness	Anthony Wilson, Facility Operator		
Photo #	3	Of	6	Date	12/11/2019	Time	1024
Description	Leachate panels for collection sump in Cell 15.

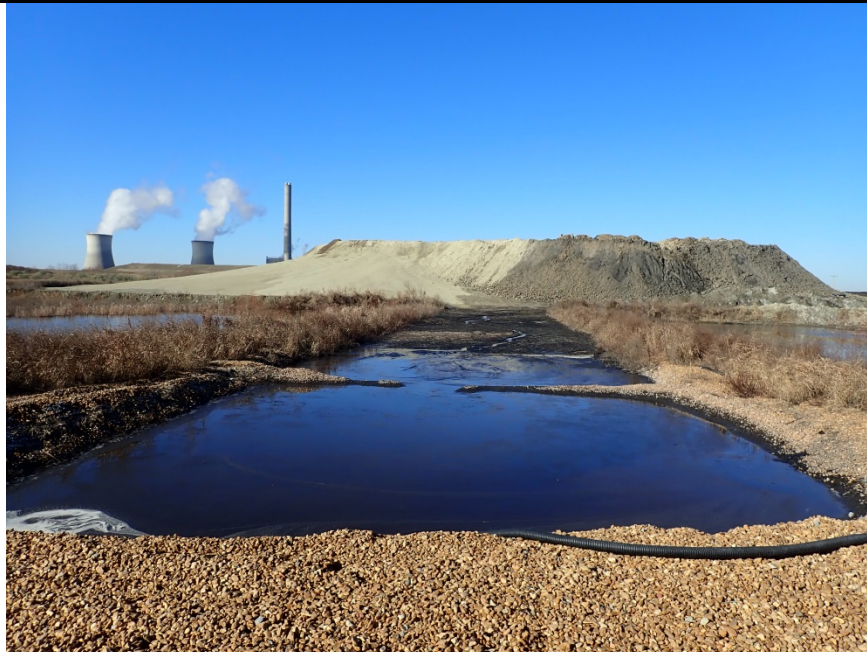
Location	Entergy-Independence Plant			Permit	0200-S3N-R2	AFIN	32-00042
Photographer	Darrell Norton, Inspector		<i>DN</i>	Witness	Anthony Wilson, Facility Operator		
Photo #	4	Of	6	Date	12/11/2019	Time	1025
Description	Leachate collection basin and the working face, as observed from east side of the landfill.

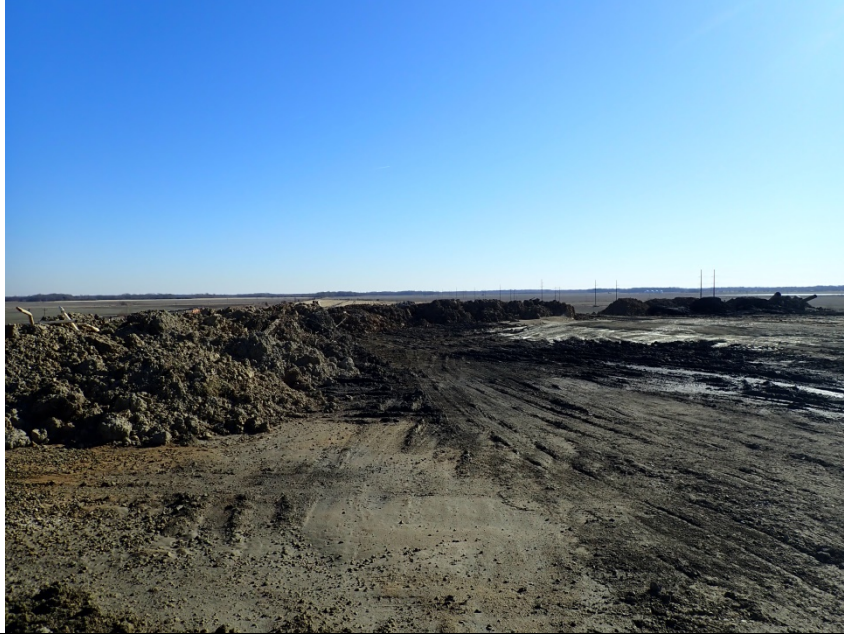
Location	Entergy-Independence Plant			Permit	0200-S3N-R2	AFIN	32-00042
Photographer	Darrell Norton , Inspector		<i>DN</i>	Witness	Anthony Wilson, Facility Operator		
Photo #	5	Of	6	Date	12/11/2019	Time	1053
Description	A view of the working face, looking east.

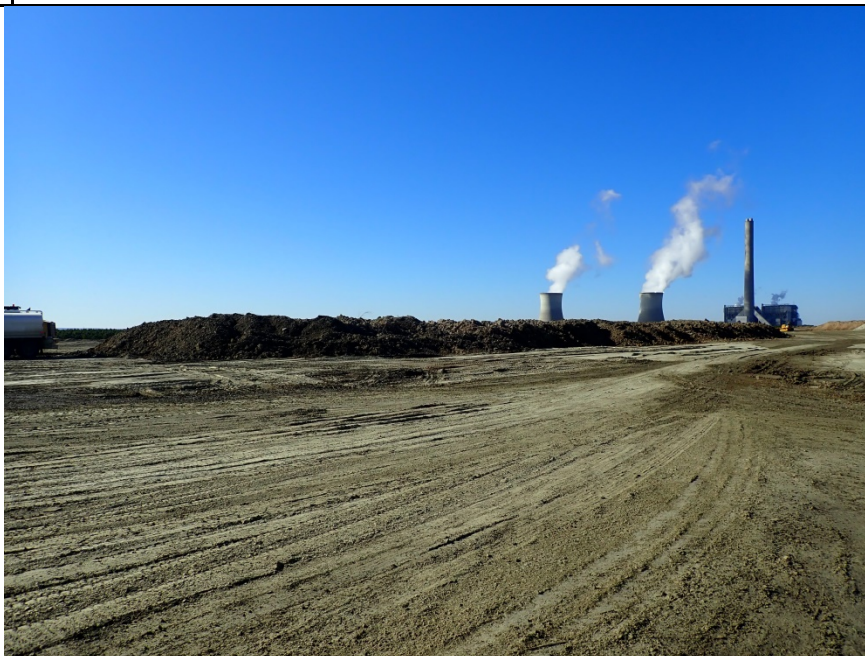
Location	Entergy-Independence Plant			Permit	0200-S3N-R2	AFIN	32-00042
Photographer	Darrell Norton, Inspector		<i>DN</i>	Witness	Anthony Wilson, Facility Operator		
Photo #	6	Of	6	Date	12/11/2019	Time	1054
Description	Stockpiled soil to be utilized for slope stabilization/cover system observed near the working face.
