RE: Quarterly Inspection conducted on February 3, 2020
AFIN 03-00051
Permit Number 0249-S1-R2

**Division of Environmental Quality
Office of Land Resources - Solid Waste Management
Class 1 Landfill Inspection**

Site Name	NABORS Landfill	County	Baxter	AFIN	03-00051
Facility Address	Hwy 5 N to CR 16 to site entrance- Three Brothers	Phone Number	870-425-3213	Permit Number	0249-S1-R2
Permittee Address	P.O. Box 1715, Mountain Home, AR 72602	E-Mail Address		PDS #	110921
Date	2/3/2020	Entry Time	1006	Exit Time	1130

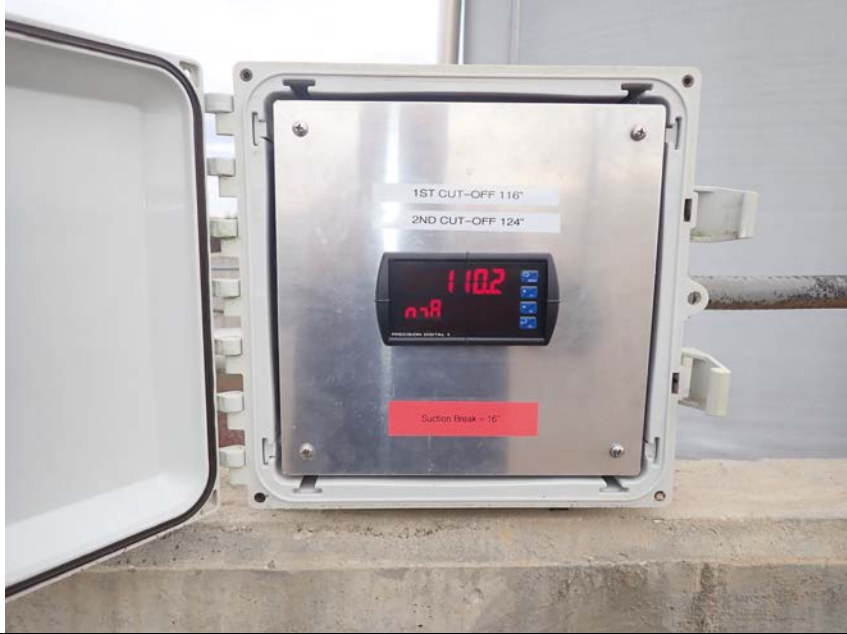
Location	NABORS Class 1			Permit	0249-S1-R2	AFIN	03-00051
Photographer	Darrell Norton, Inspector		<i>DN</i>	Witness	n/a		
Photo #	1	Of	6	Date	2/3/2020	Time	1012
Description	Observed level of leachate tank farm.

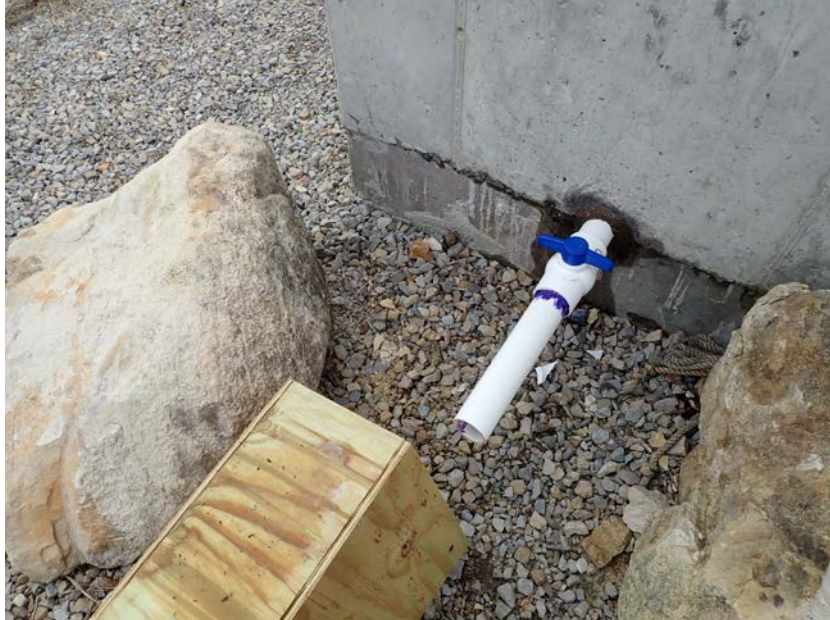
Location	NABORS Class 1			Permit	0249-S1-R2	AFIN	03-00051
Photographer	Darrell Norton, Inspector		<i>DN</i>	Witness	n/a		
Photo #	2	Of	6	Date	2/3/2020	Time	1013
Description	Newly installed secondary containment valve at leachate tank farm.

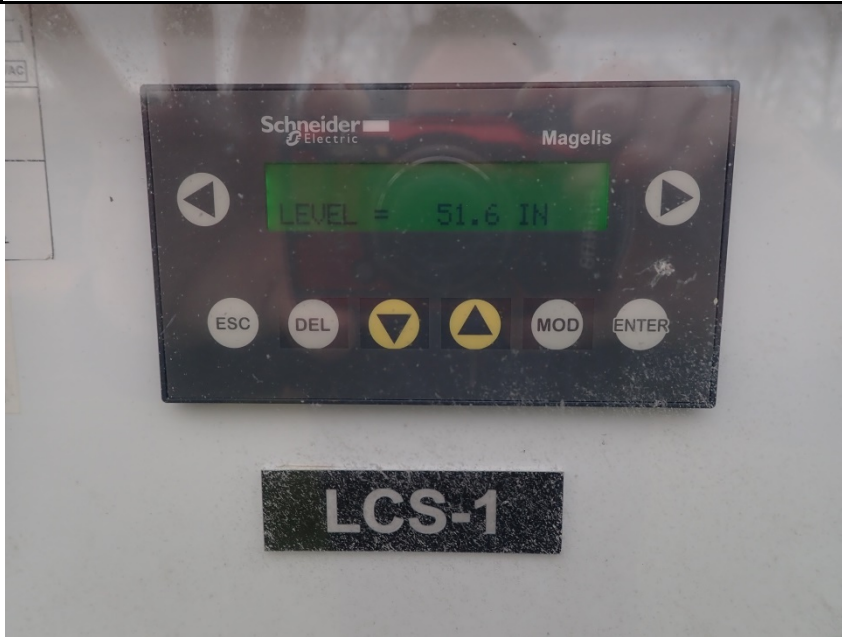
Regulation	Item Description	Comments
427	Surface Water Controls	
411(h)(1)	Contouring prevents surface water flowing into or through waste	
418(a)(b)	Run-on/off control system present and adequate	
411(h)(2)	Surface water control prevents off-site sediment accumulation	
411(i);427(f)	Adequate maintenance of intermediate/final cover vegetation	
415	Gas monitoring program	
411(o)	Leachate leaks or evidence of leachate seepage	
426	Survey controls	
429	Leachate collection system	Alarm light activated on LCS-1. Head level reading 51.6 (refer to photo #3). LCS-4 read-out not available (refer to photo #4).
420	Liquid Restrictions

Location	NABORS Class 1			Permit	0249-S1-R2	AFIN	03-00051
Photographer	Darrell Norton, Inspector		<i>DN</i>	Witness	n/a		
Photo #	3	Of	6	Date	2/3/2020	Time	1018
Description	Observed LCS -1 with active alarm.

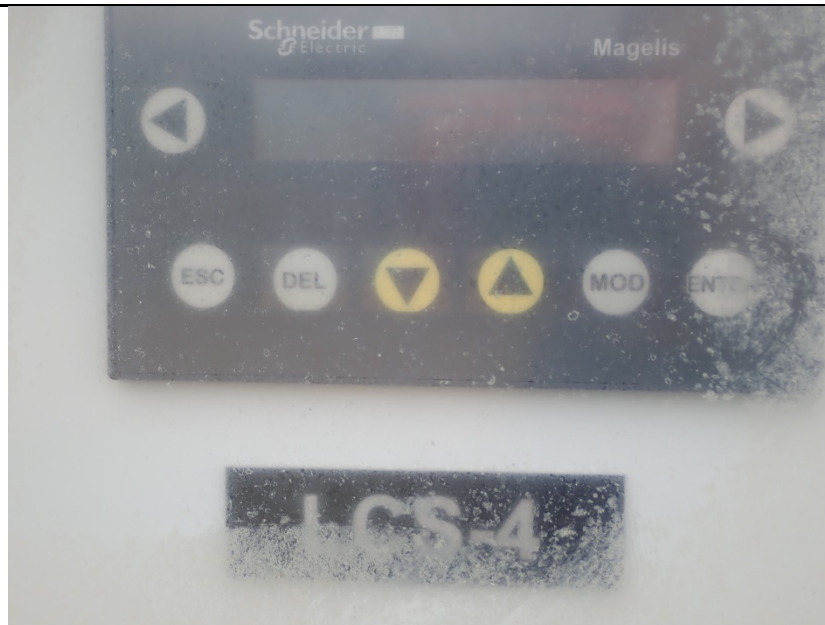
Location	NABORS Class 1			Permit	0249-S1-R2	AFIN	03-00051
Photographer	Darrell Norton, Inspector		<i>DN</i>	Witness	n/a		
Photo #	4	Of	6	Date	2/3/2020	Time	1028
Description	Observed LCS-4 lacking a digital read-out.
