**RE: Quarterly Inspection conducted on February 19, 2020**  
**AFIN 16-00923**  
**Permit Number 0254-S1-R4**

**Division of Environmental Quality  
Office of Land Resources - Solid Waste Management  
Class 1 Landfill Inspection**

| <b>Site Name</b> | Craighead County SWDA Class 1 | <b>County</b> | Craighead | <b>AFIN</b> | 16-00199 |

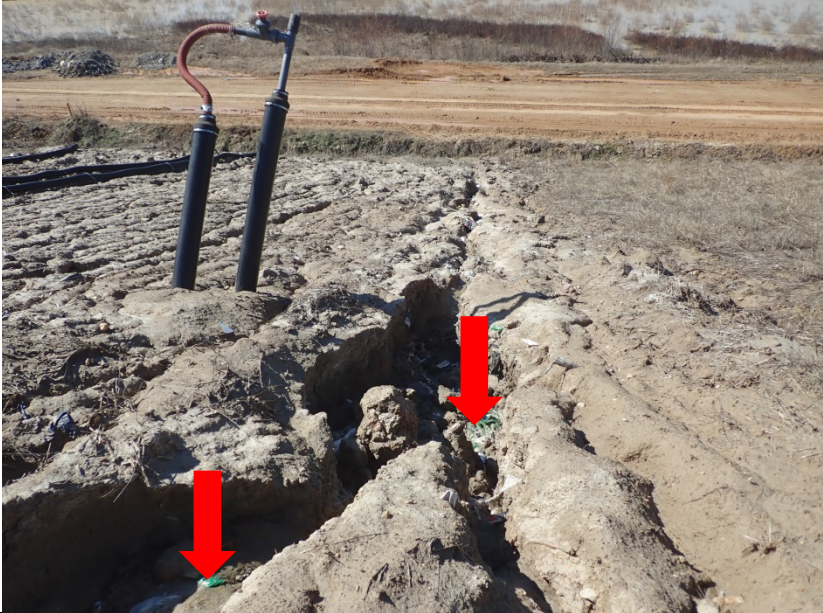
| <b>Photo #</b> | 1 | <b>Of</b> | 2 | | <b>Date</b> | 2/19/2020 | | <b>Time</b> | 1242 | |

| Category 2 (continued) | | | | | | | | | | | | | |
|---|---|---|---|---|---|---|---|---|---|---|---|---|---|
| X 411(o) | Erosion or other cover defects resulting in exposed refuse | | | | | Erosion with exposed waste observed on the south slope of Cell 4 Unit 2 by the 360 elevation bench road and on the west slope of Cell 3. (Refer to Photos #1 & #2.) | | | | | | | |

| <b>Description</b> | | Erosion with exposed waste (red arrows) observed on the west slope of Cell 3. | | | | | | | | |

You should immediately initiate actions to correct the alleged violations cited. A written response of the corrective actions taken, or to be taken, must be submitted within thirty (30) calendar days from the date on this letter to the attention of Tobin Baker. The response may include, but is not limited to, photographs, copies of disposal receipts, records, or analytical results, as applicable. If you have any questions regarding the alleged violations, please do not hesitate to contact me at (870) 935-7221 or [bakert@adeq.state.ar.us](mailto:bakert@adeq.state.ar.us).

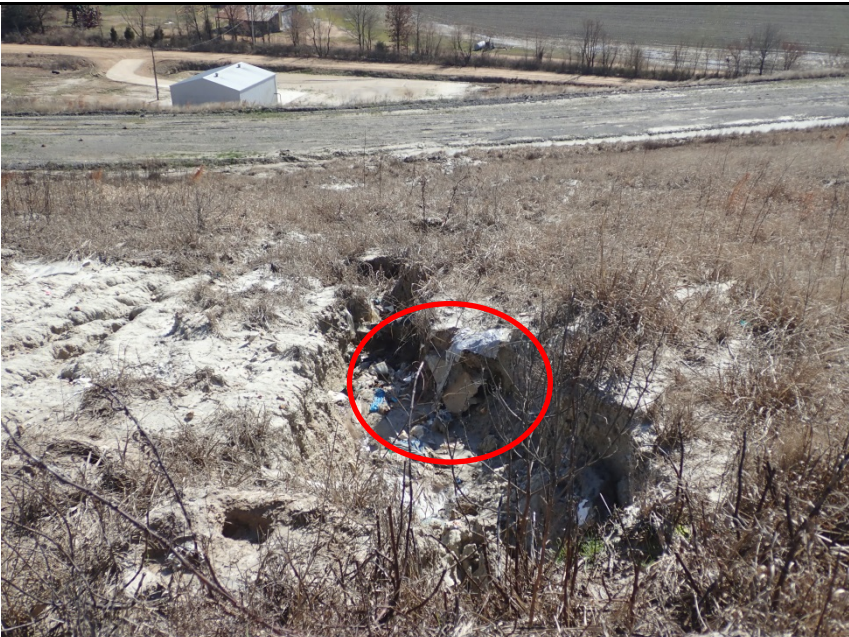
| <b>Photo #</b> | 2 | <b>Of</b> | 2 | | <b>Date</b> | 2/19/2020 | | <b>Time</b> | 1255 | |

| <b>Description</b> | | Erosion with exposed waste (red circle) observed on the south slope of Cell 4 Unit 2 by the 360 elevation bench road. | | | | | | | | |
