RE: Quarterly Inspection conducted on June 17, 2020
AFIN 03-00051
Permit Number 0249-S1-R2

**Division of Environmental Quality
Office of Land Resources - Solid Waste Management
Class 1 Landfill Inspection**

Site Name	NABORS Class 1 Landfill	County	Baxter	AFIN	03-00051
Facility Address	Hwy 5 N to CR 16 to site entrance- Three Brothers	Phone Number	870-425-3213	Permit Number	0249-S1-R2
Permittee Address	P.O. Box 1715, Mountain Home, AR 72602	E-Mail Address	judge@baxtercounty.org	PDS #	112410
Date	6/17/2020	Entry Time	1013	Exit Time	1125

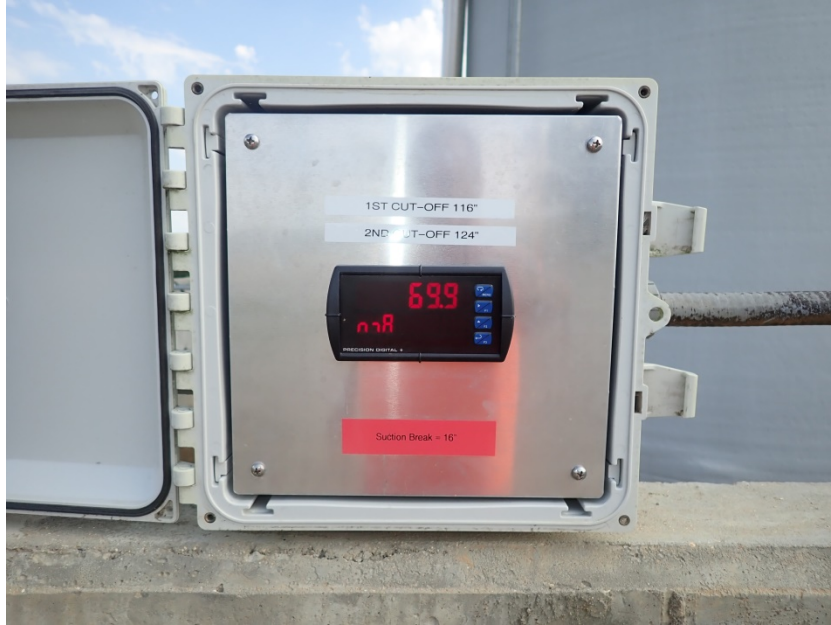
Location	NABORS Class 1			Permit	0249-S1-R2	AFIN	03-00051
Photographer	Darrell Norton, Inspector		<i>DN</i>	Witness	n/a		
Photo #	1	Of	6	Date	6/17/2020	Time	1016
Description	Level of leachate tank farm observed.

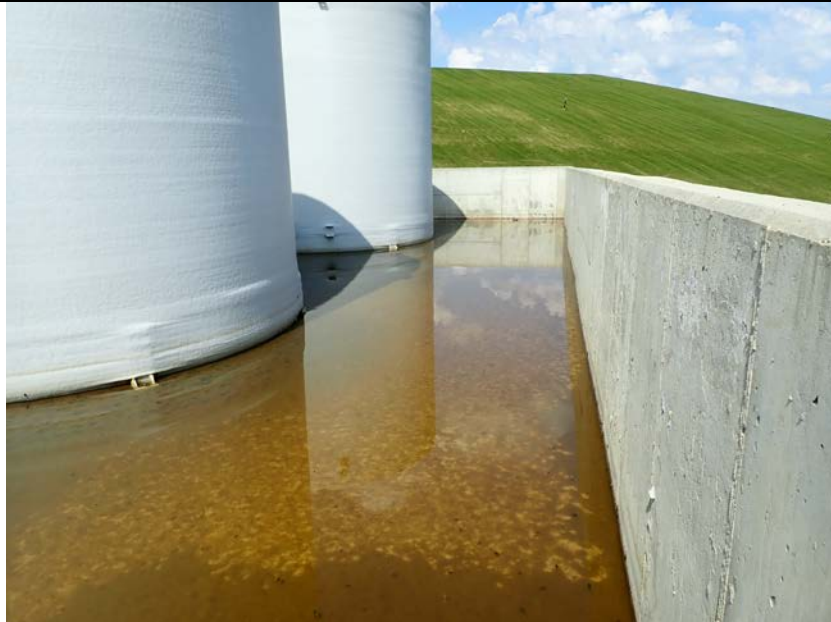
Location	NABORS Class 1			Permit	0249-S1-R2	AFIN	03-00051
Photographer	Darrell Norton, Inspector		<i>DN</i>	Witness	n/a		
Photo #	2	Of	6	Date	6/17/2020	Time	1018
Description	Secondary containment water level at tank farm observed.

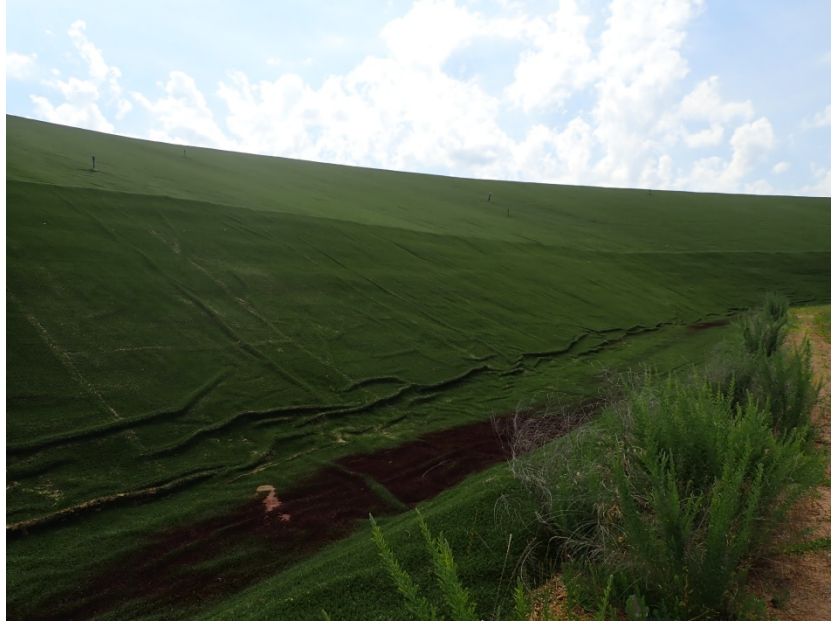
Location	NABORS Class 1			Permit	0249-S1-R2	AFIN	03-00051
Photographer	Darrell Norton, Inspector		<i>DN</i>	Witness	n/a		
Photo #	3	Of	6	Date	6/17/2020	Time	1024
Description	Example of turf roll off observed in multiple areas.

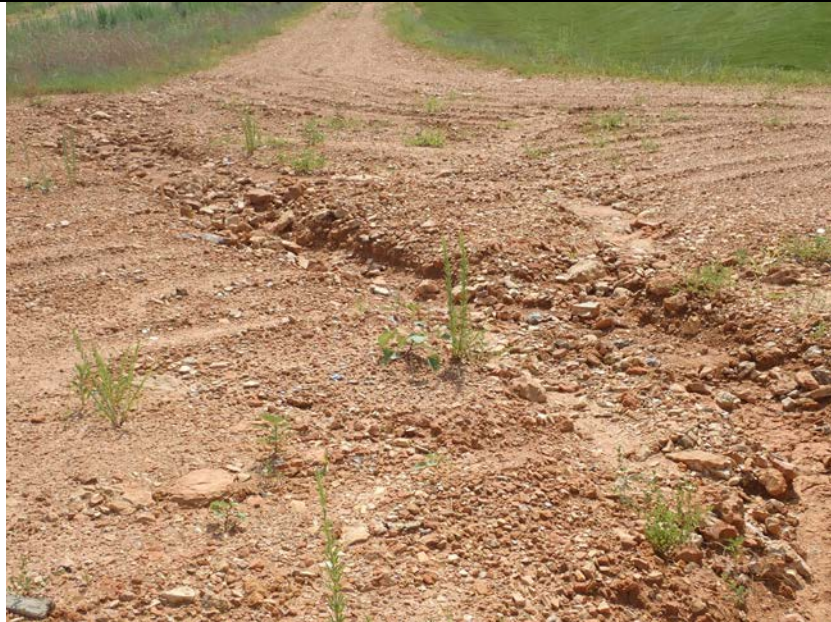
Regulation	Item Description	Comments
411(a)	Operations in accordance with permit documents	
417(c)	Adequate all weather operational roads	Road erosion present between LCS-4 and LCS-5. (Refer to Photo #4.)
411(c)	Smallest practical area, unloading supervised, single working face	
411(e)	Salvage operations meet approved conditions	
411(f)(1)	Scavenging of waste prohibited	
411(p)	Proper wet weather repairs	
411(b)	Operations by licensed on-site personnel at all times	
411(d)	Waste spread and compacted as unloaded	
411(g)	Litter control provisions maintained	
414(a)	Disease vectors controlled

Location	NABORS Class 1			Permit	0249-S1-R2	AFIN	03-00051
Photographer	Darrell Norton, Inspector		<i>DN</i>	Witness	n/a		
Photo #	4	Of	6	Date	6/17/2020	Time	1029
Description	Erosion on roadway observed between LCS-4 and LCS-5.

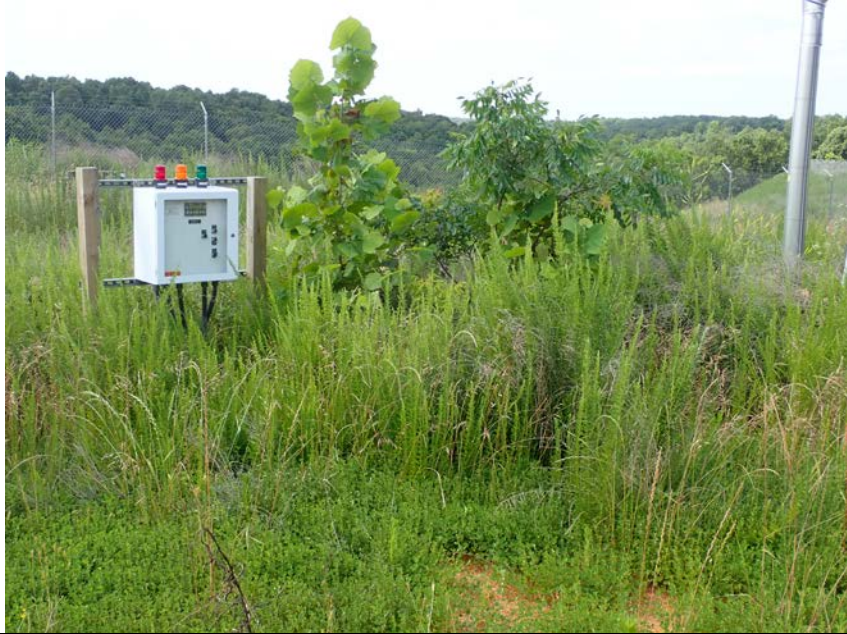
Location	NABORS Class 1			Permit	0249-S1-R2	AFIN	03-00051
Photographer	Darrell Norton, Inspector		<i>DN</i>	Witness	n/a		
Photo #	5	Of	6	Date	6/17/2020	Time	1027
Description	Vegetative growth control needed around LCS-3.

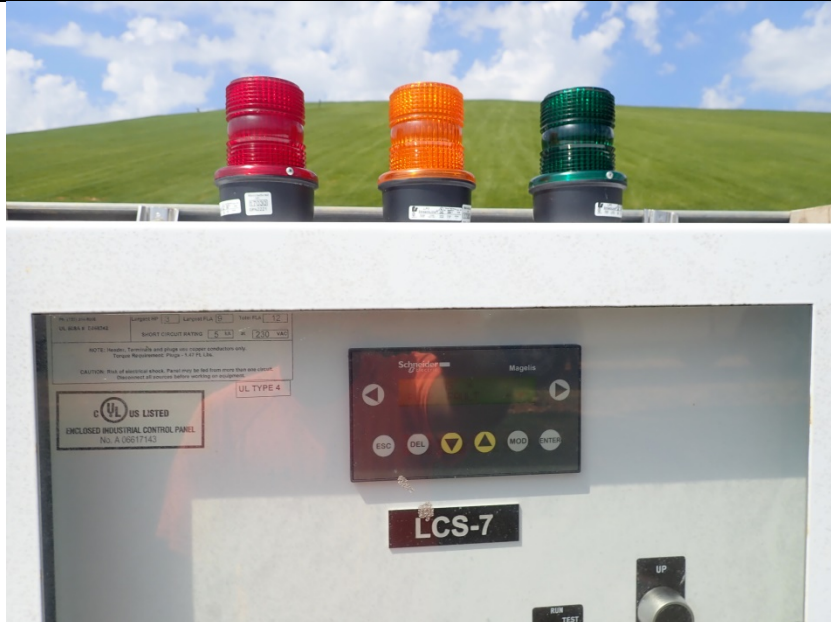
Regulation	Item Description	Comments
427	Surface Water Controls	
411(h)(1)	Contouring prevents surface water flowing into or through waste	
418(a)(b)	Run-on/off control system present and adequate	
411(h)(2)	Surface water control prevents off-site sediment accumulation	
411(i);427(f)	Adequate maintenance of intermediate/final cover vegetation	Turf roll observed in multiple areas. (Refer to Photo #3.)
415	Gas monitoring program	
411(o)	Leachate leaks or evidence of leachate seepage	
426	Survey controls	
429	Leachate collection system	LCS-6 panel had no readout. Alarm light activated on LCS-7, pump fault indicated. (Refer to Photo #6.)
420	Liquid Restrictions

Location	NABORS Class 1			Permit	0249-S1-R2	AFIN	03-00051
Photographer	Darrell Norton, Inspector		<i>DN</i>	Witness	n/a		
Photo #	6	Of	6	Date	6/17/2020	Time	1053
Description	LCS-7 with pump fault indicated.
