**ARKANSAS**  
ENERGY & ENVIRONMENT

RE: City of Corning Inspection  
AFIN: 11-00061 Permit No.: AR0033979

<p><b>ENVIRONMENTAL QUALITY</b></p>	<b>OFFICE OF WATER QUALITY INSPECTION REPORT</b>				
	AFIN: 11-00061	PERMIT #: AR0033979	DATE: 8/18/2020		
	COUNTY: 11 Clay	PDS #: 113829	MEDIA: WN		
	GPS LAT: 36.38941 LONG: -90.597149 LOCATION: Entrance				
<b>FACILITY INFORMATION</b>		<b>INSPECTION INFORMATION</b>			
NAME: <b>City of Corning</b> LOCATION: ~1.65 miles south from Hwy. 62 to Cr. 128 CITY: <b>Corning</b>		FACILITY TYPE: <b>1 - Municipal</b> INSPECTOR ID#: <b>112347 S - State</b> FACILITY EVALUATION RATING: <b>N</b> INSPECTION TYPE: <b>Compliance Assistance</b>			
<b>RESPONSIBLE OFFICIAL</b>		DATE(S):      ENTRY TIME:      EXIT TIME:      PERMIT EFFECTIVE DATE: <b>8/18/2020</b> <b>11:45</b> <b>13:10</b> <b>4/1/2019</b> PERMIT EXPIRATION DATE: <b>3/31/2024</b>			
NAME: / TITLE <b>Greg Ahrent / Mayor</b> COMPANY: <b>City of Corning</b> MAILING ADDRESS: <b>P.O. Box 538</b> CITY, STATE, ZIP: <b>Corning AR 72422</b> PHONE & EXT: / FAX:  EMAIL:		FAYETTEVILLE SHALE RELATED: <b>N</b> FAYETTEVILLE SHALE VIOLATIONS: <b>N</b> <b>INSPECTION PARTICIPANTS</b> NAME/TITLE/PHONE/FAX/EMAIL/ETC

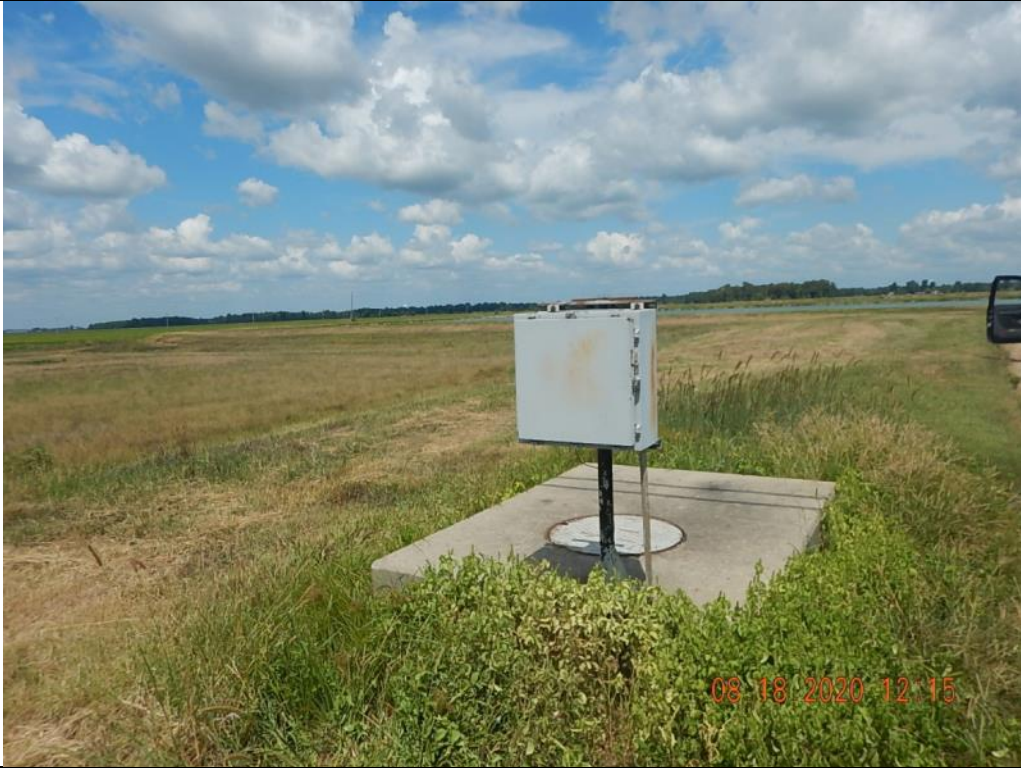
Location:	<b>City of Corning</b>		
Photographer:	<b>Sarah Frasher</b>	Date:	<b>8/18/2020</b>
Time:	<b>12:15</b>	Witness:	<b>None</b>
Photo #:	<b>1</b>	Description:	<b>Overview of the flow meter equipment.</b>

<ol style="list-style-type: none"> <li>1. The flow meter was non-operational and should be repaired/replaced by a qualified professional (Photos 1-2).</li> <li>2. Effluent pumps should be checked to make sure that they are operational in preparation for future discharge needs. (Photo 3).</li> <li>3. Vegetation was observed in the rock filter that needs to be removed to prevent clogging/blinding of the filter (Photo 4).</li> <li>4. Solid waste from the bar screen should be properly disposed of into a trash receptacle and sent to the landfill (Photos 6-7).</li> <li>5. The erosion and vegetation of lagoon levees should be carefully monitored for any possible issues (Photo 8).</li> </ol>

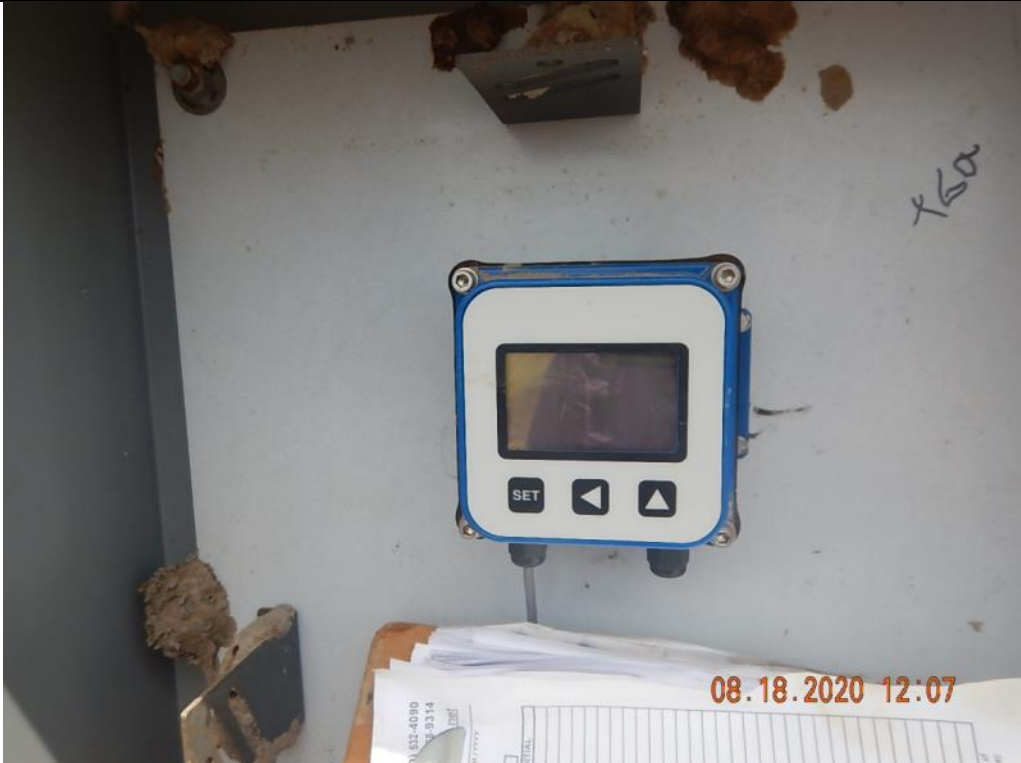
Photographer:	<b>Sarah Frasher</b>	Date:	<b>8/18/2020</b>
Time:	<b>12:07</b>	Witness:	<b>None</b>
Photo #:	<b>2</b>	Description:	<b>View of the flow meter. Note the equipment is off.</b>

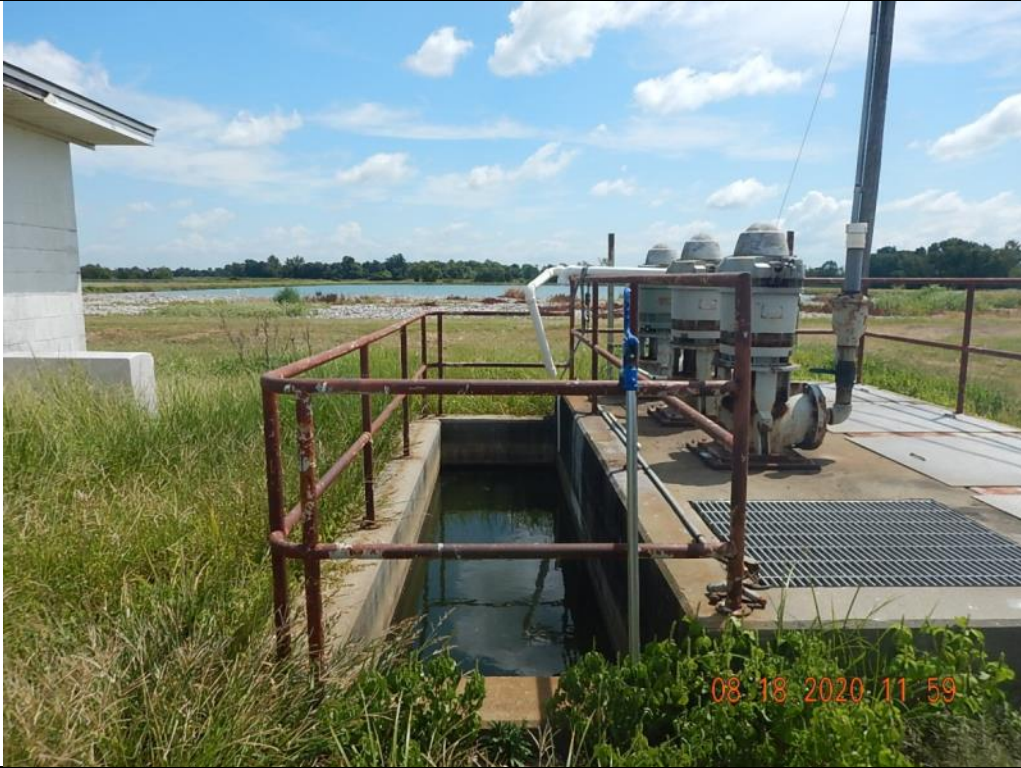
Location:	<b>City of Corning</b>		
Photographer:	<b>Sarah Frasher</b>	Date:	<b>8/18/2020</b>
Time:	<b>11:59</b>	Witness:	<b>None</b>
Photo #:	<b>3</b>	Description:	<b>View of the outfall structure. Note the pumps need maintenance.</b>

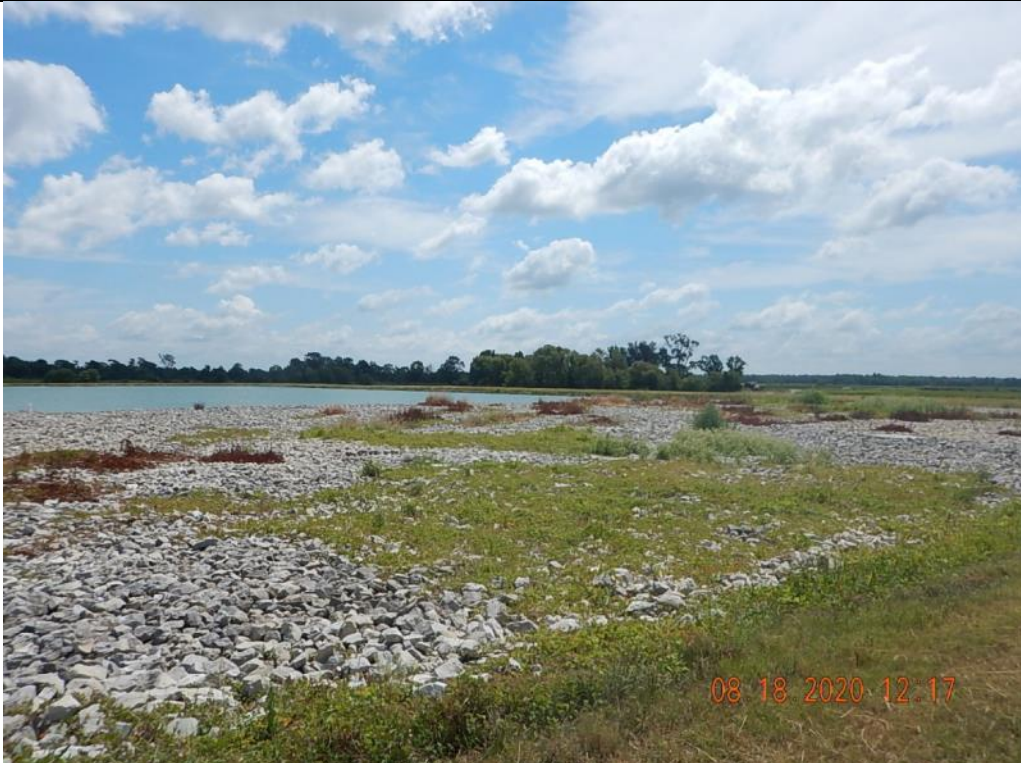
Photographer:	<b>Sarah Frasher</b>	Date:	<b>8/18/2020</b>
Time:	<b>12:17</b>	Witness:	<b>None</b>
Photo #:	<b>4</b>	Description:	<b>View of the rock filter. Note the vegetation that needs to be removed.</b>

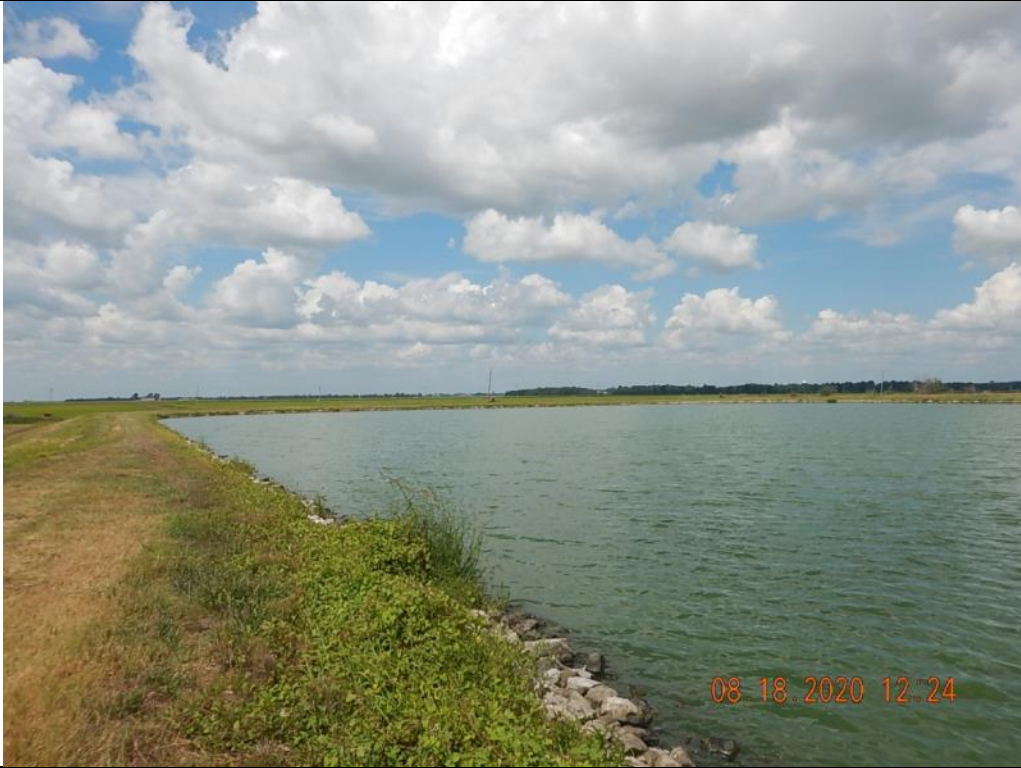
Location:	<b>City of Corning</b>				
Photographer:	<b>Sarah Frasher</b>	Date:	<b>8/18/2020</b>	Time:	<b>12:24</b>
Witness:	<b>None</b>	Photo #:	<b>5</b>		
Description:	<b>View of Cell 2.</b>

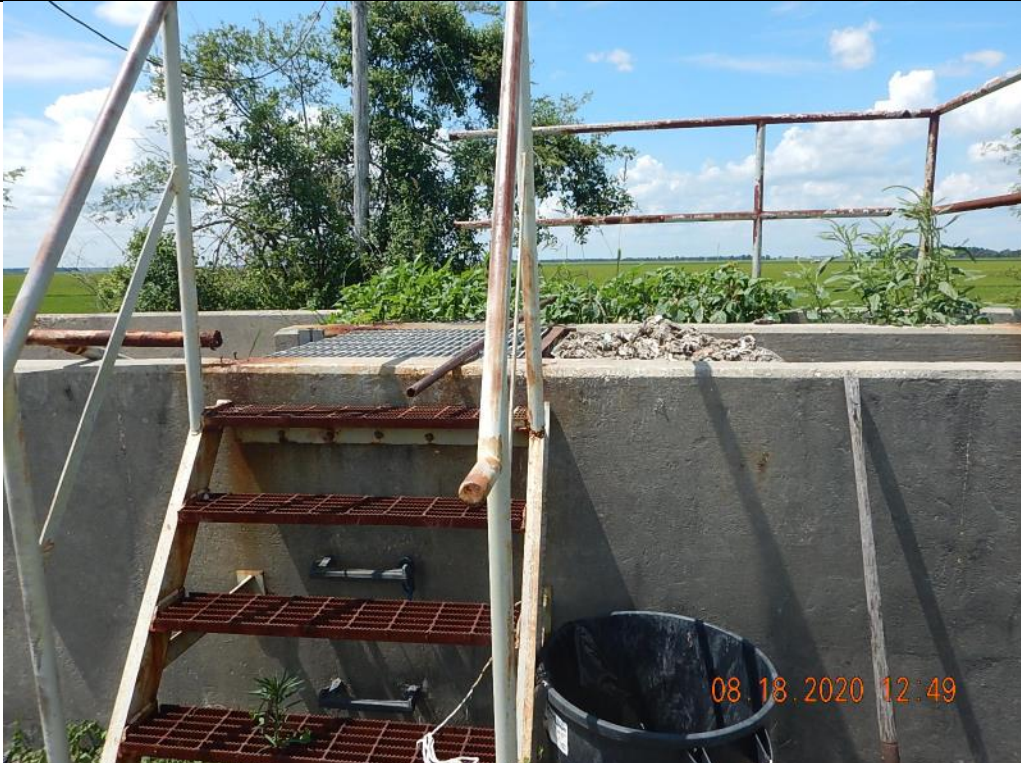
Photographer:	<b>Sarah Frasher</b>	Date:	<b>8/18/2020</b>	Time:	<b>12:49</b>
Witness:	<b>None</b>	Photo #:	<b>6</b>		
Description:	<b>View of the influent structure. Note the solids on the bar screen.</b>

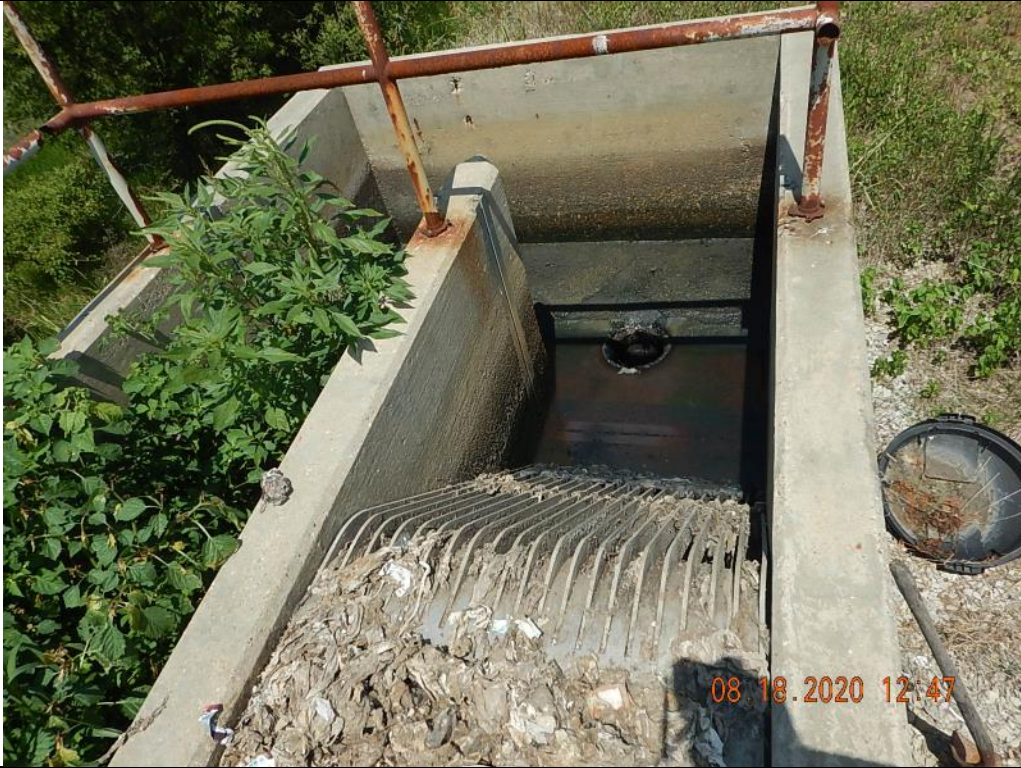
Location:	<b>City of Corning</b>		
Photographer:	<b>Sarah Frasher</b>	Date:	<b>8/18/2020</b>
Time:	<b>12:47</b>	Witness:	<b>None</b>
Photo #:	<b>7</b>	Description:	<b>View of the inside of the influent structure with a close-up of the bar screen.</b>

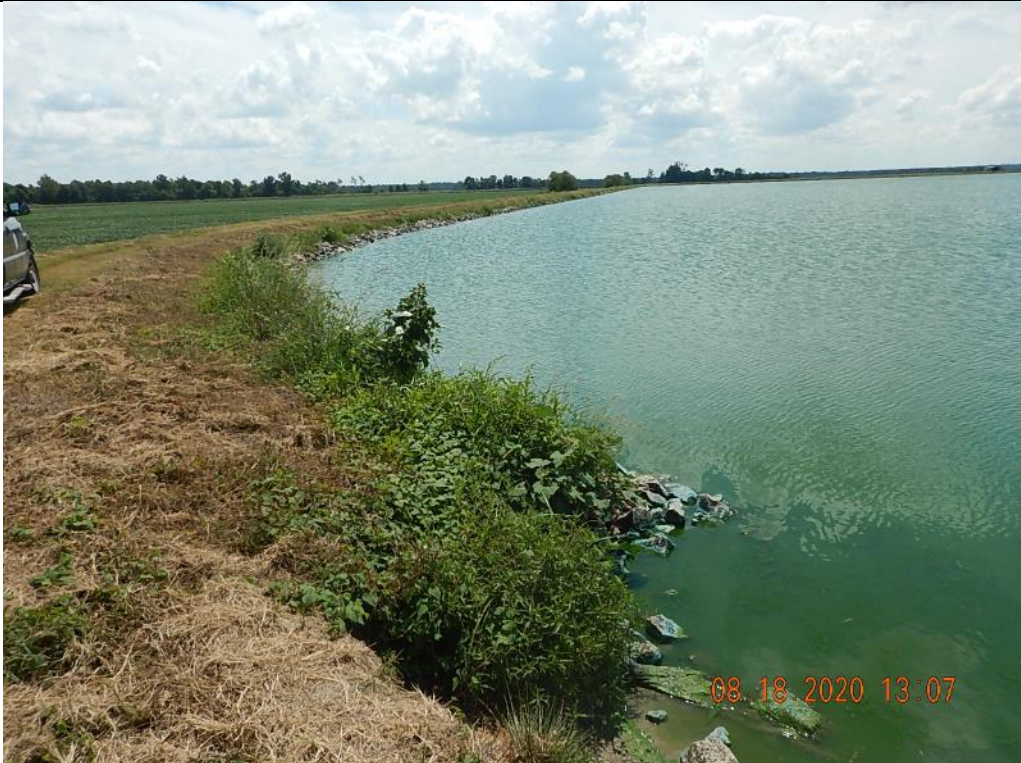
Photographer:	<b>Sarah Frasher</b>	Date:	<b>8/18/2020</b>
Time:	<b>13:07</b>	Witness:	<b>None</b>
Photo #:	<b>8</b>	Description:	<b>View of Cell 1. Note the erosion and vegetation inside of the lagoon levee.</b>
