RE: Quarterly inspection conducted on November 2, 2020
AFIN 03-00051
Permit Number 0249-S1-R2

Division of Environmental Quality
Office of Land Resources - Solid Waste Management
Class 1 Landfill Inspection

Site Name	NABORS Landfill	County	Baxter	AFIN	03-00051
Facility Address	Hwy 5 N to CR 16 to site entrance- Three Brothers	Phone Number	870-425-3213	Permit Number	0249-S1-R2
Permittee Address	P.O. Box 1715, Mountain Home, AR 72602	E-Mail Address	judge@baxtercounty.org	PDS #	114085
Date	11/2/2020	Entry Time	0954	Exit Time	1130

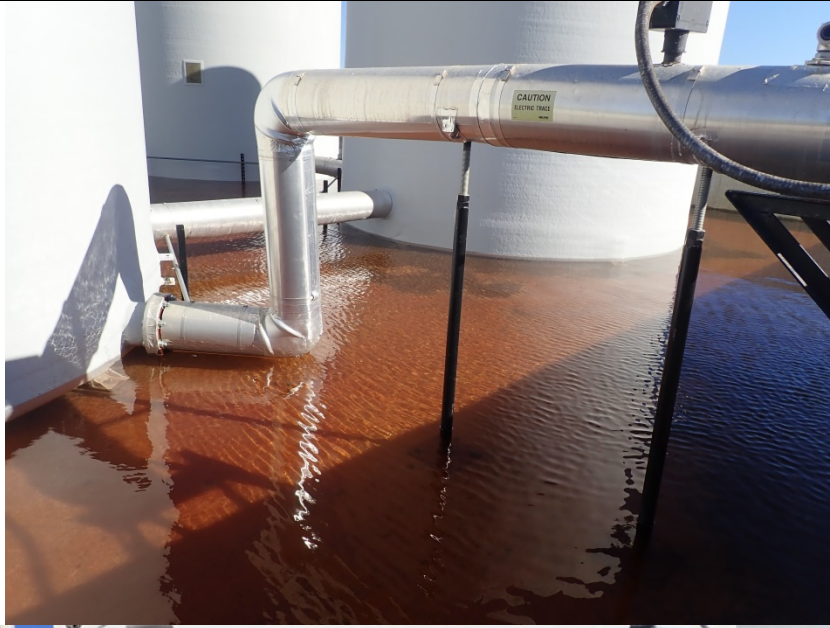
Location	NABORS Class 1			Permit	0249-S1-R2	AFIN	03-00051
Photographer	Darrell Norton, Inspector		<i>DN</i>	Witness	n/a		
Photo #	1	Of	6	Date	11/2/2020	Time	1058(time not adjusted)
Description	Secondary containment unit of tank farm.

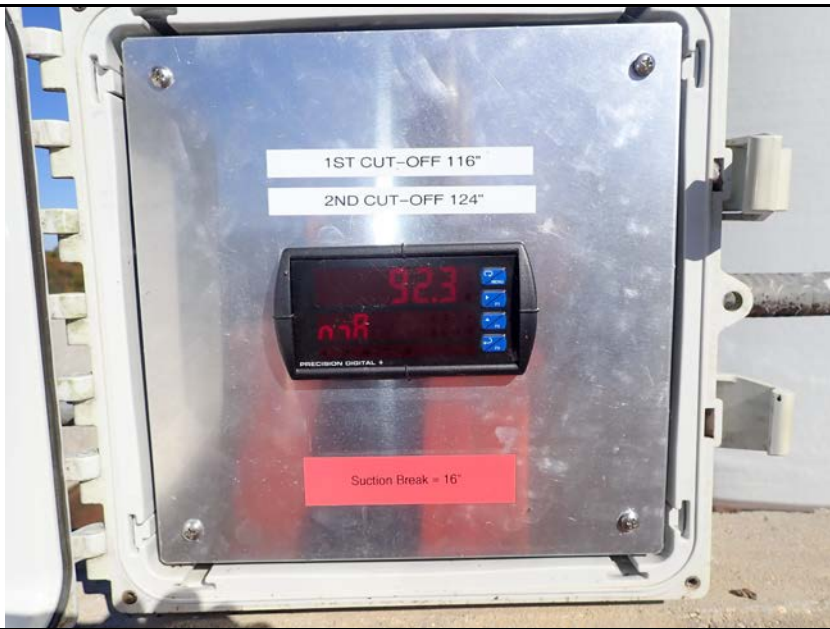
Location	NABORS Class 1			Permit	0249-S1-R2	AFIN	03-00051
Photographer	Darrell Norton, Inspector		<i>DN</i>	Witness	n/a		
Photo #	2	Of	6	Date	11/2/2019	Time	1059(time not adjusted)
Description	Level of tank farm observed.

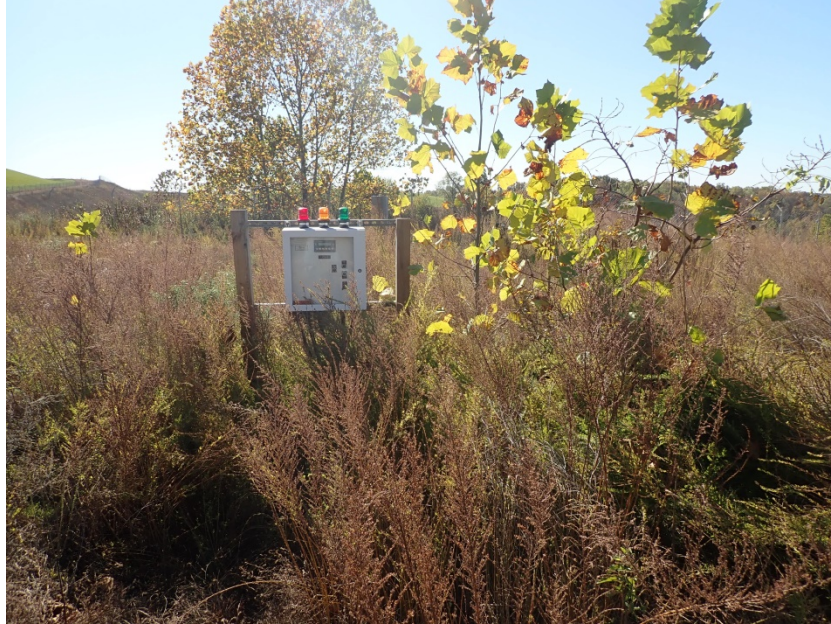
Regulation	Item Description	Comments
411(a)	Operations in accordance with permit documents	
417(c)	Adequate all weather operational roads	Road erosion present between LCS-4 and LCS-5. (Refer to Photo #6.) Vegetative control needed along roads and around LCS panels. (Refer to Photo #5.)
411(c)	Smallest practical area, unloading supervised, single working face	
411(e)	Salvage operations meet approved conditions	
411(f)(1)	Scavenging of waste prohibited	
411(p)	Proper wet weather repairs	
411(b)	Operations by licensed on-site personnel at all times	
411(d)	Waste spread and compacted as unloaded	
411(g)	Litter control provisions maintained	
414(a)	Disease vectors controlled

Location	NABORS Class 1			Permit	0249-S1-R2	AFIN	03-00051
Photographer	Darrell Norton, Inspector		<i>DN</i>	Witness	n/a		
Photo #	5	Of	6	Date	11/2/2020	Time	1109 (time not adjusted)
Description	Vegetative growth along roads and near LCS panels observed.

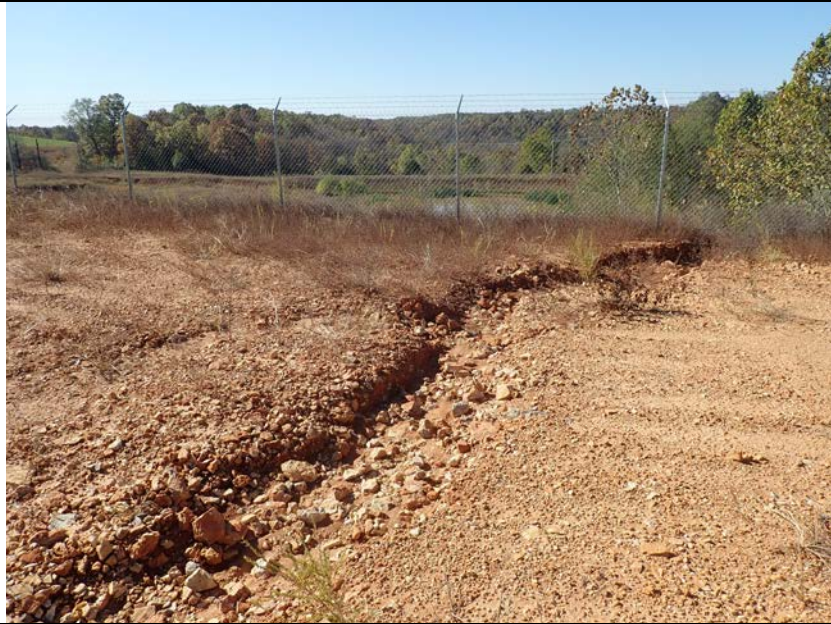
Location	NABORS Class 1			Permit	0249-S1-R2	AFIN	03-00051
Photographer	Darrell Norton, Inspector		<i>DN</i>	Witness	n/a		
Photo #	6	Of	6	Date	8/19/2020	Time	1114 (time not adjusted)
Description	Road wash near LCS 4.
