RE: Quarterly inspection conducted on March 1, 2021
AFIN 03-00051
Permit Number 0249-S1-R2

Division of Environmental Quality
Office of Land Resources - Solid Waste Management
Class 1 Landfill Inspection

Site Name	NABORS Landfill	County	Baxter	AFIN	03-00051
Facility Address	Hwy 5 N to CR 16 to site entrance- Three Brothers	Phone Number	870-425-3213	Permit Number	0249-S1-R2
Permittee Address	P.O. Box 1715, Mountain Home, AR 72602	E-Mail Address	judge@baxtercounty.org	PDS #	115150
Date	3/1/2021	Entry Time	1157	Exit Time	1330

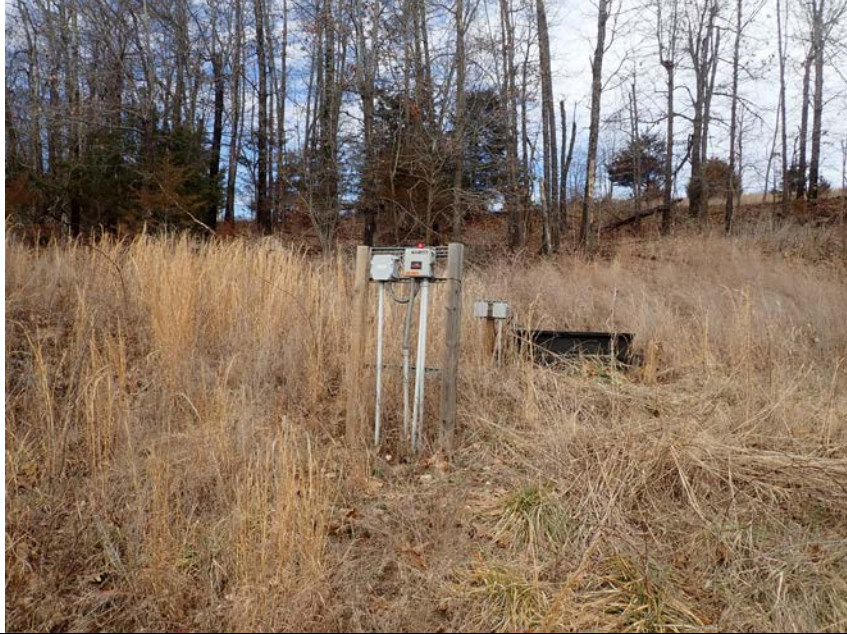
Regulation	Item Description	Comments
427	Surface Water Controls	
411(h)(1)	Contouring prevents surface water flowing into or through waste	
418(a)(b)	Run-on/off control system present and adequate	
411(h)(2)	Surface water control prevents off-site sediment accumulation	
411(i);427(f)	Adequate maintenance of intermediate/final cover vegetation	Turf roll observed in multiple areas. (Refer to Photos #3 and #4.)
415	Gas monitoring program	
411(o)	Leachate leaks or evidence of leachate seepage	
426	Survey controls	
429	Leachate collection system	VLCS-1 alarm active. (Refer to Photo #1.) LCS-1 still reading auto-test in progress.
420	Liquid Restrictions

Location	NABORS Class 1			Permit	0249-S1-R2	AFIN	03-00051
Photographer	Darrell Norton, Inspector		<i>DN</i>	Witness	n/a		
Photo #	1	Of	6	Date	3/1/2021	Time	1158
Description	Alarm activated at VLCS-1

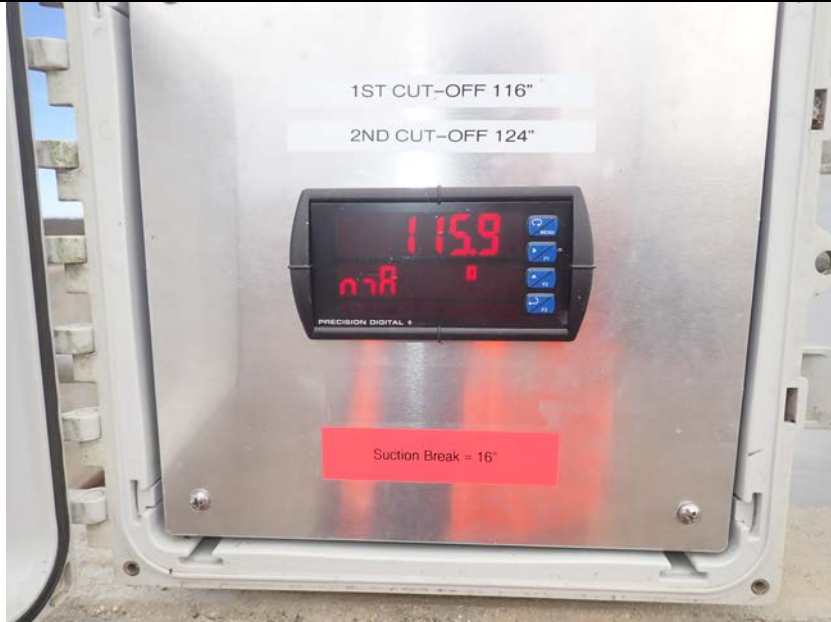
Location	NABORS Class 1			Permit	0249-S1-R2	AFIN	03-00051
Photographer	Darrell Norton, Inspector		<i>DN</i>	Witness	n/a		
Photo #	2	Of	6	Date	3/1/2021	Time	1202
Description	Leachate level of tank farm.

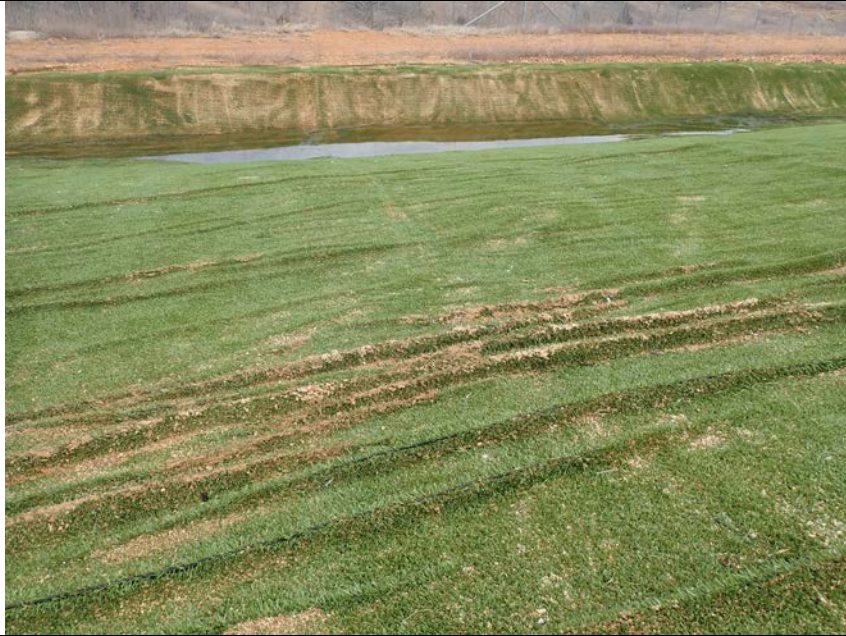
Location	NABORS Class 1			Permit	0249-S1-R2	AFIN	03-00051
Photographer	Darrell Norton, Inspector		<i>DN</i>	Witness	n/a		
Photo #	3	Of	6	Date	3/1/2021	Time	1208
Description	Negative drainage and turf roll observed between LCS-6 and LCS-7.

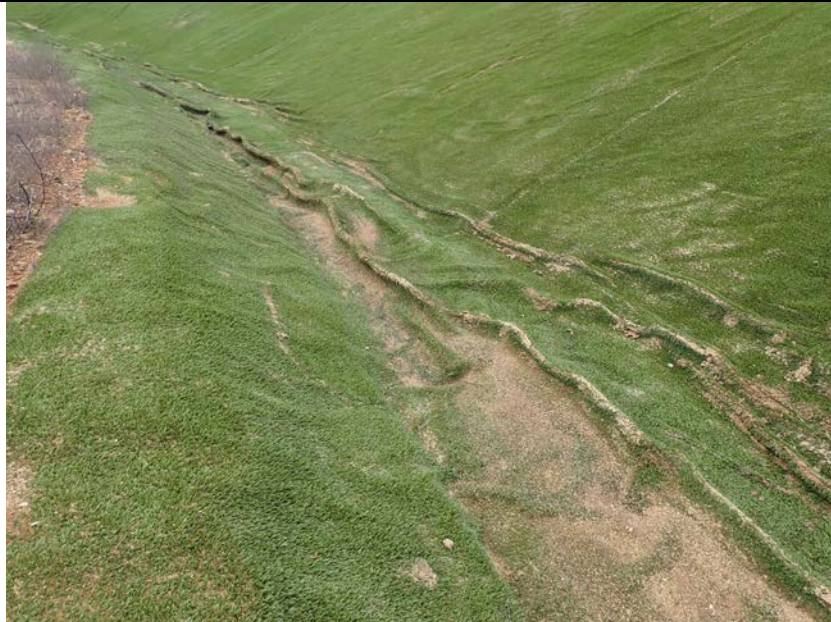
Location	NABORS Class 1			Permit	0249-S1-R2	AFIN	03-00051
Photographer	Darrell Norton, Inspector		<i>DN</i>	Witness	n/a		
Photo #	4	Of	6	Date	3/1/2021	Time	1234
Description	Turf roll observed.

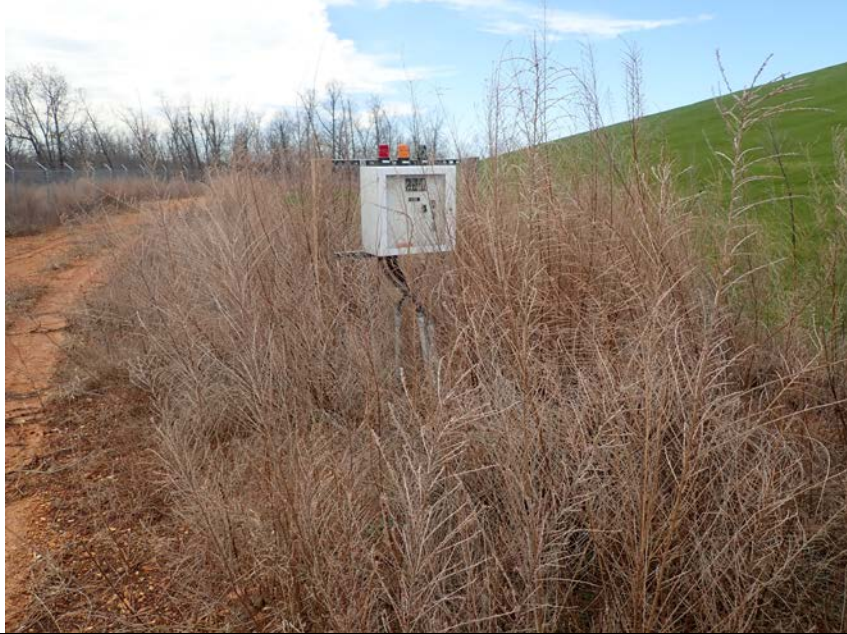
Regulation	Item Description	Comments
411(a)	Operations in accordance with permit documents	
417(c)	Adequate all weather operational roads	Road erosion observed between LCS-4 and LCS-5. Vegetative control needed along roads and around LCS panels. (Refer to Photo #5.)
411(c)	Smallest practical area, unloading supervised, single working face	
411(e)	Salvage operations meet approved conditions	
411(f)(1)	Scavenging of waste prohibited	
411(p)	Proper wet weather repairs	
411(b)	Operations by licensed on-site personnel at all times	
411(d)	Waste spread and compacted as unloaded	
411(g)	Litter control provisions maintained	
414(a)	Disease vectors controlled

Location	NABORS Class 1			Permit	0249-S1-R2	AFIN	03-00051
Photographer	Darrell Norton, Inspector		<i>DN</i>	Witness	n/a		
Photo #	5	Of	6	Date	3/1/2021	Time	1237
Description	Vegetative growth observed along roads and near LCS panels.

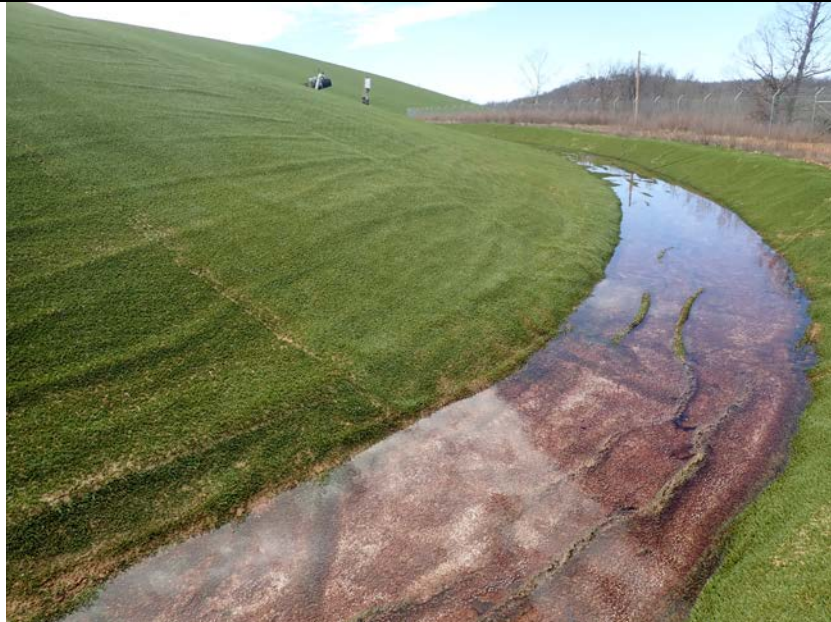
Location	NABORS Class 1			Permit	0249-S1-R2	AFIN	03-00051
Photographer	Darrell Norton, Inspector		<i>DN</i>	Witness	n/a		
Photo #	6	Of	6	Date	3/1/2021	Time	1247
Description	Negative drainage observed near LCS-1
