**RE: Quarterly Inspection conducted on June 2, 2021**  
**AFIN 32-00042**  
**Permit Number 0200-S3N-R2**

**Division of Environmental Quality**  
**Office of Land Resources - Solid Waste Management**  
**Class 3 Landfill Inspection**

| <b>Site Name</b> | Entergy- Independence Plant | <b>County</b> | Independence | <b>AFIN</b> | 32-00042 |

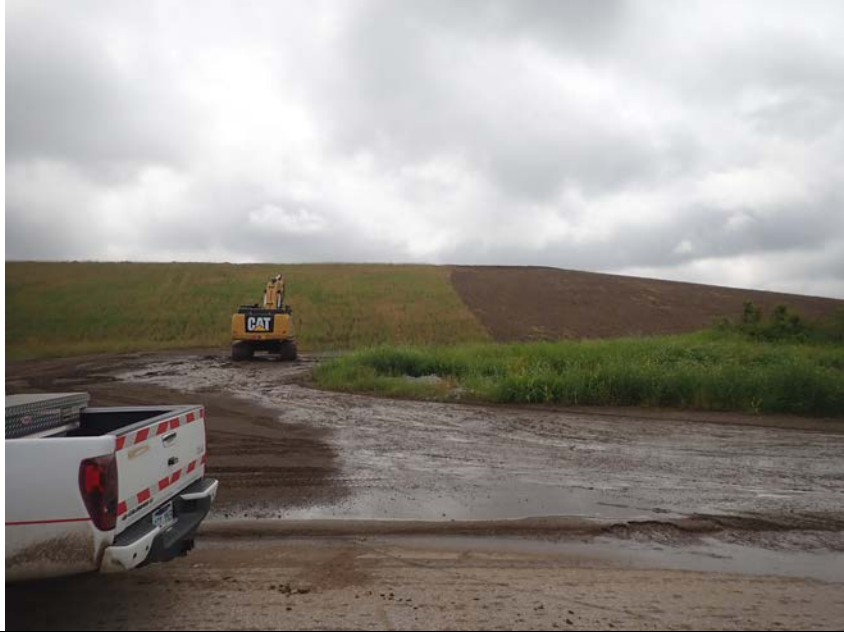
| <b>Photo #</b> | 1 | <b>Of</b> | 4 | <b>Date</b> | 6/2/2021 | <b>Time</b> | 1030 |

| <b>Description</b> | A view of slope stabilization and seeding occurring. | | | | | | |

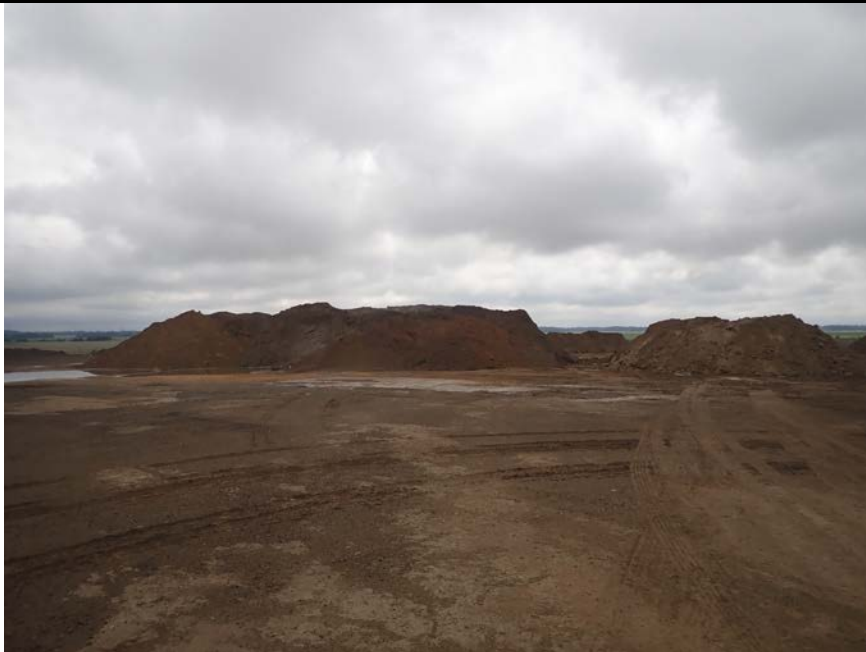
| <b>Photo #</b> | 2 | <b>Of</b> | 4 | <b>Date</b> | 6/2/2021 | <b>Time</b> | 1035 |

| <b>Description</b> | A view of stockpiled material near the working face. | | | | | | |

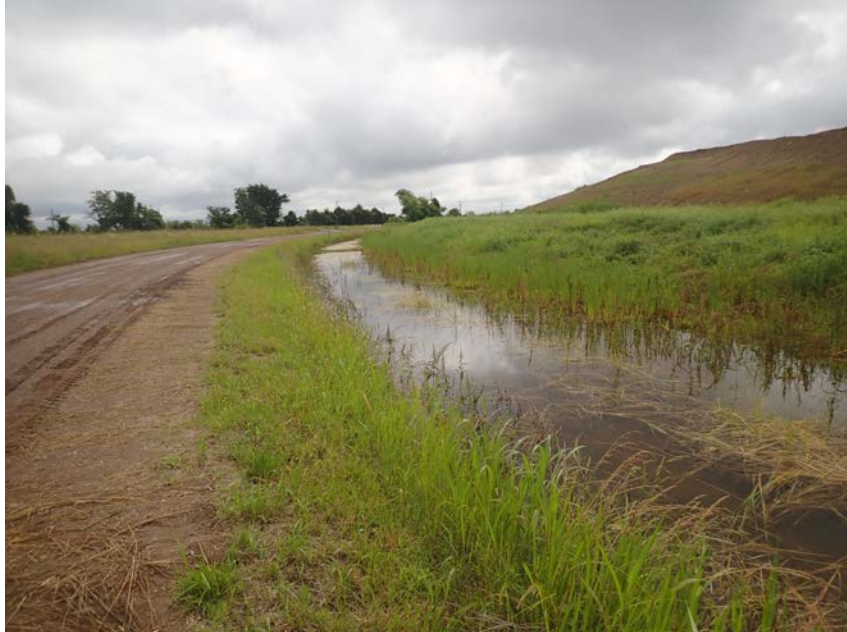
| <b>Photo #</b> | 3 | <b>Of</b> | 4 | <b>Date</b> | 6/2/2021 | <b>Time</b> | 1044 |

| <b>Regulation</b> | <b>Item Description</b> | <b>Comments</b> |
|---|--|---|
| 510(a) | Operations in accordance with permit documents | No flow of the water observed in the storm water ditch on the northwest side of the landfill. |

| <b>Description</b> | A view of the storm water ditch on the northwest side of the landfill. No flow of the water observed. | | | | | | |

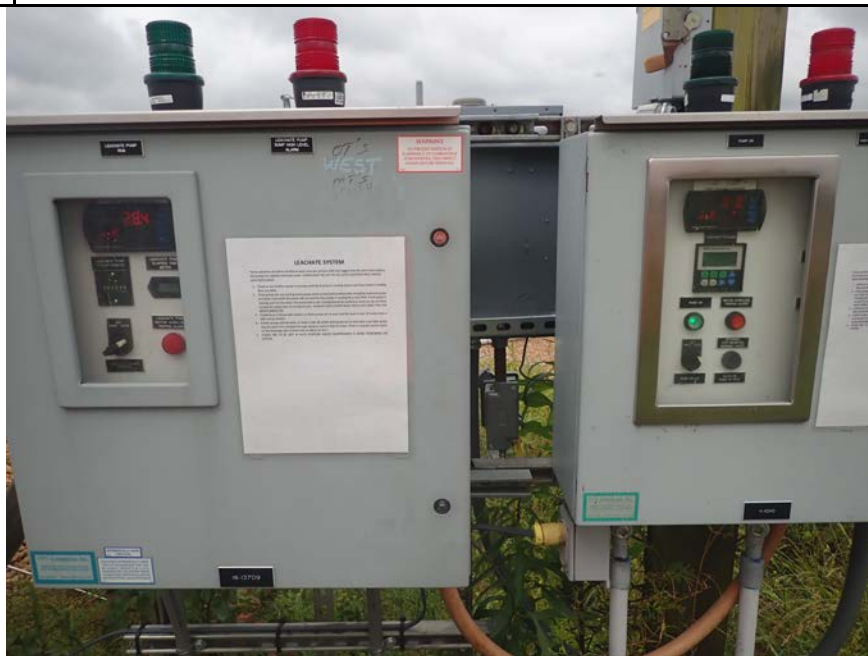
| <b>Photo #</b> | 4 | <b>Of</b> | 4 | <b>Date</b> | 6/2/2021 | <b>Time</b> | 1048 |

| Regulation | Item Description | Comments |
|---|---|---|
| 529 | Leachate collection system | Both pumps set to "auto" at the time of the inspection. |

| <b>Description</b> | A view of leachate pump control panels with the auto setting activated. | | | | | | |
