RE: Quarterly Inspection conducted on June 14, 2021
AFIN 60-01071
Permit Number 0266-S1

Division of Environmental Quality
Office of Land Resources - Solid Waste Management
Class 1 Landfill Inspection

Site Name	City of Little Rock Class 1 Landfill	County	Pulaski	AFIN	60-01071
Facility Address	10803 Ironton Cutoff, Little Rock, AR 72206	Phone Number	501-888-4493	Permit Number	0266-S1
Permittee Address	10803 Ironton Cutoff, Little Rock, AR 72206	E-Mail Address	ncharles@littlerock.gov		PDS# 116528
Date	6/14/2021	Entry Time	1000	Exit Time	1145

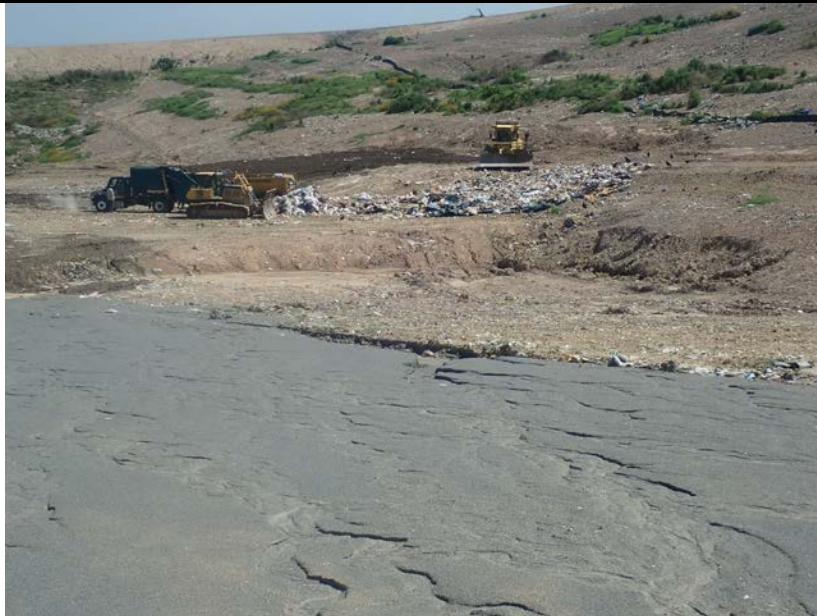
Location	City of Little Rock Class 1 Landfill			Permit	0266-S1	AFIN	60-01071
Photographer	Kim Davenport, Inspector		<i>KD</i>	Witness	N/A		
Photo #	1	Of	10	Date	6/14/2021	Time	1046
Description	A view of the active working face is observed in the background. Run-on controls are not observed to prevent stormwater from coming into contact with waste under daily cover, looking northeast at Cell 5 west.

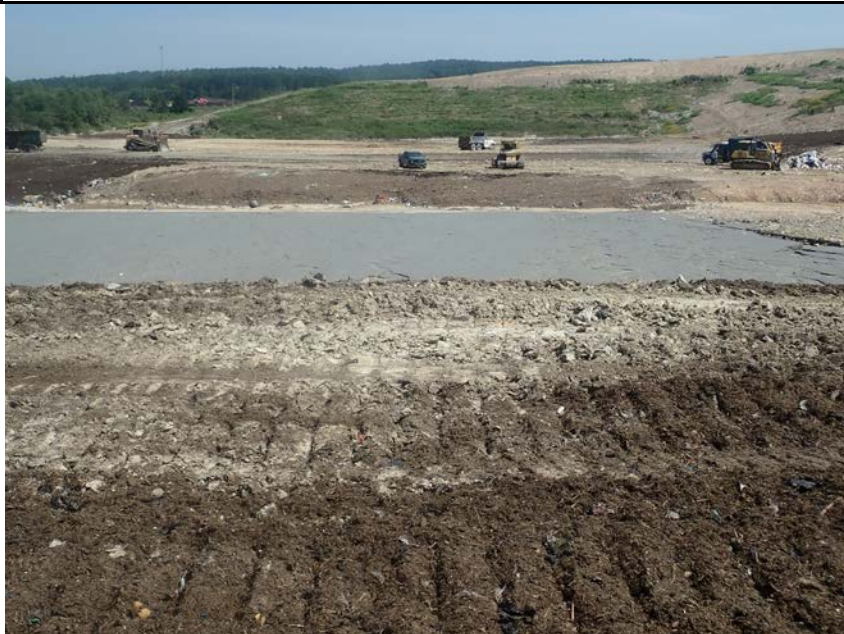
Location	City of Little Rock Class 1 Landfill			Permit	0266-S1	AFIN	60-01071
Photographer	Kim Davenport, Inspector		<i>KD</i>	Witness	N/A		
Photo #	2	Of	10	Date	6/14/2021	Time	1045
Description	A northern view of Cell 5 west to show run-on controls are not in place to prevent stormwater from contacting waste. The foreground shows shredded wood containing plastic waste used as an alternate daily cover.

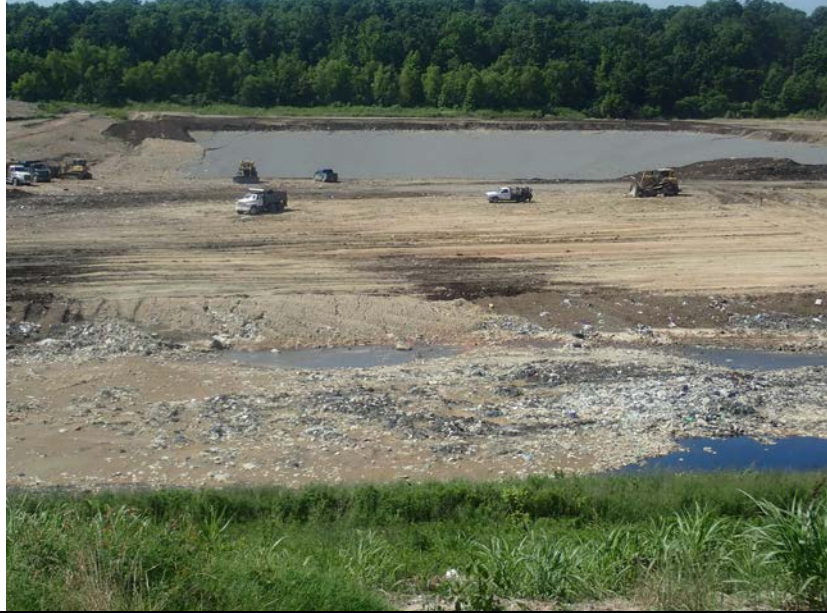
Regulation	Item Description	Comments
	427	Surface Water Controls	
	411(h)(1)	Contouring prevents surface water flowing into or through waste	
X	418(a)(b)	Run-on/off control system present and adequate	A run-on control system was not observed in place to prevent flow onto the active portion of the landfill during the peak discharge from a 24-hour, 25-year (return frequency) storm. (Refer to Photos #1 - #3 & #5.)
	411(h)(2)	Surface water control prevents off-site sediment accumulation	
	411(i);427(f)	Adequate maintenance of intermediate/final cover vegetation	
	415	Gas monitoring program	
X	411(o)	Leachate leaks or evidence of leachate seepage	Leachate observed pooling in Cell 5 west and on the exterior slope of Cell 4 east. (Refer to Photos # 4 - #8.)
	426	Survey controls	
	429	Leachate collection system	
	420	Liquid Restrictions

Location	City of Little Rock Class 1 Landfill			Permit	0266-S1	AFIN	60-01071
Photographer	Kim Davenport, Inspector		<i>KD</i>	Witness	N/A		
Photo #	5	Of	10	Date	6/14/2021	Time	1021
Description	An overview of the center of Cell 5 west shows ponded leachate in the northern portion of the cell. No run-on controls observed to decrease flow of storm water into the waste mass.

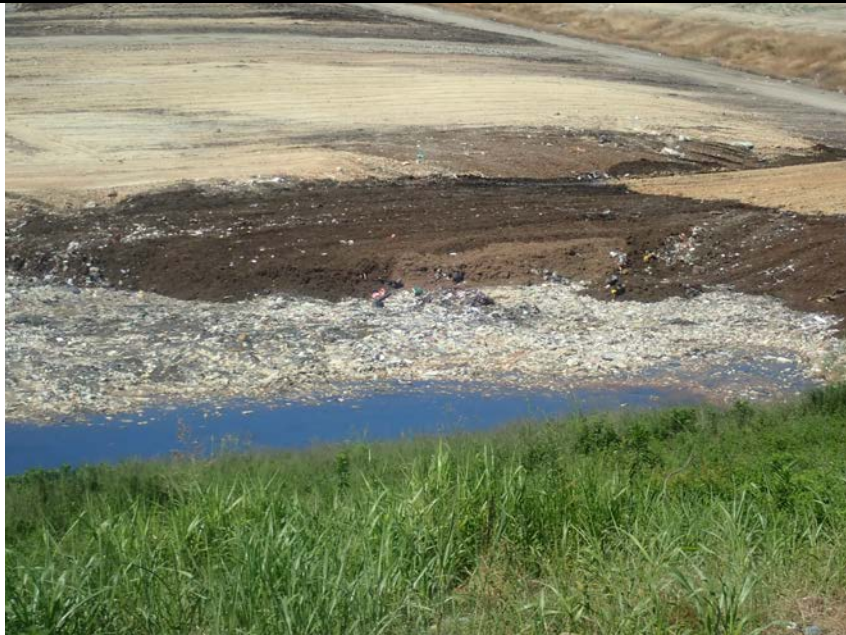
Location	City of Little Rock Class 1 Landfill			Permit	0266-S1	AFIN	60-01071
Photographer	Kim Davenport, Inspector		<i>KD</i>	Witness	N/A		
Photo #	6	Of	10	Date	6/14/2021	Time	1021
Description	A view of ponded leachate in the northwest portion of Cell 5 west.

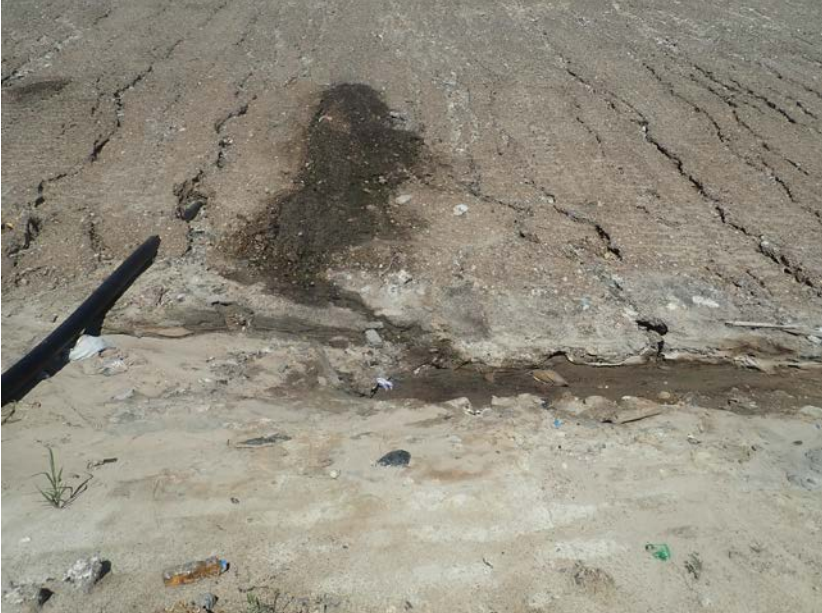
Location	City of Little Rock Class 1 Landfill			Permit	0266-S1	AFIN	60-01071
Photographer	Kim Davenport, Inspector		<i>KD</i>	Witness	N/A		
Photo #	7	Of	10	Date	6/14/2021	Time	1038
Description	Leachate observed on the exterior slope of Cell 4 east.

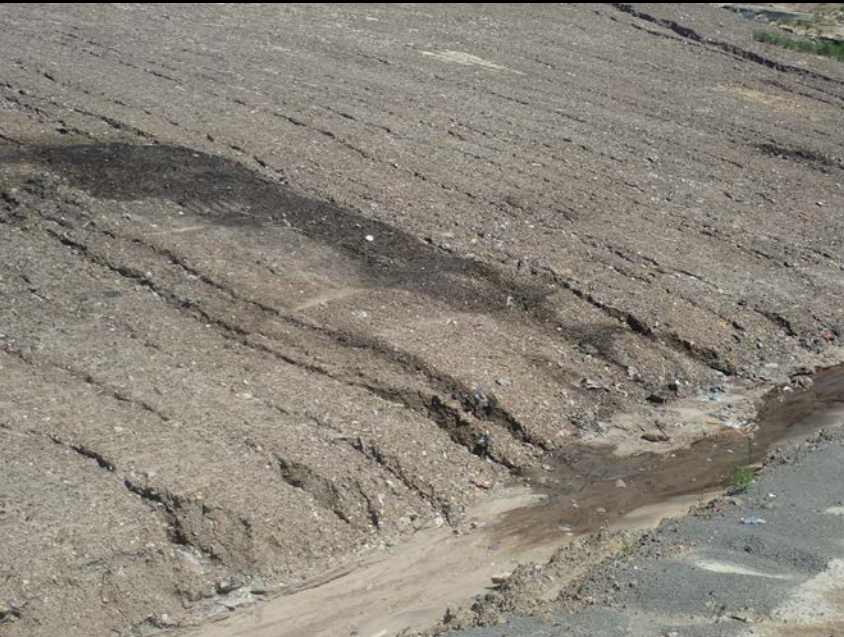
Location	City of Little Rock Class 1 Landfill			Permit	0266-S1	AFIN	60-01071
Photographer	Kim Davenport, Inspector		<i>KD</i>	Witness	N/A		
Photo #	8	Of	10	Date	6/14/2021	Time	1038
Description	Leachate observed on the exterior slope of cell 4 east.

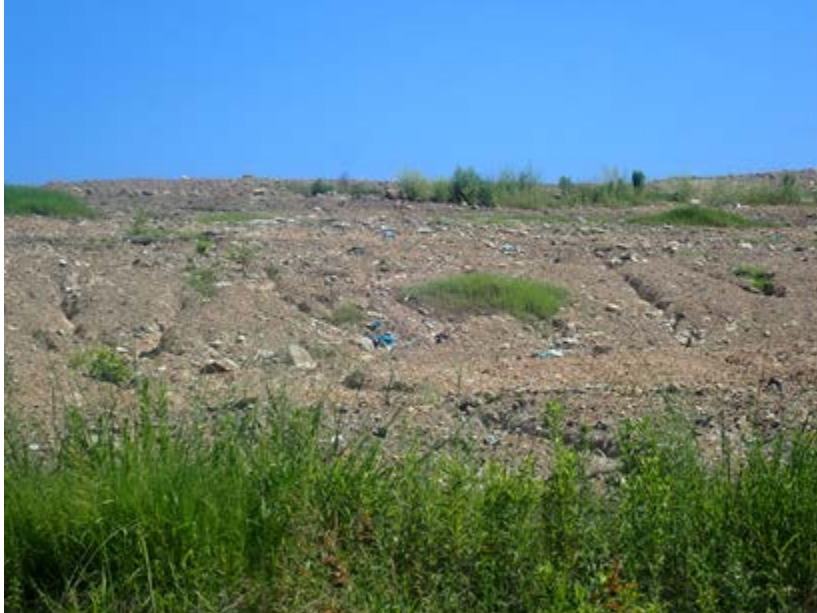
Regulation	Item Description	Comments
	412	Implementation of hazardous/unauthorized waste exclusion plan	
	413(a)(b)	Satisfactory daily/alternative cover	
X	413(c)	Satisfactory intermediate cover	Erosion with exposed waste observed in the interim cover on the south slopes of Cells 4 & 5. (Refer to Photos #9 & #10.)
	416(b),411(f)(4)	Open burning prohibited	
	419	Cause discharge/leachate discharge leaving landfill	
	411(f)(3),419(a)(4)	Depositing waste in standing water prohibited	
X	411(o)	Erosion or other cover defects resulting in exposed refuse	Cover defects resulting in exposed waste were observed in the north portion of Cell 5 west. (Refer to Photos #3 - #5.)
	309(c)	Overfill/Off lined area

Location	City of Little Rock Class 1 Landfill			Permit	0266-S1	AFIN	60-01071
Photographer	Kim Davenport, Inspector		<i>KD</i>	Witness	N/A		
Photo #	9	Of	10	Date	6/14/2021	Time	1042
Description	Erosion with exposed waste observed on the south slope of Cells 4 & 5, under interim cover.

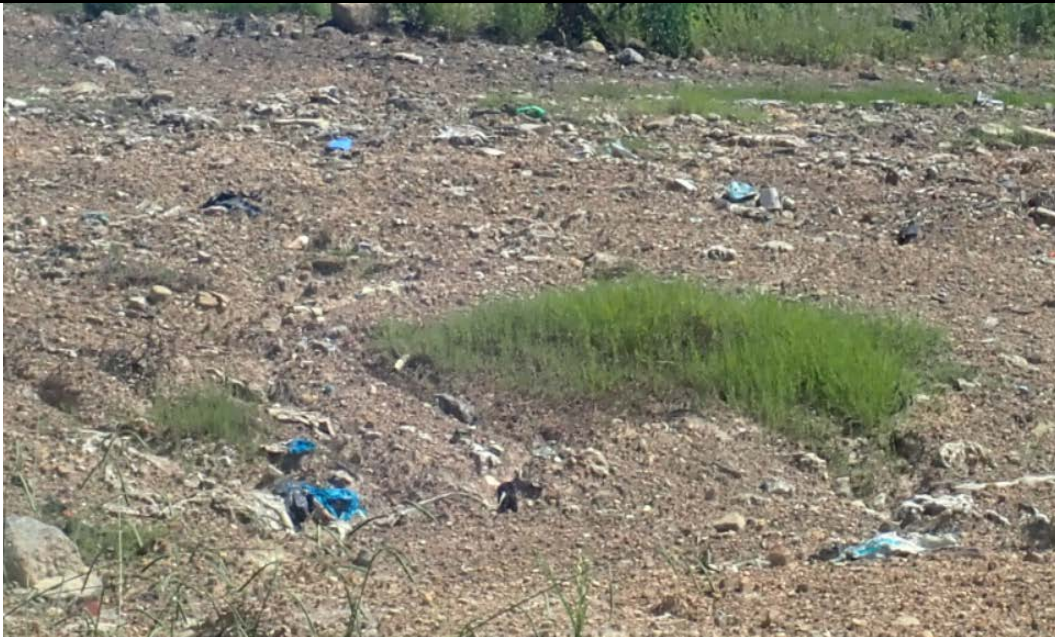
Location	City of Little Rock Class 1 Landfill			Permit	0266-S1	AFIN	60-01071
Photographer	Kim Davenport, Inspector		<i>KD</i>	Witness	N/A		
Photo #	10	Of	10	Date	6/14/2021	Time	1042
Description	A closer view of the erosion and exposed waste shown in Photo #9.
