**RE: Quarterly inspection conducted on July 26, 2021**  
**AFIN 03-00051**  
**Permit Number 0249-S1-R2**

**Division of Environmental Quality**  
**Office of Land Resources - Solid Waste Management**  
**Class 1 Landfill Inspection**

| <b>Site Name</b> | NABORS Class 1 Landfill | <b>County</b> | Baxter | <b>AFIN</b> | 03-00051 |

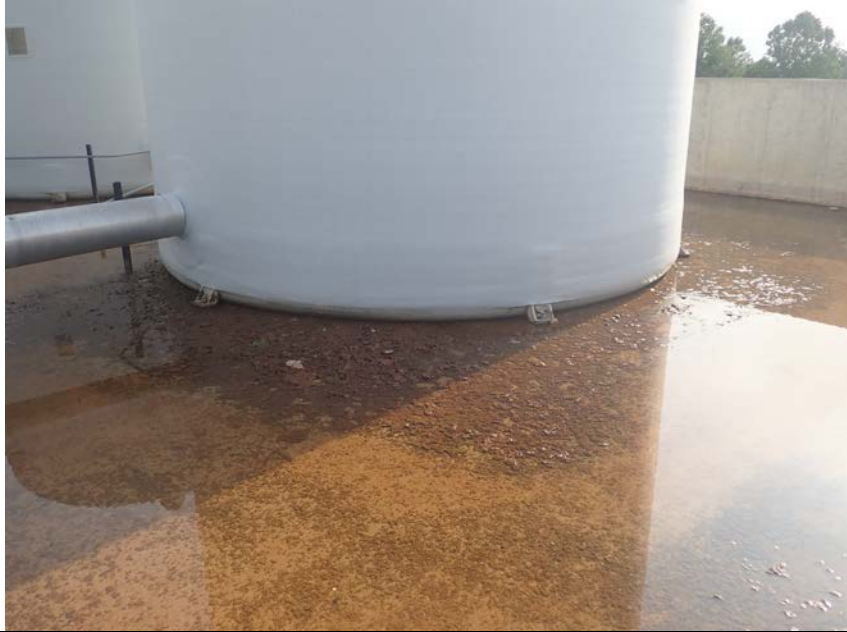
| <b>Photo #</b> | 1 | <b>Of</b> | 6 | <b>Date</b> | 7/26/2021 | <b>Time</b> | 0833 |

| <b>Description</b> | Storm water in the tank farm secondary containment. | | | | | | |

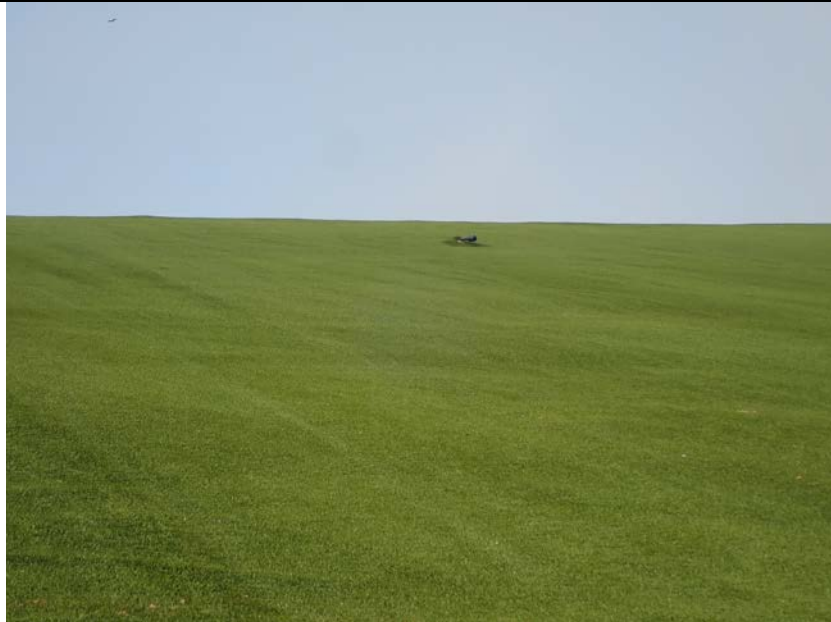
| <b>Photo #</b> | 2 | <b>Of</b> | 6 | <b>Date</b> | 7/26/2021 | <b>Time</b> | 0839 |

| <b>Description</b> | Vent down on the North slope of Area 1-2. | | | | | | |

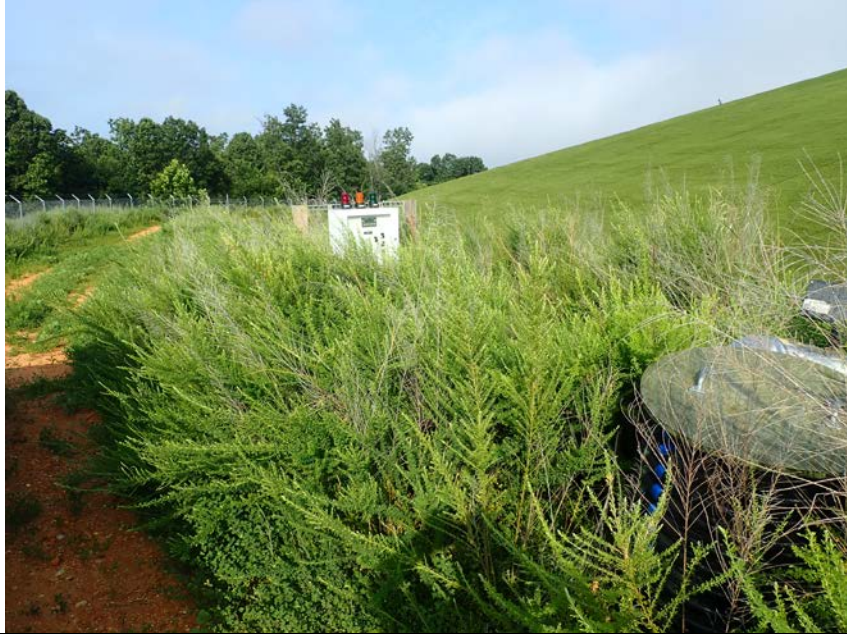
| <b>Photo #</b> | 3 | <b>Of</b> | 6 | <b>Date</b> | 7/26/2021 | <b>Time</b> | 0843 |

| Regulation | Item Description | Comments |
|---|--|--|
| 417(c) | Adequate all weather operational roads | Road erosion present in multiple areas. (Refer to Photo #5.) Vegetative control needed along roads and around LCS panels. (Refer to Photo #3.) |

| <b>Description</b> | Vegetative growth present along roads and around LCS Panels. | | | | | | |

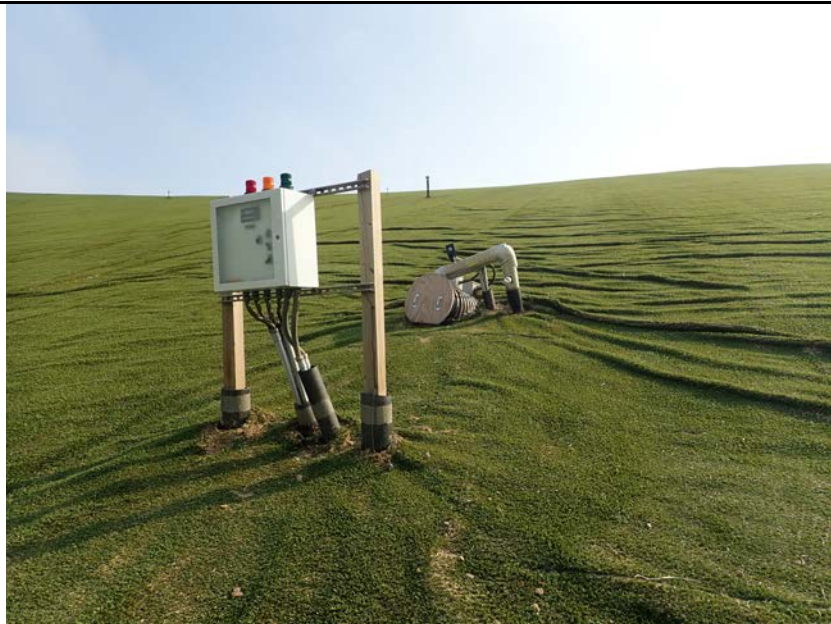
| <b>Photo #</b> | 4 | <b>Of</b> | 6 | <b>Date</b> | 7/26/2021 | <b>Time</b> | 0846 |

| Regulation | Item Description | Comments |
|---|---|--|
| 411(i);427(f) | Adequate maintenance of intermediate/final cover vegetation | Turf roll observed in multiple areas. (Refer to Photo #4 & Photo #6.) |

| <b>Description</b> | Turf roll present near LCS 4. | | | | | | |

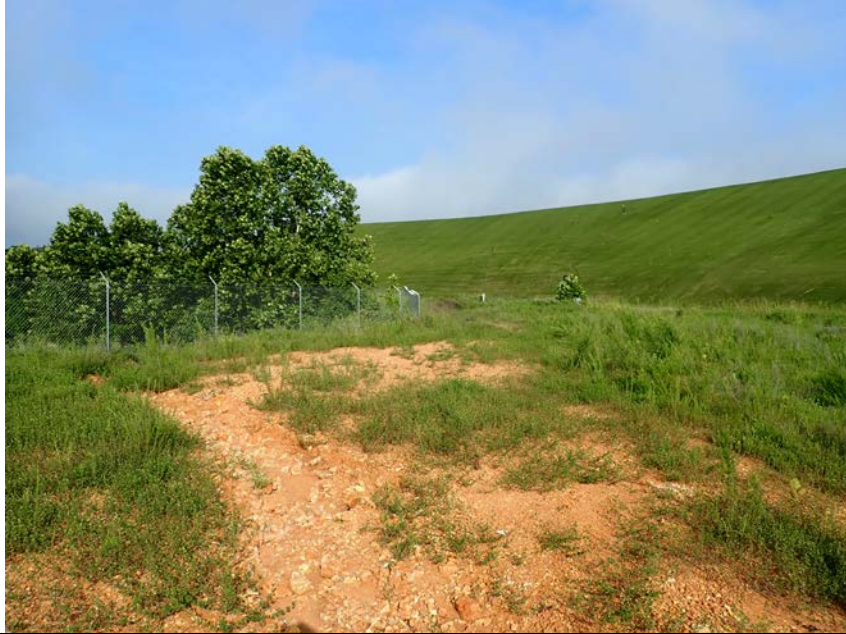
| <b>Photo #</b> | 5 | <b>Of</b> | 6 | <b>Date</b> | 7/26/2021 | <b>Time</b> | 0848 |

| <b>Description</b> | Road wash present between LCS 4 and LCS 5 | | | | | | |

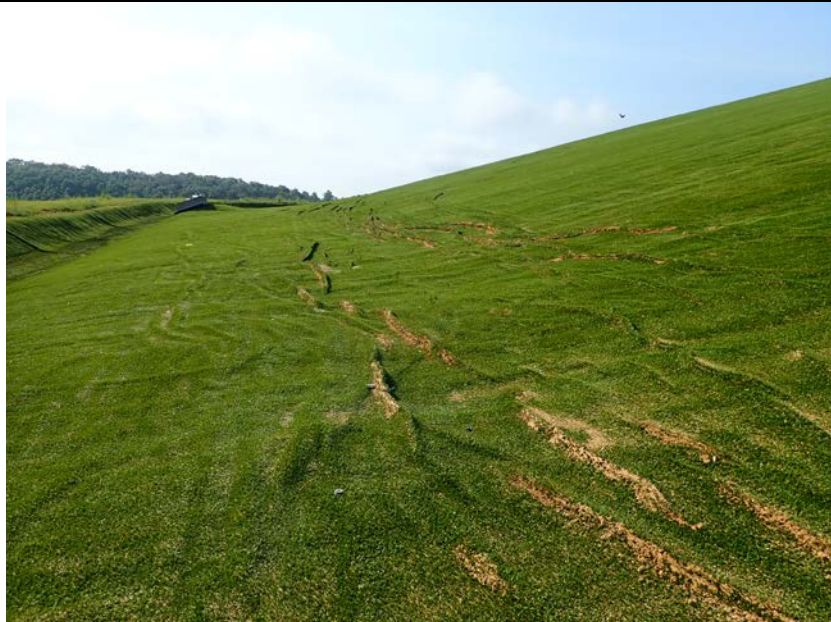
| <b>Photo #</b> | 6 | <b>Of</b> | 6 | <b>Date</b> | 7/26/2021 | <b>Time</b> | 0901 |

| <b>Description</b> | Turf roll present near LCS 7. | | | | | | |
