OFFICE OF WATER QUALITY INSPECTION REPORT

AFIN: **67-00023** PERMIT #: **AR0021733** DATE: 5/20/2021

FACILITY INFORMATION				INSPECTION INFORMATION					
City of DeQueen WWTP			FACILITY TYPE: INSPECTOR ID#: 129177 S - State						
670 South 9 th Street						SSO/	NSPECTION TYPE: SSO/Collection System		
DeQueen			DATE(S): 5/20/2021	ENTRY T		12:		PERMIT EFFECTIVE DATE: 4/1/2020	
	RESPONSIBLE OFFIC	CIAL	_	00					PERMIT EXPIRATION DATE:
	ह / तात्राह ffrey A. Brown / Mayor								3/31/2025
COMPANY:			FAYETTEVILLE SHALE RELATED: N						
City of DeQueen			FAYETTEVILLE SHALE VIOLATIONS: N						
P.O. Box 730			INSPECTION PARTICIPANTS						
CITY, STATE, ZIP:			NAME/TITLE/PHONE/FAX/EMAIL/ETC.:						
DeQueen AR 71832			Wesley Cox / Wastewater Operator Kerri McCabe / DEQ Inspector Supervisor						
870-584-3445 /			Trey Butler / OWQ Inspector						
_	EMAIL:			licy Butien /	O I I Q	1113	pecto		
Ма	Mayor@cityofdequeen.com								
CC	NTACTED DURING INSPECTION	***							
	AREA EVALUATIONS (S=Satisfactory, M=Marginal, U=Unsatisfactory, N=Not Applicable/Evaluated)

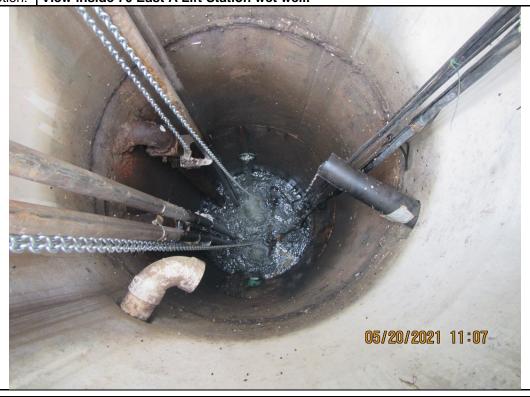
<u>70 East A Lift Station</u> (located at coordinates 34.046225; -94.318358): This lift station is just behind an AutoZone Auto Parts store. The lift station had a sign with emergency contact information and the light was in working order at the time of inspection. The wet well did not show any signs of solids or grease accumulations.

Office of Water Quality Photographic Evidence Sheet Location: City of DeQueen WWTP Photographer: Brittanie Gloyd Date: 05/20/2021 Time: 11:07 Witness: Kerri McCabe; Trey Butler Photo #: 1 Description: View inside 70 East A Lift Station wet well.

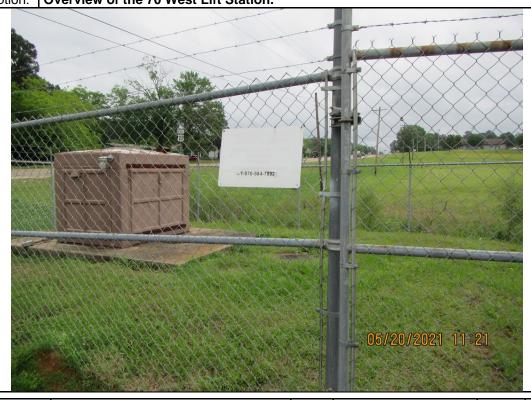
<u>70 West Lift Station</u> (located at coordinates 34.045231; -94.366398): This lift station is located across the street of University of Arkansas – Cossatot Community College. The lift station had two aboveground pumps that push the wastewater into the force main. The light was in working order and the gate had a sign with emergency contact information in the case of an overflow. The wet well did not show any signs of solids or grease accumulations.

City of DeQueen WWTP Photographer: Brittanie Gloyd Date: 05/20/2021 Time: 11:21 Witness: Kerri McCabe; Trey Butler Photo #: 5 Description: Overview of the 70 West Lift Station.
