RE: City of Dumas Inspections (Desha Co)

AFIN: 21-00045 NPDES Permit No.: AR0033987

OFFICE OF WATER QUALITY INSPECTION REPORT

AFIN: **21-00045** | PERMIT #: **AR0033987** | DATE: **5/20/2021**

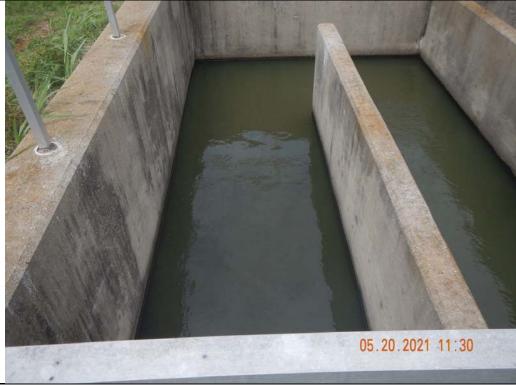
Photographer:	Michael Young	Date:	05/20/2021	Time:	11:30
Witness:				Photo #:	12

Description: Chlorine contact chamber viewed from where water enters chamber.

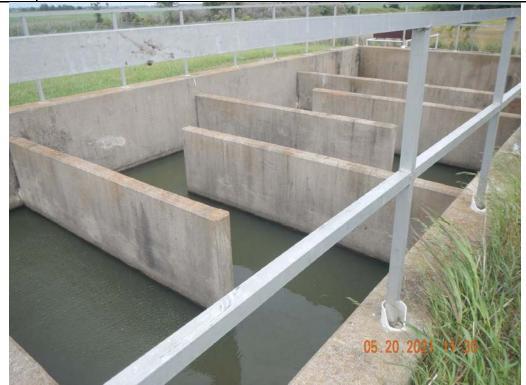
City of Dumas Photographer: Michael Young Date: 05/20/2021 Time: 11:29 Witness: Photo #: 13

Description: Dechlorination area prior to sampling and flow readings.

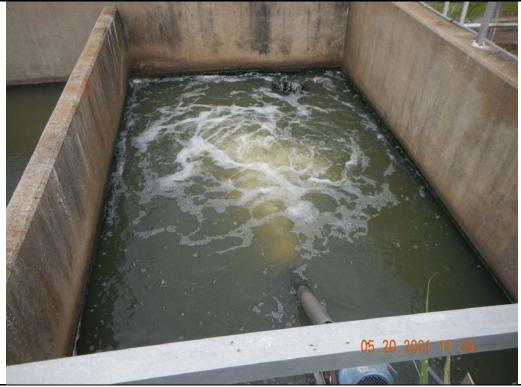
Photographer: Michael Young	Date: 05/20/2021	Time:	11:32
Witness:		Photo #	: 14

- 1.) At the time of the inspection, solid waste materials removed from the bar screen are being placed in a wheelbarrow that is uncovered and exposed to rainfall. Stormwater runoff is not directed back to the treatment system. This is a violation of permit condition Part II. (6.).
- 2.) There is rust and other materials on the staff gauge causing it to be illegible. This is a violation of permit condition Part III. (C.) (2.). To perform flow checks on the totalizer, the staff gauge needs to be cleaned and legible.

Description: Parshall flume used as primary flow device. Note that measuring device is corroded and hard to read at normal flow level.

The staff gauge was replaced after the 1-10-19 inspection was performed, the operator has cleaned the staff gauge to make legible for readings. The city is currently changing means of operation when dealing with the solid waste materials off of the bar screen to prevent stormwater runoff. Currently a tarp is being utilized to cover the wheel barrow. McClelland Consulting Engineers, Inc. Is designing a new headworks with a cover for the future. This is a part current project connecting the Mitchellville system to Dumas. If you have any question please do not hesitate to call or email me at atriche@mce.us.com

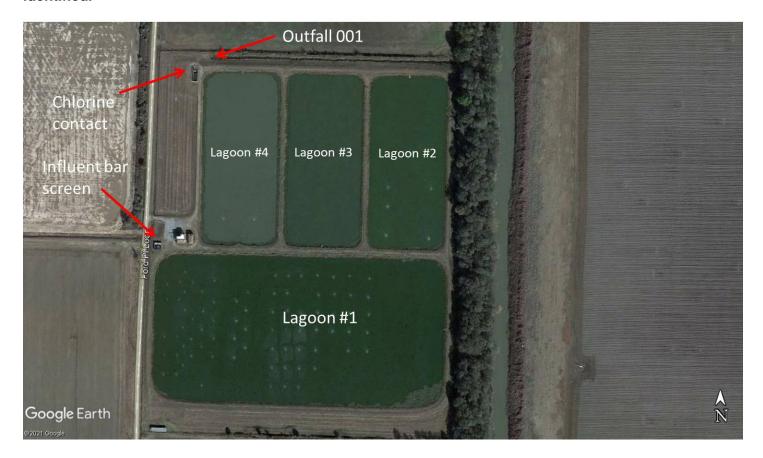
Figure 1. Overview of the City of Dumas wastewater treatment system with treatment components identified.
