**RE: Inspection conducted on October 5, 2021**  
**AFIN 03-00051**  
**Permit Number 0249-S1-R2**

**Office of Land Resources  
Regulated Waste Operations  
Class 1 Landfill Inspection Form**

<b>Site Name</b>	NABORS Class 1 Landfill	<b>County</b>	Baxter	<b>AFIN</b>	03-00051
<b>Facility Address</b>	Hwy 5 N to CR 16 to site entrance- Three Brothers	<b>Phone #</b>	870-425-3213	<b>Permit #</b>	0249-S1-R2
<b>Permittee Address</b>	P.O. Box 1715, Mountain Home, AR 72602	<b>Email Address</b>	<a href="mailto:kilburn@adeq.state.ar.us">kilburn@adeq.state.ar.us</a> <a href="mailto:judge@baxtercounty.org">judge@baxtercounty.org</a>	<b>PDS #</b>	117959
<b>Date</b>	10/5/2021	<b>Entry Time</b>	1045	<b>Exit Time</b>	1250

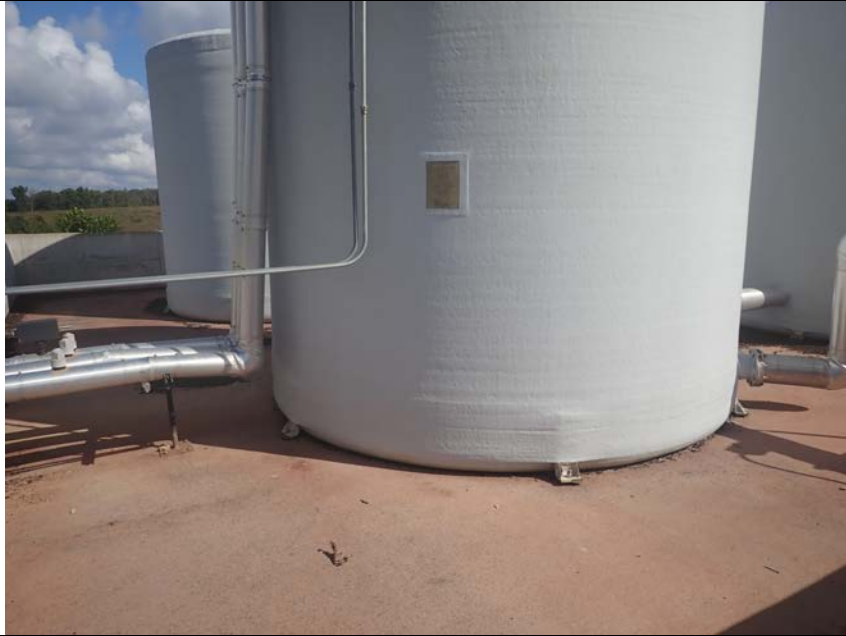
<b>Location</b>	NABORS Class 1			<b>Permit</b>	0249-S1-R2	<b>AFIN</b>	03-00051
<b>Photographer</b>	Darrell Norton, Inspector		<i>DN</i>	<b>Witness</b>	n/a		
<b>Photo #</b>	1	<b>Of</b>	6	<b>Date</b>	10/5/2021	<b>Time</b>	1049
<b>Description</b>	Secondary containment at tank farm.

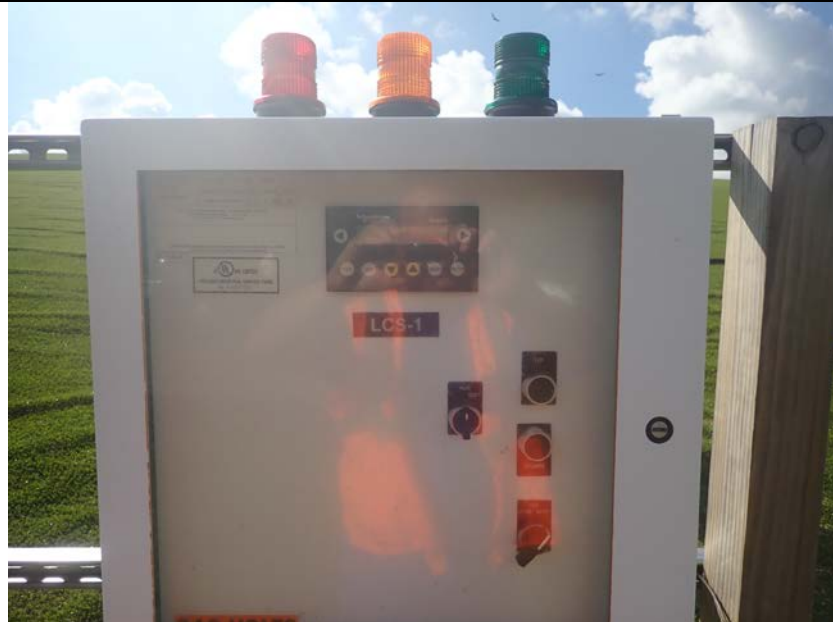
<b>Location</b>	NABORS Class 1			<b>Permit</b>	0249-S1-R2	<b>AFIN</b>	03-00051
<b>Photographer</b>	Darrell Norton, Inspector		<i>DN</i>	<b>Witness</b>	n/a		
<b>Photo #</b>	2	<b>Of</b>	6	<b>Date</b>	10/5/2021	<b>Time</b>	1052
<b>Description</b>	LCS-1 with auto test in progress.

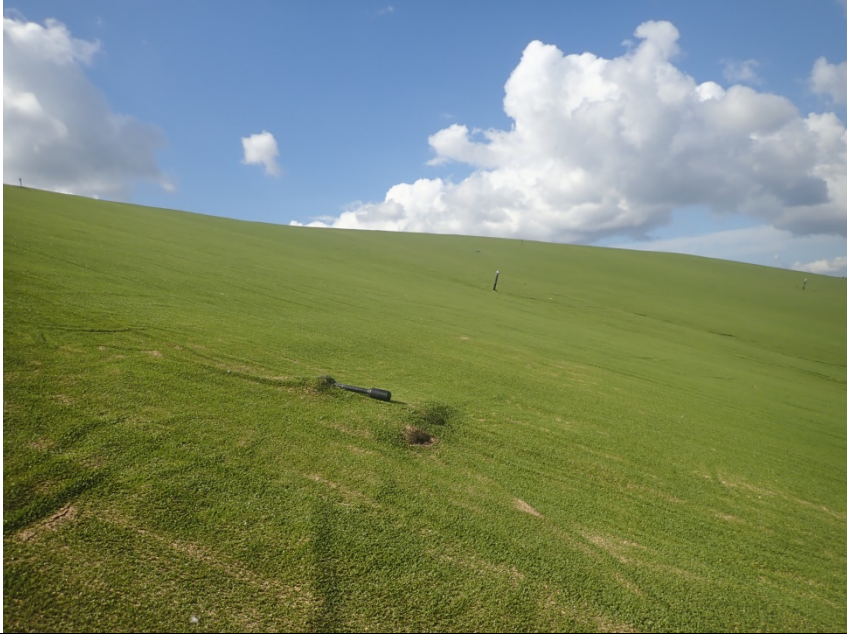
<b>Location</b>	NABORS Class 1			<b>Permit</b>	0249-S1-R2	<b>AFIN</b>	03-00051
<b>Photographer</b>	Darrell Norton, Inspector		<i>DN</i>	<b>Witness</b>	n/a		
<b>Photo #</b>	3	<b>Of</b>	6	<b>Date</b>	10/5/2021	<b>Time</b>	1053
<b>Description</b>	Vents observed down on the North slope of Area 1-2.

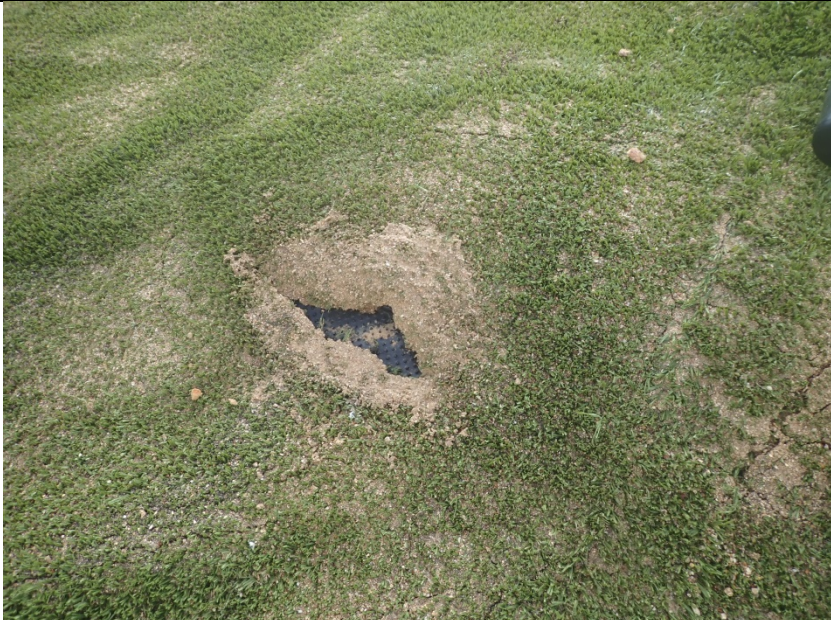
<b>Regulation</b>	<b>Item Description</b>	<b>Comments</b>
413(a)(b)(c)	Satisfactory Daily/Alternate/Intermediate Cover	
419(a)(5)	Cause Discharge/Leachate Leaving Landfill	
411(f)(3)	Depositing Waste in Standing Water Prohibited	
X	411(o) Erosion or Other Cover Defects	Turf roll and damage to the final cover system observed in multiple areas. (Refer to Photos #4 - #6.)
	309(c) Overfill/Off Lined Area

<b>Location</b>	NABORS Class 1			<b>Permit</b>	0249-S1-R2	<b>AFIN</b>	03-00051
<b>Photographer</b>	Darrell Norton, Inspector		<i>DN</i>	<b>Witness</b>	n/a		
<b>Photo #</b>	4	<b>Of</b>	6	<b>Date</b>	10/5/2021	<b>Time</b>	1054
<b>Description</b>	Damage to the turf cover system observed west of LCS-1.

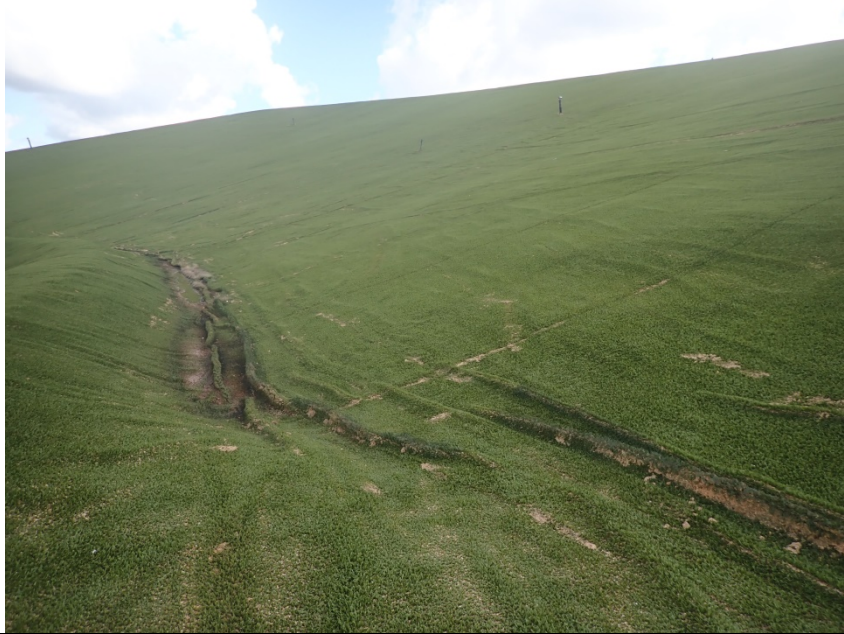
<b>Location</b>	NABORS Class 1			<b>Permit</b>	0249-S1-R2	<b>AFIN</b>	03-00051
<b>Photographer</b>	Darrell Norton, Inspector		<i>DN</i>	<b>Witness</b>	n/a		
<b>Photo #</b>	5	<b>Of</b>	6	<b>Date</b>	10/5/2021	<b>Time</b>	1111
<b>Description</b>	Turf roll observed.

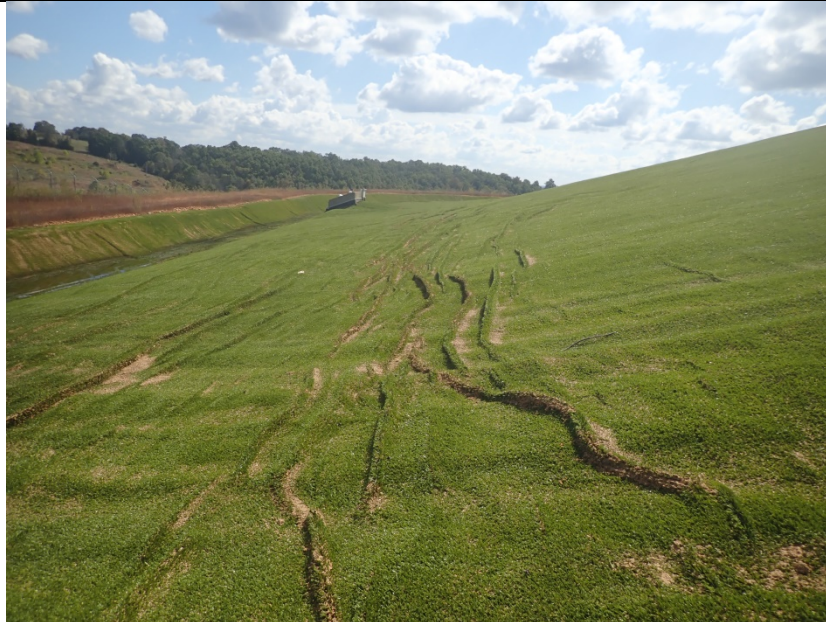
<b>Location</b>	NABORS Class 1			<b>Permit</b>	0249-S1-R2	<b>AFIN</b>	03-00051
<b>Photographer</b>	Darrell Norton, Inspector		<i>DN</i>	<b>Witness</b>	n/a		
<b>Photo #</b>	6	<b>Of</b>	6	<b>Date</b>	10/5/2021	<b>Time</b>	1201
<b>Description</b>	Turf roll observed near LCS-7.
