OFFICE OF WATER QUALITY INSPECTION REPORT

NAME:
West Memphis WWTP
 LOCATION:
502 South Loop Road
 CITY:
West Memphis

This was an Industrial User Inspection of:
Quala Services, LLC, 400 Mound City Road, West Memphis, AR, 72301

Name of Industry: Quala Services, LLC

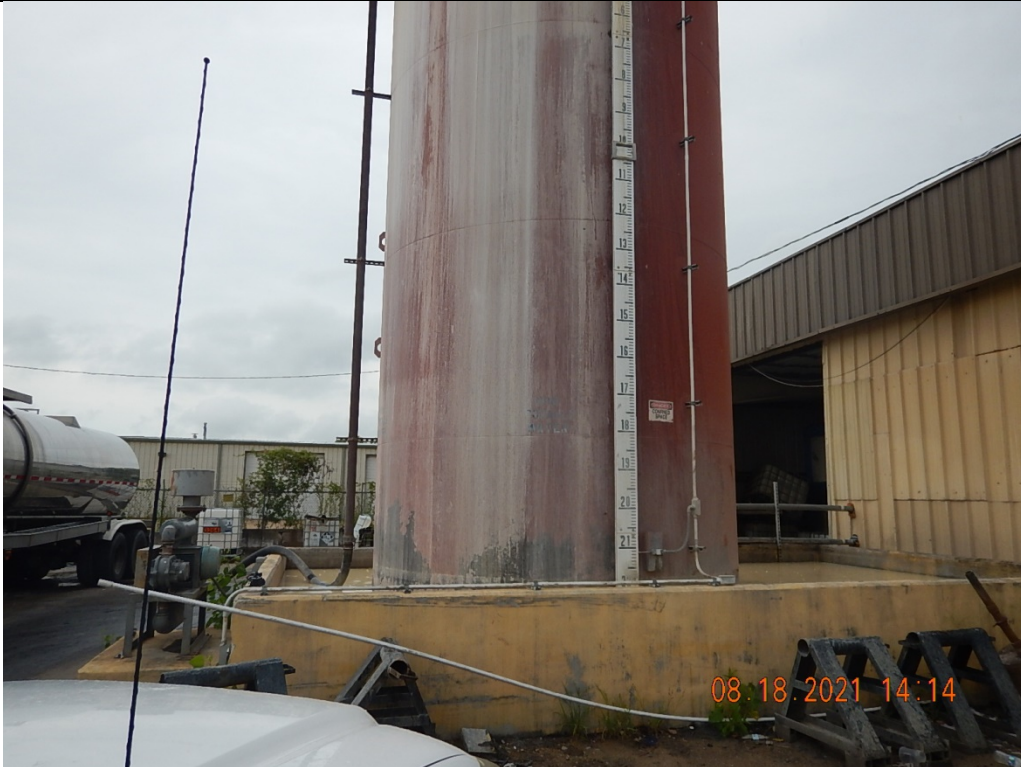
Location:	Quala Services, LLC – IU of West Memphis WWTP				
Photographer:	Sarah Frasher	Date:	8/18/2021	Time:	14:14
Witness:	Wes Klasky and Brent Walker			Photo #:	1
Description:	View of the outdoor wastewater tank.

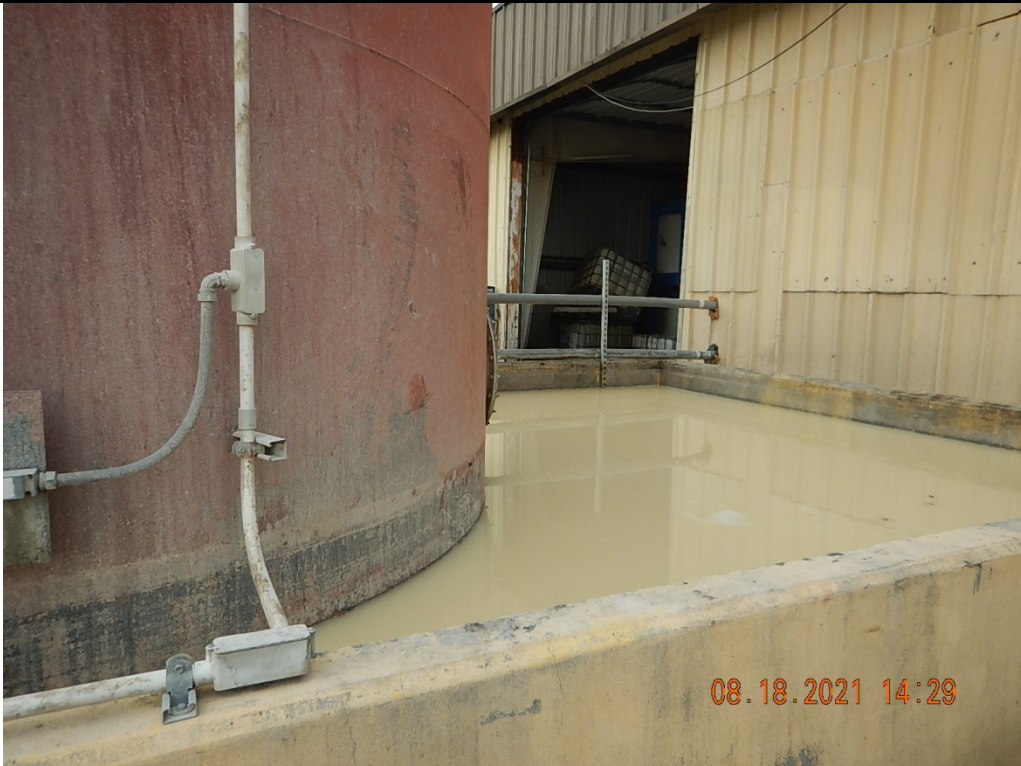
1. Sampling location is suitable for representative sampling, but may not provide adequate protection against tampering.
2. Facility did not have adequate staff for operating and maintaining equipment.
3. The secondary containment for the outdoor wastewater holding tank was nearly full of visibly contaminated water (Photo 2).
4. The polymer equipment was reported as non-operational during the inspection.
5. An accumulation of visible solids were in the outfall tank prior to the weir, thus indicating likely pass through and/or inadequate treatment (Photo 8).

Photographer:	Sarah Frasher	Date:	8/18/2021	Time:	14:29
Witness:	Wes Klasky and Brent Walker			Photo #:	2
Description:	View of the containment area. Note the visibly contaminated water.

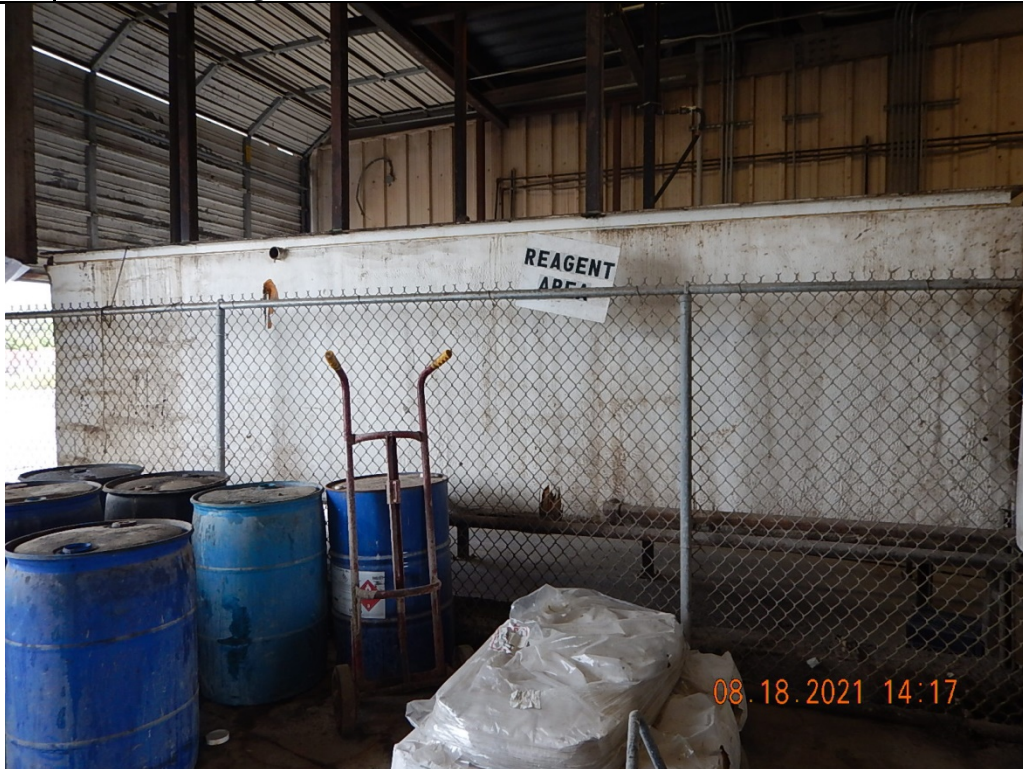
Location:	Quala Services, LLC – IU of West Memphis WWTP				
Photographer:	Sarah Frasher	Date:	8/18/2021	Time:	14:17
Witness:	Wes Klasky and Brent Walker			Photo #:	3
Description:	View of the reagent area.

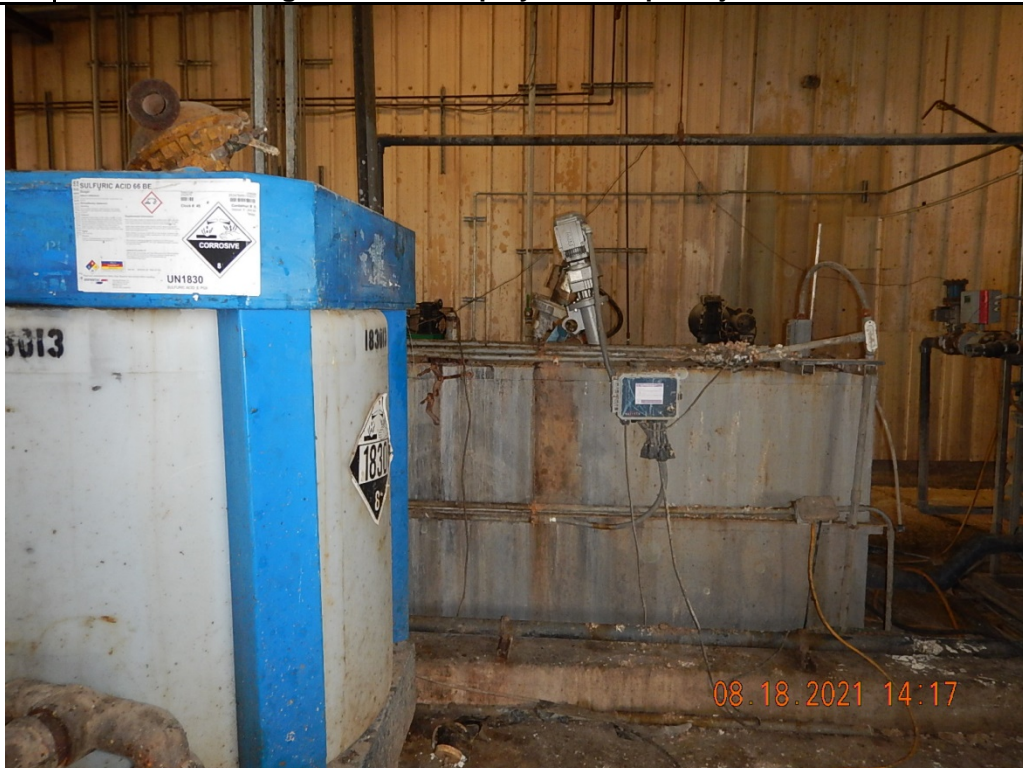
Photographer:	Sarah Frasher	Date:	8/18/2021	Time:	14:17
Witness:	Wes Klasky and Brent Walker			Photo #:	4
Description:	View of the mixing tank used for polymer and pH adjustment.

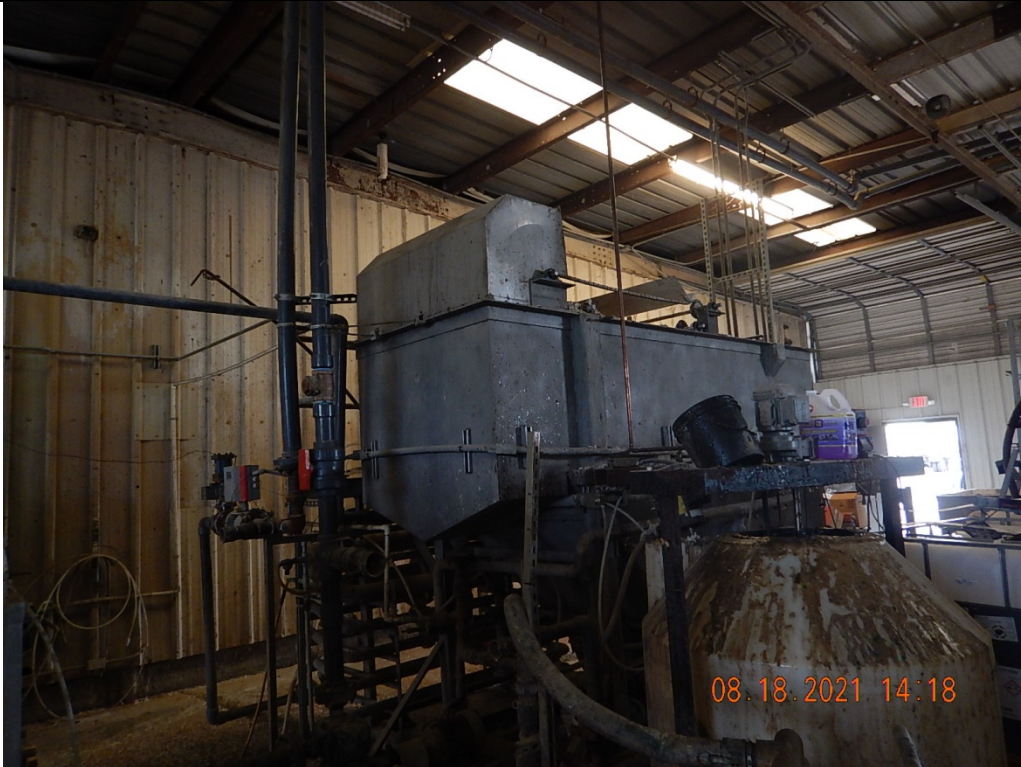
Location:	Quala Services, LLC – IU of West Memphis WWTP				
Photographer:	Sarah Frasher	Date:	8/18/2021	Time:	14:18
Witness:	Wes Klasky and Brent Walker			Photo #:	5
Description:	Overview of the DAF unit.

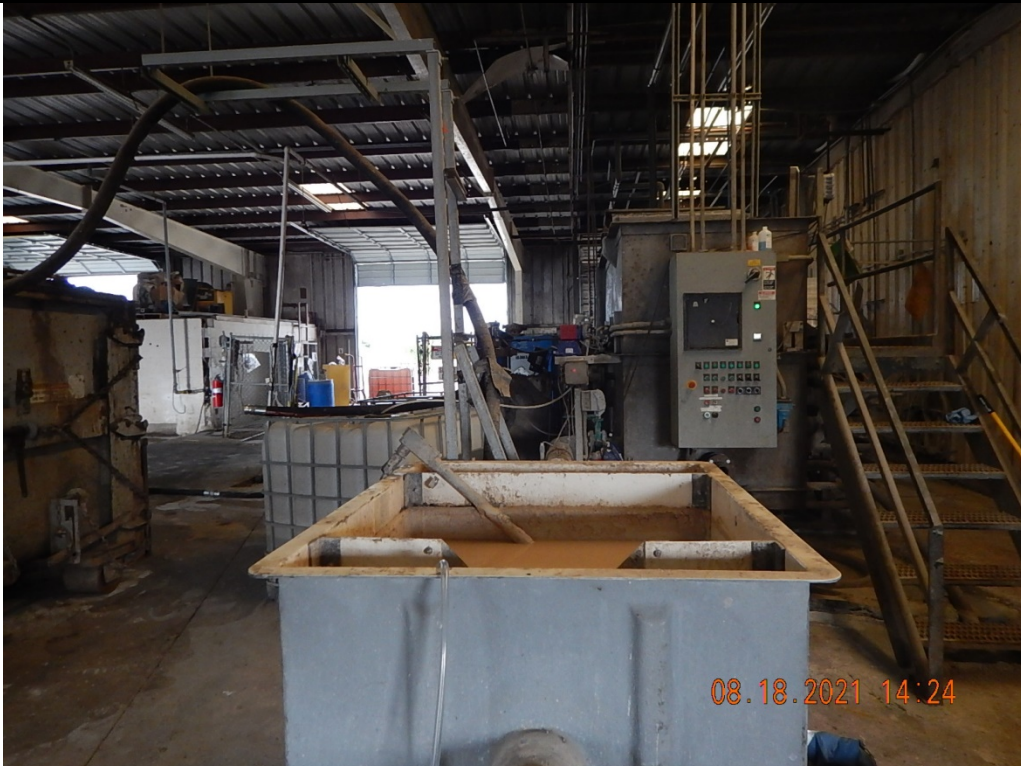
Photographer:	Sarah Frasher	Date:	8/18/2021	Time:	14:24
Witness:	Wes Klasky and Brent Walker			Photo #:	6
Description:	View of the weir and DAF unit.

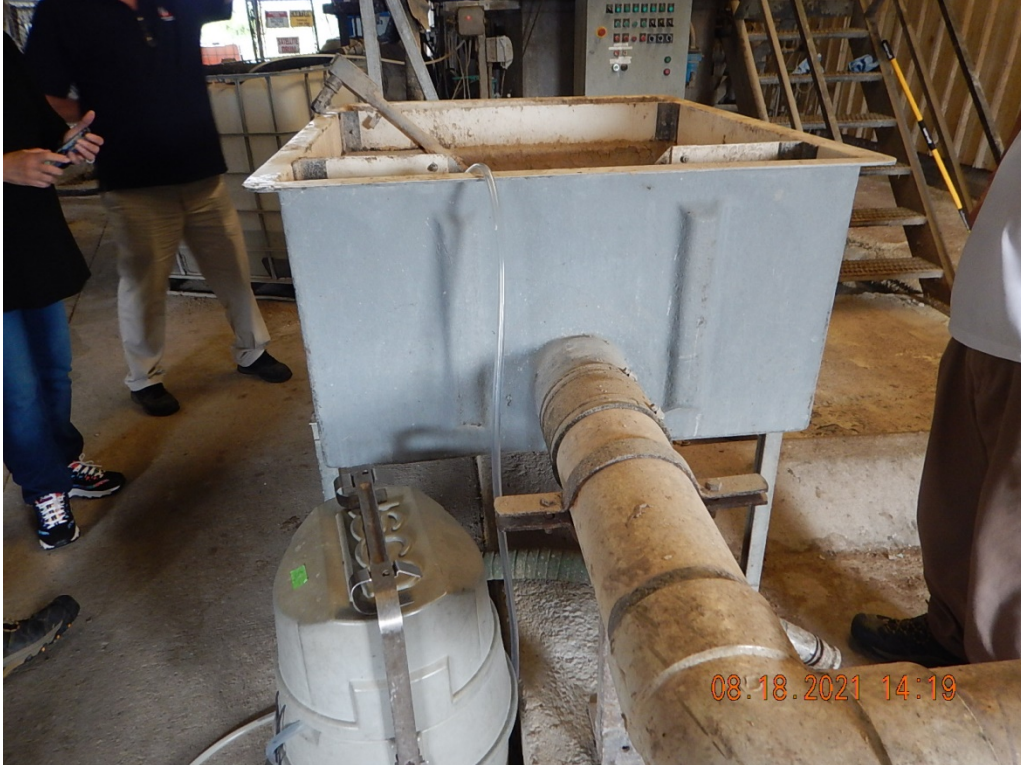
Location:	Quala Services, LLC – IU of West Memphis WWTP				
Photographer:	Sarah Frasher	Date:	8/18/2021	Time:	14:19
Witness:	Wes Klasky and Brent Walker			Photo #:	7
Description:	View of the Outfall tank. Note the sampler.

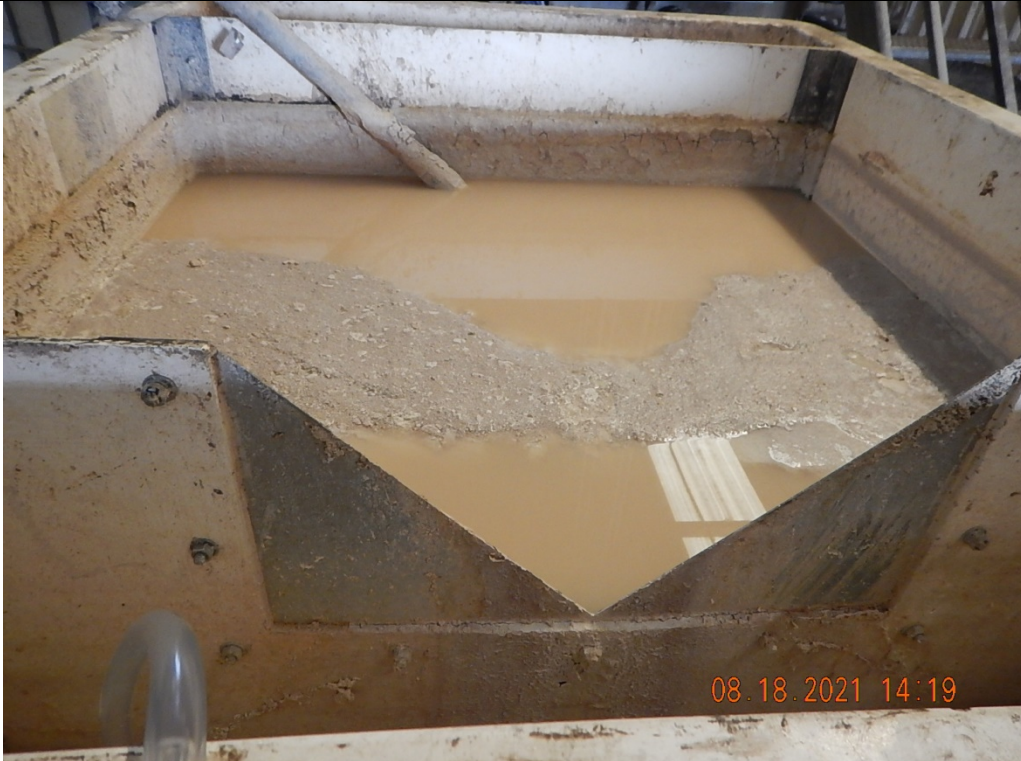
Photographer:	Sarah Frasher	Date:	8/18/2021	Time:	14:19
Witness:	Wes Klasky and Brent Walker			Photo #:	8
Description:	View of the weir to the Outfall tank. Note the accumulation of solids at the surface.

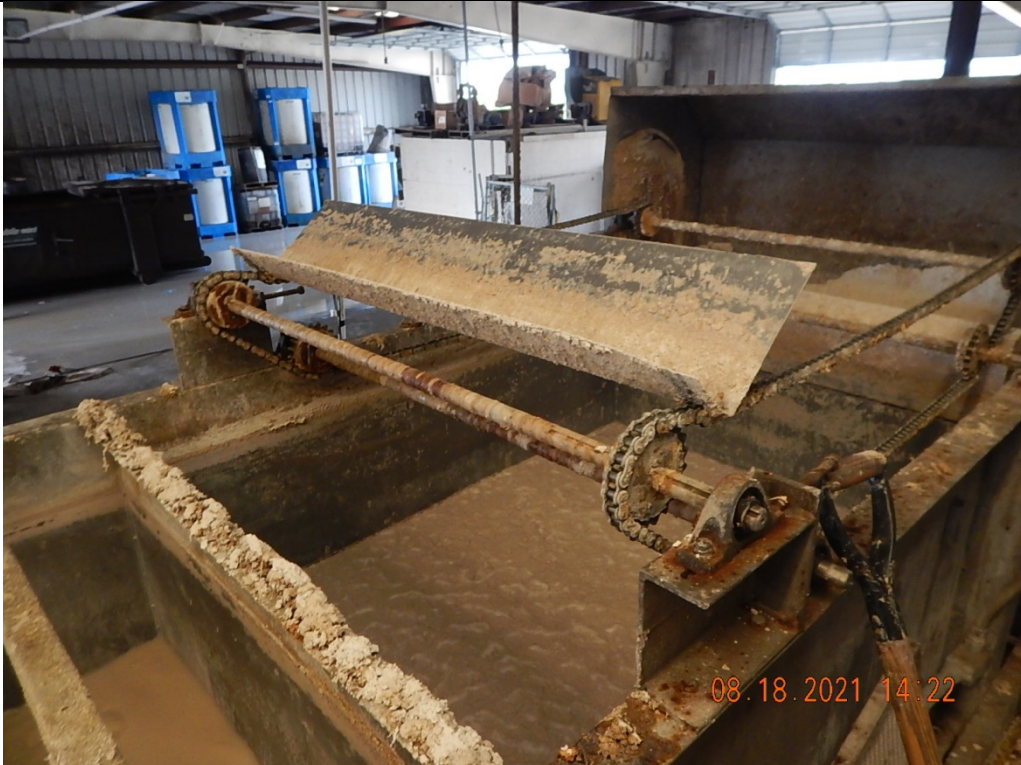
Location:	Quala Services, LLC – IU of West Memphis WWTP				
Photographer:	Sarah Frasher	Date:	8/18/2021	Time:	14:22
Witness:	Wes Klasky and Brent Walker			Photo #:	9
Description:	View of the inside of the DAF unit. Note the level and that the equipment is non-operational.

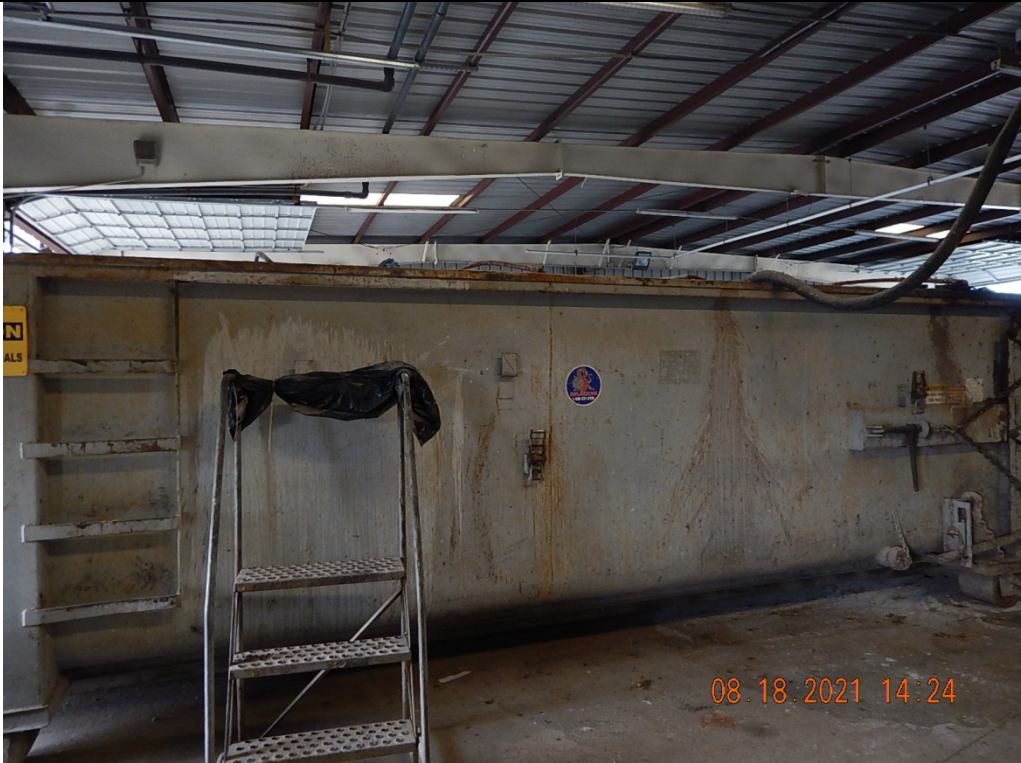
Photographer:	Sarah Frasher	Date:	8/18/2021	Time:	14:24
Witness:	Wes Klasky and Brent Walker			Photo #:	10
Description:	View of the dumpster used for sludge disposal.

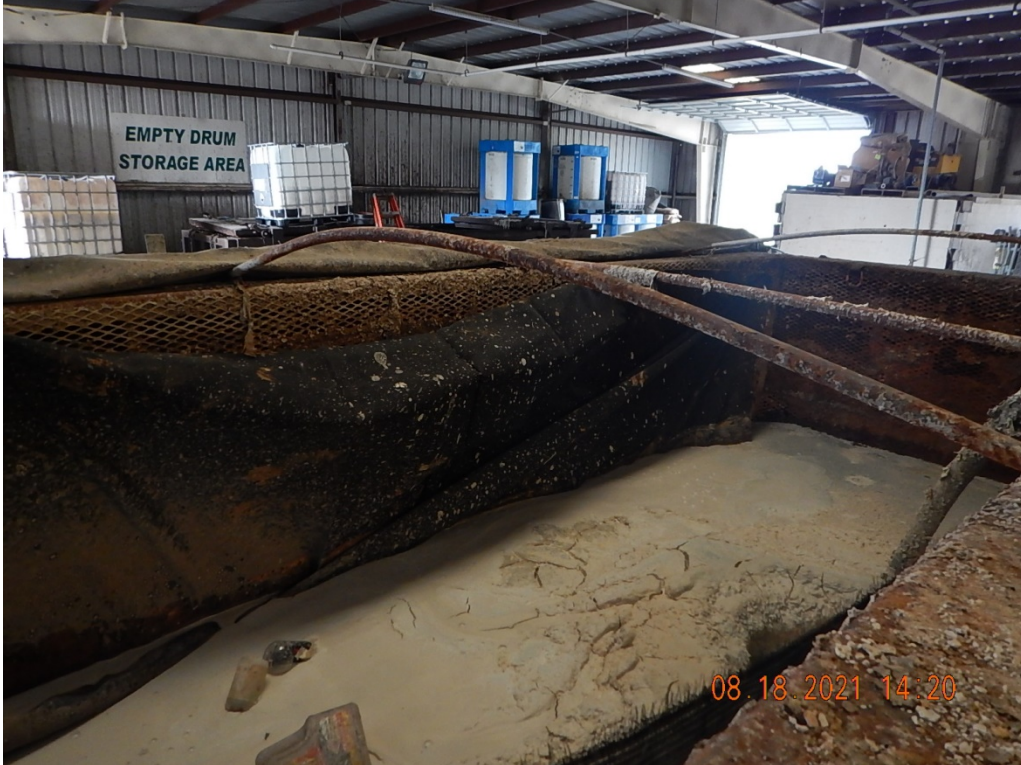
Location:	Quala Services, LLC – IU of West Memphis WWTP				
Photographer:	Sarah Frasher	Date:	8/18/2021	Time:	14:20
Witness:	Wes Klasky and Brent Walker			Photo #:	11
Description:	View of the inside of the dumpster.

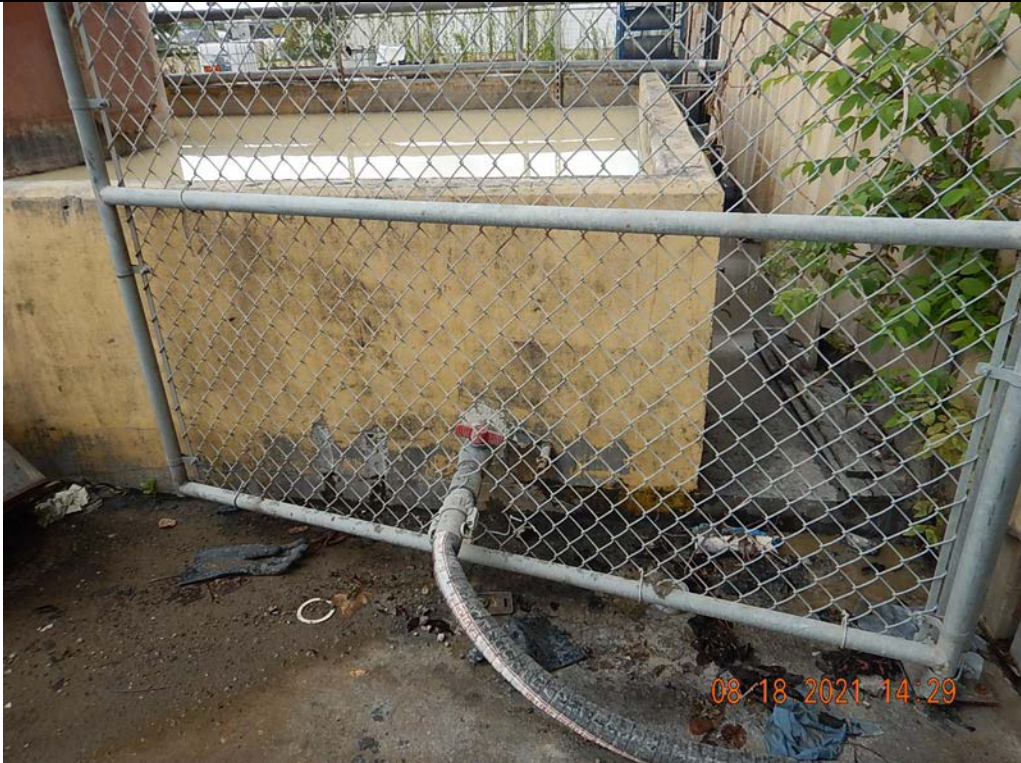
***Sampling location is suitable for representative sampling, but may not provide adequate protection against tampering. Facility did not have adequate staff for operating and maintaining equipment. Discolored contaminated water was observed in the secondary containment area. A hose was connected to the valve of the secondary containment area. The operator, Sam Malone, explained there were operational issues with the polymer equipment. Floating solids were observed in the outfall tank prior to the weir. No discharge was observed during the inspection – water levels were lower than the weir.**

Photographer:	Sarah Frasher	Date:	8/18/2021	Time:	14:29
Witness:	Wes Klasky and Brent Walker			Photo #:	12
Description:	View of the valve of the containment area. Note the hose connected to it leading back into facility.
