RE: Inspection conducted on January 24, 2022
AFIN 03-00051
Permit Number 0249-S1-R2

**Office of Land Resources
Regulated Waste Operations
Class 1 Landfill Inspection Form**

Site Name	NABORS Landfill	County	Baxter	AFIN	03-00051
Facility Address	Hwy 5 N to CR 16 to site entrance- Three Brothers	Phone #	870-425-3213	Permit #	0249-S1-R2
Permittee Address	P.O. Box 1715, Mountain Home, AR 72602	Email Address	Steve.kershaw.engr@gmail.com judge@baxtercounty.org	PDS #	119113
Date	1/24/2022	Entry Time	1045	Exit Time	1215

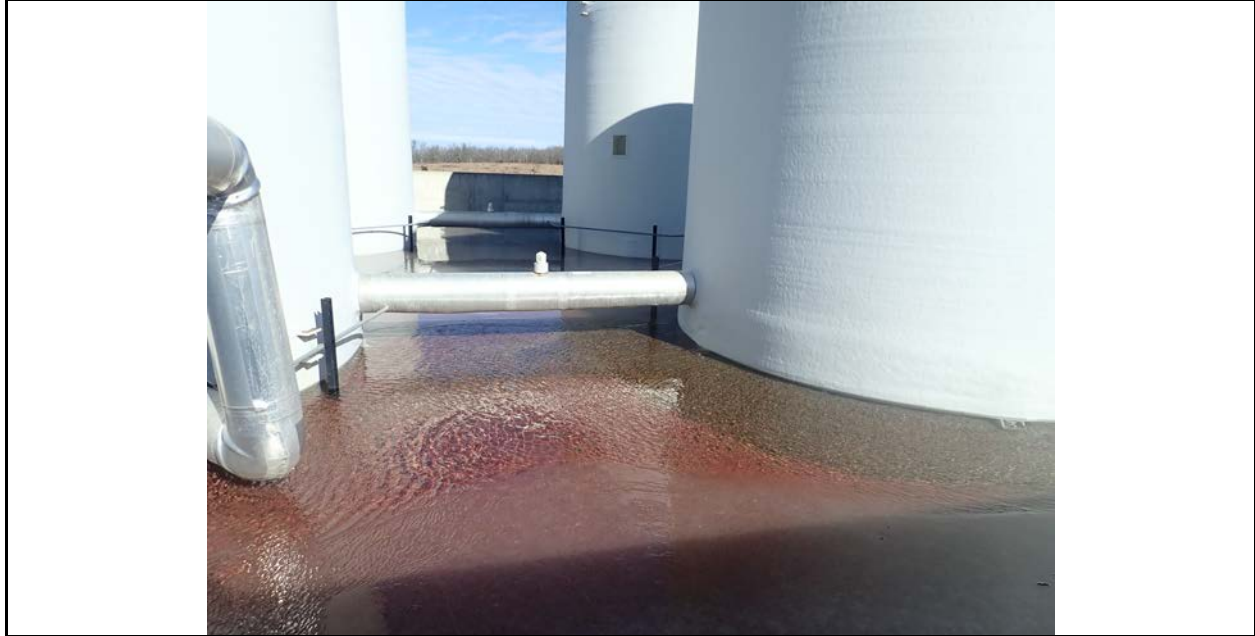
Location	NABORS Class 1			Permit	0249-S1-R2	AFIN	03-00051
Photographer	Darrell Norton, Inspector		<i>DN</i>	Witness	n/a		
Photo #	1	Of	6	Date	1/24/2022	Time	1052
Description	Secondary containment at tank farm.

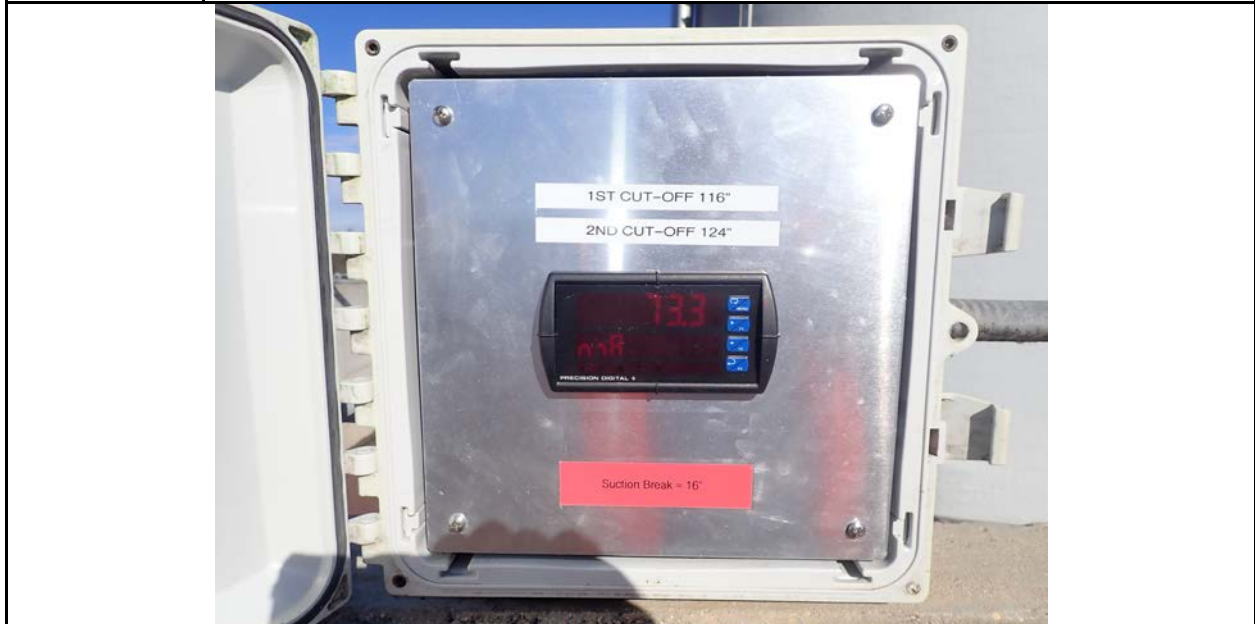
Location	NABORS Class 1			Permit	0249-S1-R2	AFIN	03-00051
Photographer	Darrell Norton, Inspector		<i>DN</i>	Witness	n/a		
Photo #	2	Of	6	Date	1/24/2022	Time	1052
Description	Level observed at tank farm.

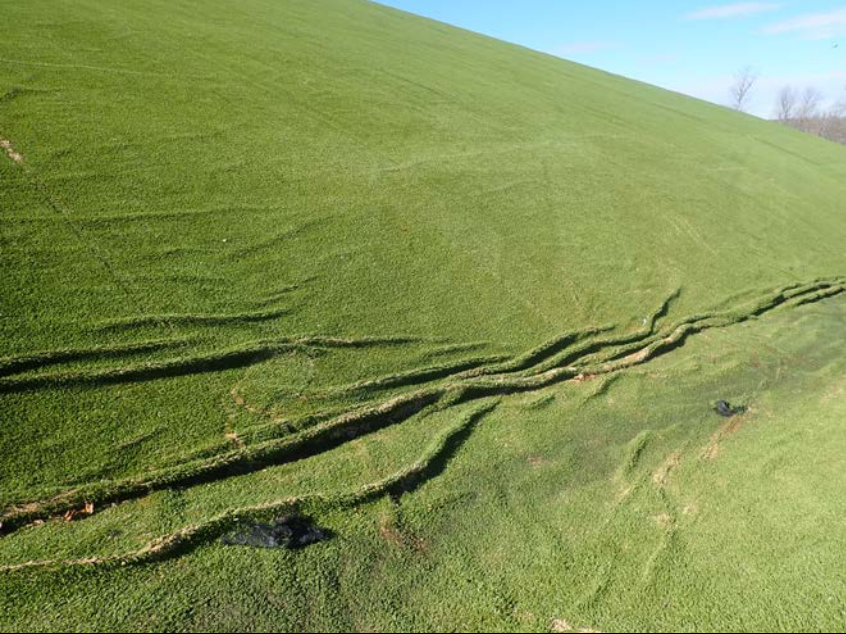
Location	NABORS Class 1			Permit	0249-S1-R2	AFIN	03-00051
Photographer	Darrell Norton, Inspector		<i>DN</i>	Witness	n/a		
Photo #	3	Of	6	Date	1/24/2022	Time	1054
Description	Turf roll observed near LCS 1

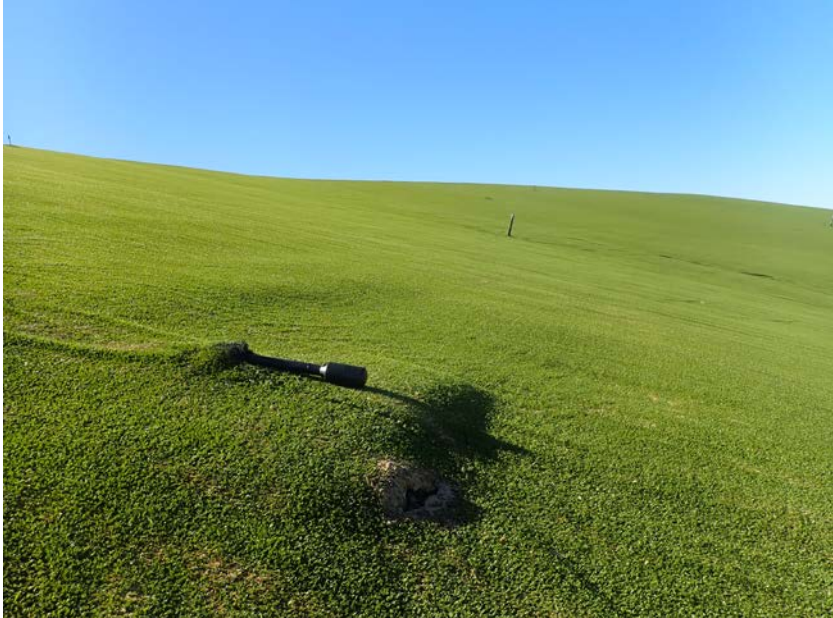
Location	NABORS Class 1			Permit	0249-S1-R2	AFIN	03-00051
Photographer	Darrell Norton, Inspector		<i>DN</i>	Witness	n/a		
Photo #	4	Of	6	Date	1/24/2022	Time	1052
Description	Gas vents down near LCS 1.

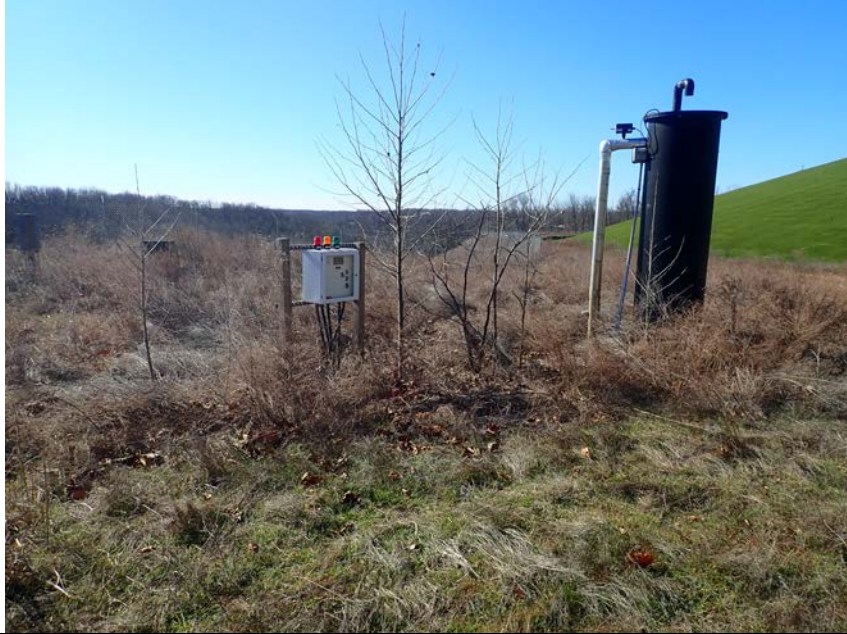
Regulation	Item Description	Comments
411(a)	Operations in Accordance with Permit Documents	
411(c)	Smallest Practical Area, Unloading Supervised, Single Working Face	
411(b)	Operations by Licensed On-site Personnel at All Times	
411(g)	Litter Control Provisions Maintained	
427	Surface Water Controls	
411(h)(1)	Contouring Prevents Surface Water Flowing Into or Through Waste	
418(a)(b)	Run-on/off Control System Present and Adequate	
411(h)(2)	Surface Water Control Prevents Off-site Sediment Accumulation	
X	411(i) Adequate Maintenance of Intermediate/Final Cover Vegetation	Turf roll and damage observed in multiple areas. (Refer to Photos #3 & #6.)
	415 Gas Monitoring Program	
	411(o) Leachate Leaks or Evidence of Leachate Seepage	
X	429 Leachate Collection System	Multiple LCS stations with station ok-alarms readout.
	417(c) Access and Operational Roads	Road erosion present between LCS-4 and LCS-5. Vegetative control needed along roads and around LCS panels. (Refer to Photo #5.)

Location	NABORS Class 1			Permit	0249-S1-R2	AFIN	03-00051
Photographer	Darrell Norton, Inspector		<i>DN</i>	Witness	n/a		
Photo #	5	Of	6	Date	1/24/2022	Time	1109
Description	Vegetative growth observed along roads and near LCS panels.

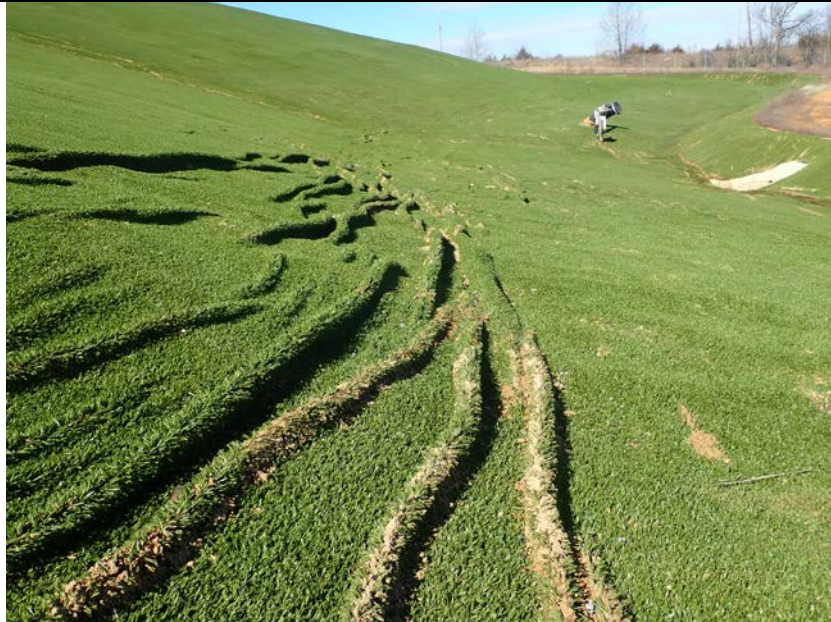
Location	NABORS Class 1			Permit	0249-S1-R2	AFIN	03-00051
Photographer	Darrell Norton, Inspector		<i>DN</i>	Witness	n/a		
Photo #	6	Of	6	Date	1/24/2022	Time	1128
Description	Turf roll observed near LCS 6 and LCS 7.
