**RE: Inspection conducted on March 16, 2022**  
**AFIN 63-00155**  
**Permit Number 0261-S1-R3**

**Office of Land Resources**  
**Regulated Waste Operations**  
**Class 1 Landfill Inspection Form**

<b>Site Name</b>	BFI Waste Systems of Arkansas	<b>County</b>	Saline	<b>AFIN</b>	63-00155
<b>Facility Address</b>	18511 W Sardis Road, Bauxite, AR	<b>Phone #</b>	901-873-8334 (Brad Zimmerman) 501-602-8440 (Robert Sanchez)	<b>Permit #</b>	0261-S1-R3
<b>Permittee Address</b>	18511 W Sardis Road, Bauxite, AR	<b>Email Address</b>	<a href="mailto:Bzimmerman2@republicservices.com">Bzimmerman2@republicservices.com</a> <a href="mailto:RSanchez2@republicservices.com">RSanchez2@republicservices.com</a>	<b>PDS #</b>	119513
<b>Date</b>	3/16/2022	<b>Entry Time</b>	1330	<b>Exit Time</b>	1530

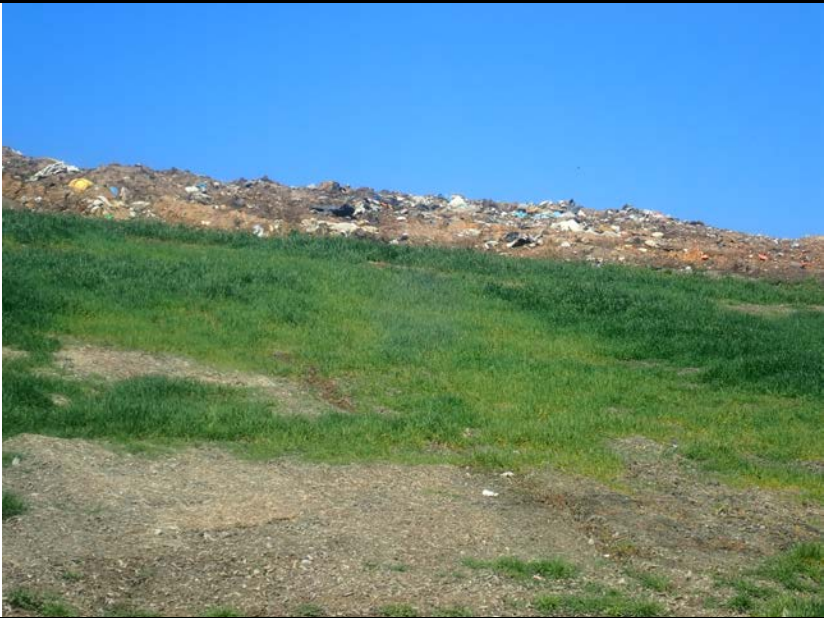
<b>Regulation</b>	<b>Item Description</b>	<b>Comments</b>
	413(a)(b)(c)	Satisfactory Daily/Alternate/Intermediate Cover	
	419(a)(5)	Cause Discharge/Leachate Leaving Landfill	
	411(f)(3)	Depositing Waste in Standing Water Prohibited	
X	411(o)	Erosion or Other Cover Defects Resulting in Exposed Refuse	Erosion with exposed waste observed on the south slope. (Refer to Photos #3 - #5.) Cover defects resulting in exposed waste observed across the upper deck of Cells 1-5. (Refer to Photos #1 -#5.)

<b>Witness</b>	N/A		
<b>Photo #</b>	1	<b>Of</b>	5		<b>Date</b>	3/16/2022	<b>Time</b>	1426
<b>Description</b>	An example of exposed waste observed across the top deck of the landfill. Vegetative growth at test area in Cell 2 observed in the foreground.

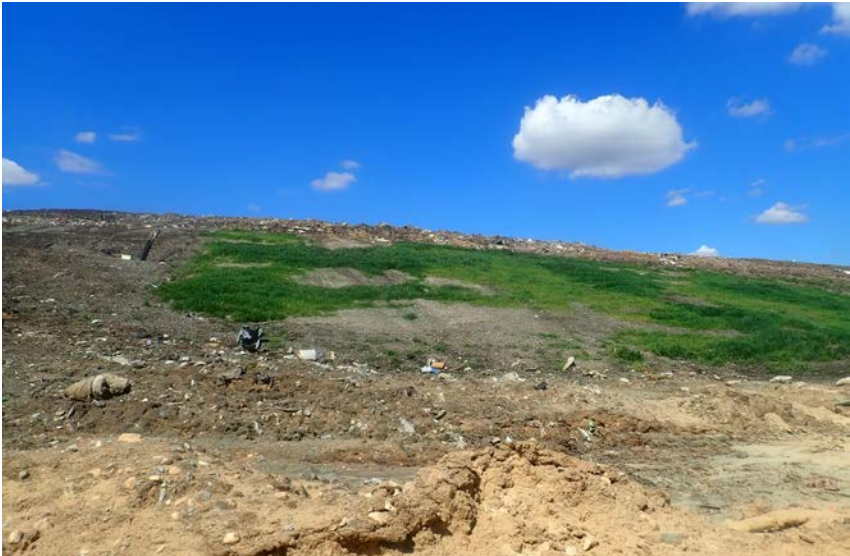
<b>Witness</b>	N/A		
<b>Photo #</b>	2	<b>Of</b>	5		<b>Date</b>	3/16/2022	<b>Time</b>	1426
<b>Description</b>	An overview of the area (Cells #2 & #4) shown in Photo #1 is observed.
