**RE: Inspection conducted on April 29, 2022**  
**AFIN 16-00923**  
**Permit Number 0254-S1-R4**

**Office of Land Resources  
Regulated Waste Operations  
Class 1 Landfill Inspection Form**

| <b>Site Name</b> | Craighead County SWDA Class 1 | <b>County</b> | Craighead | <b>AFIN</b> | 16-00199 |

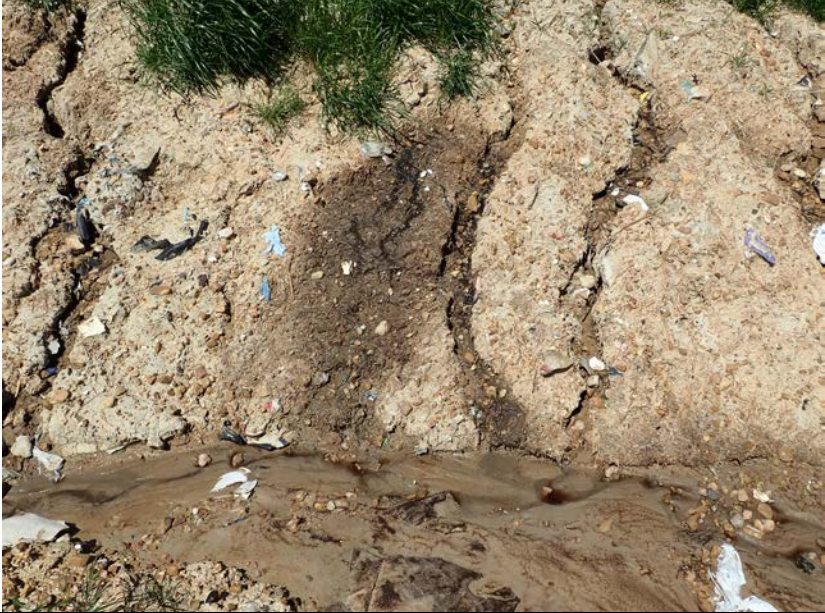
| <b>Photo #</b> | 1 | <b>Of</b> | 3 | | <b>Date</b> | 4/29/2022 | <b>Time</b> | 1116 |

| | <b>Regulation</b> | <b>Item Description</b> | <b>Comments</b> |
|---|---|---|---|
| X | 411(o) | Leachate Leaks or Evidence of Leachate Seepage | Leachate leaks observed on the east slope of Cell 3. (Refer to Photos #1 & #2.) |

| <b>Description</b> | Leachate leaks observed on the east slope of Cell 3. | | | | | | | |

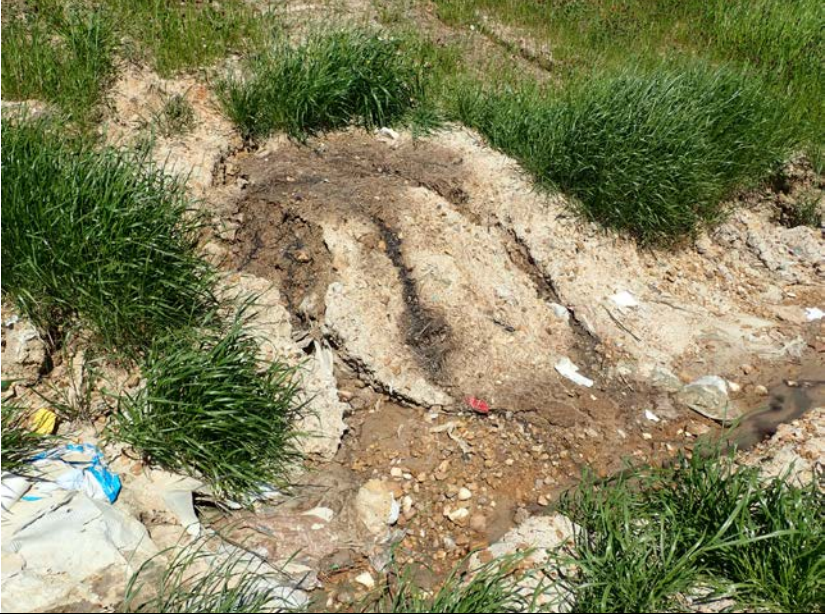
| <b>Photo #</b> | 2 | <b>Of</b> | 3 | | <b>Date</b> | 4/29/2022 | <b>Time</b> | 1117 |

| <b>Description</b> | Leachate leaks observed on the east slope of Cell 3. | | | | | | | |

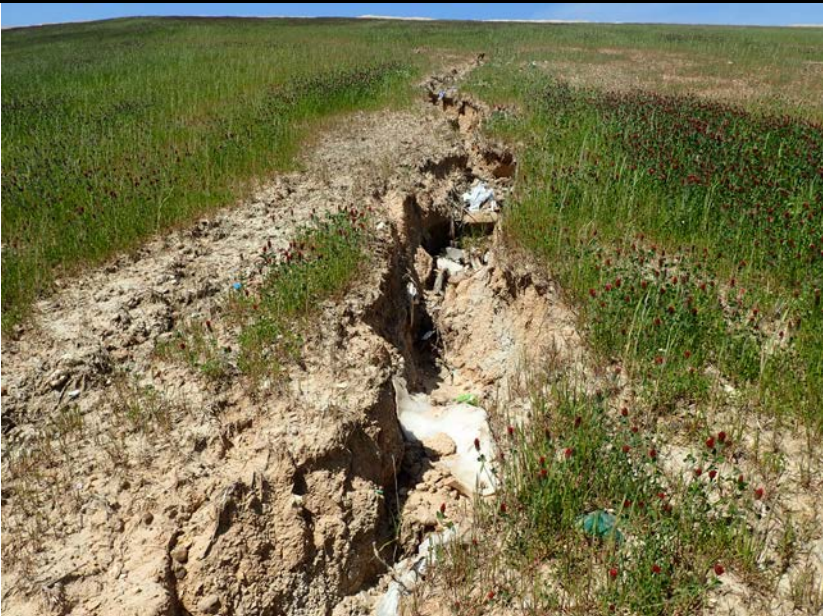
| | <b>Regulation</b> | <b>Item Description</b> | <b>Comments</b> |
|---|---|---|---|
| X | 411(o) | Erosion or Other Cover Defects Resulting in Exposed Refuse | Erosion with exposed waste observed on the east slope of Cell 3. (Refer to Photo #3.) |

| <b>Description</b> | Erosion with exposed waste observed on the east slope of Cell 3. | | | | | | | |
