RE: Inspection conducted on June 16, 2022
AFIN 03-00051
Permit Number 0249-S1-R2

**Office of Land Resources
Regulated Waste Operations
Class 1 Landfill Inspection Form**

Site Name	NABORS Landfill	County	Baxter	AFIN	03-00051
Facility Address	Hwy 5 N to CR 16 to site entrance- Three Brothers	Phone #	870-688-3822	Permit #	0249-S1-R2
Permittee Address	P.O. Box 1669 Harrison, AR 72602	Email Address	Steve.kershaw.engr@gmail.com judge@baxtercounty.org	PDS #	120732
Date	6/16/2022	Entry Time	1228	Exit Time	1350

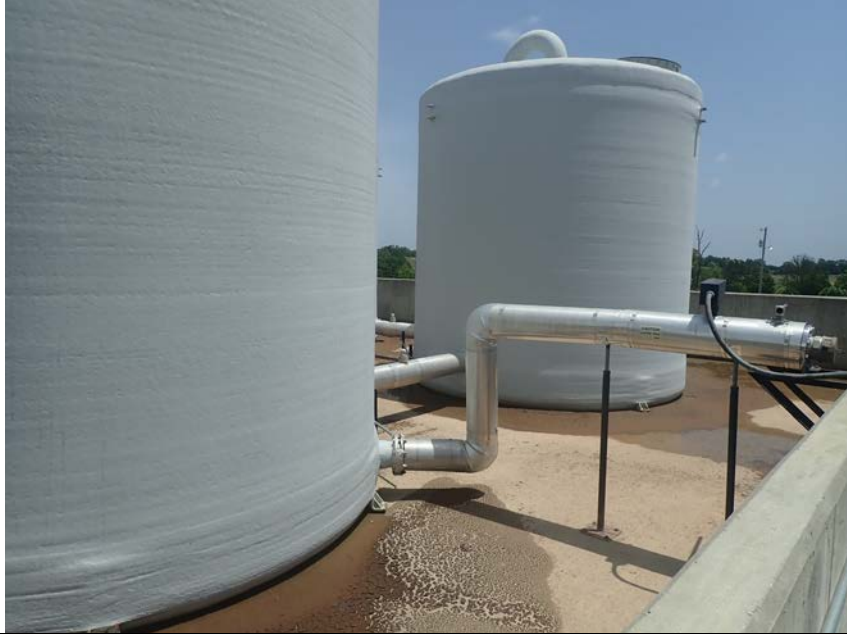
Location	NABORS Class 1			Permit	0249-S1-R2	AFIN	03-00051
Photographer	Darrell Norton		<i>DN</i>	Witness	N/A		
Photo #	1	Of	6	Date	6/16/2022	Time	1234
Description	Secondary containment at tank farm.

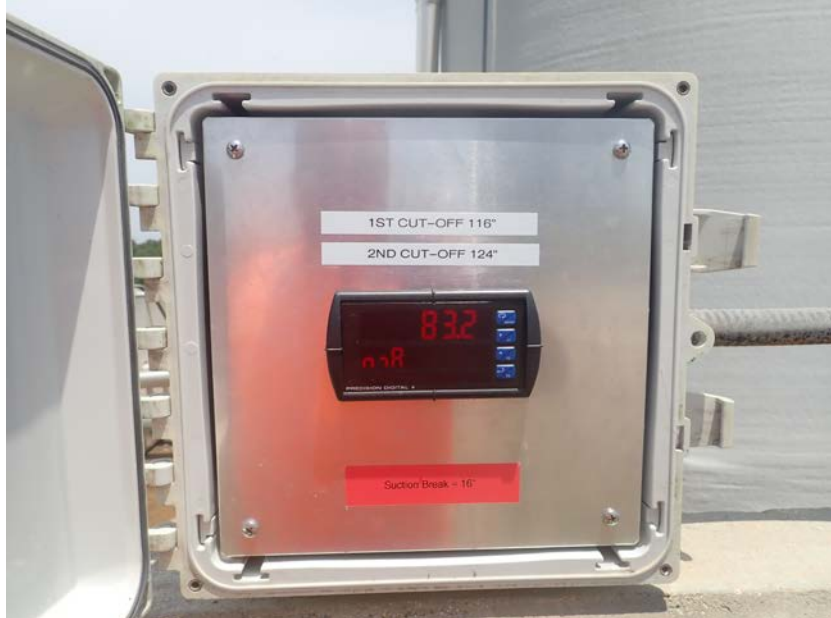
Location	NABORS Class 1			Permit	0249-S1-R2	AFIN	03-00051
Photographer	Darrell Norton		<i>DN</i>	Witness	N/A		
Photo #	2	Of	6	Date	6/16/2022	Time	1234
Description	Leachate level observed at tank farm.

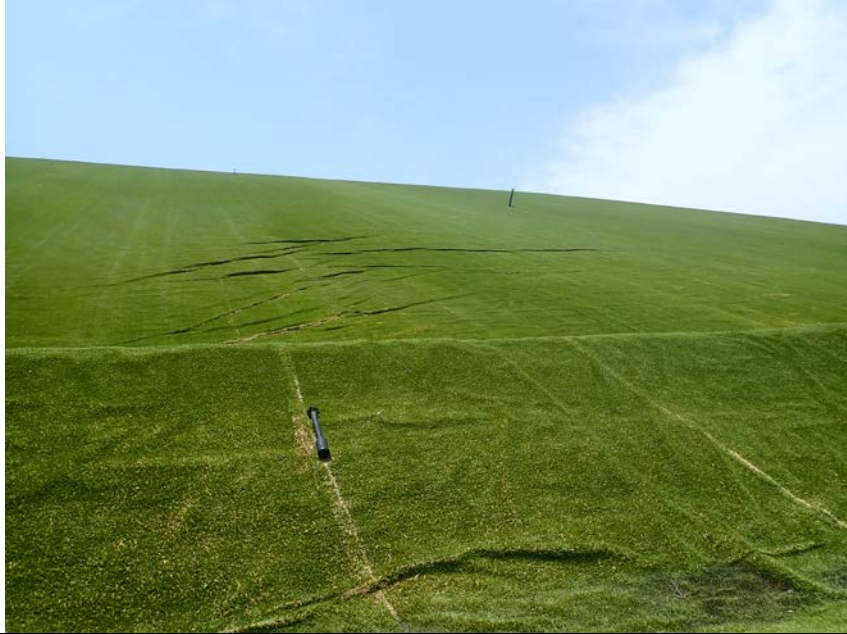
Location	NABORS Class 1			Permit	0249-S1-R2	AFIN	03-00051
Photographer	Darrell Norton		<i>DN</i>	Witness	N/A		
Photo #	3	Of	6	Date	6/16/2022	Time	1238
Description	Turf roll observed near LCS 1. Broken gas vent observed.

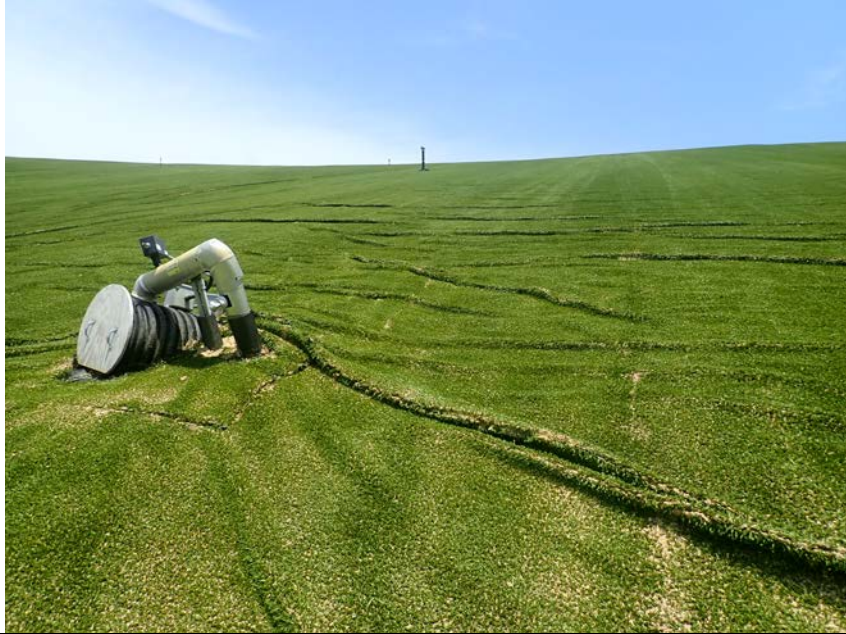
Location	NABORS Class 1			Permit	0249-S1-R2	AFIN	03-00051
Photographer	Darrell Norton		DN	Witness	N/A		
Photo #	5	Of	6	Date	6/16/2022	Time	1243
Description	Turf roll observed near LCS 4.

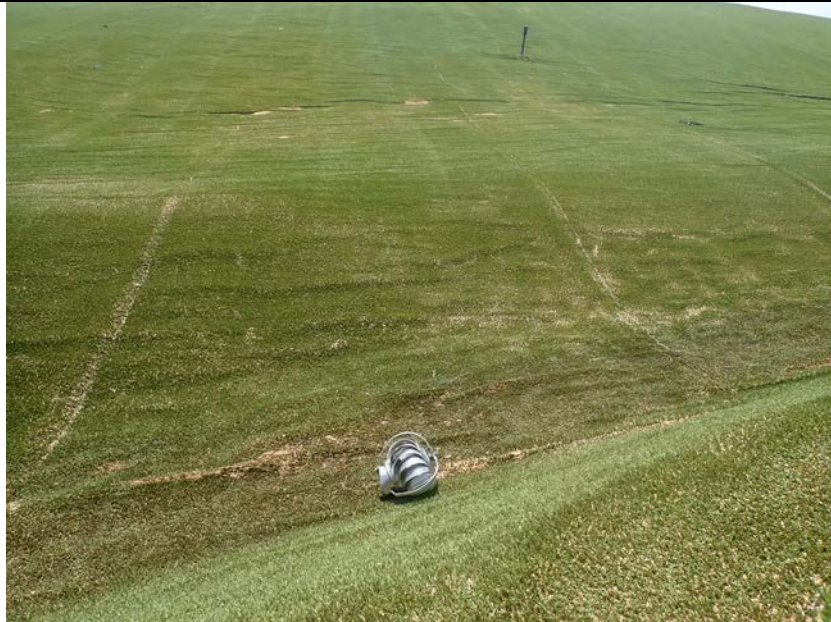
Location	NABORS Class 1			Permit	0249-S1-R2	AFIN	03-00051
Photographer	Darrell Norton		DN	Witness	N/A		
Photo #	6	Of	6	Date	6/16/2022	Time	1300
Description	Broken gas vent observed near the northwest corner of area 1-3.
