RE: Drew Foam Companies Inc. Inspection (Drew Co) AFIN: 22-00057 NPDES Permit No.: ARR000817

| A SHI DEAR YOUR | OFFICE OF WATER QUALITY INSPECTION REPORT | | | | |

Inspection Report: Drew Foam Companies Inc., AFIN: 22-00057, Permit #: ARR000817

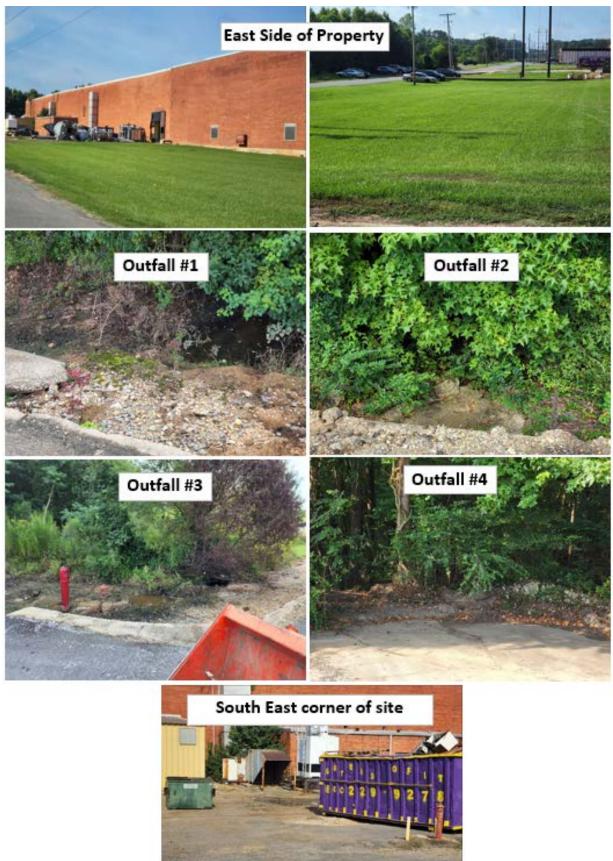
Housekeeping practices not implemented on east-side of facility. This includes excess garbage and scattered foam produced in the facility. This is a violation of Part 3.1.2 of the general permit

Improvement photos on next page:
