## ARKANSAS ENERGY & ENVIRONMENT

**RE: Inspection conducted on August 3, 2022**  
**AFIN 16-00199**  
**Permit Number 0254-S1-R4**

**Office of Land Resources  
Regulated Waste Operations  
Class 1 Landfill Inspection Form**

| <b>Site Name</b> | Craighead County SWDA Class 1 | <b>County</b> | Craighead | <b>AFIN</b> | 16-00199 |

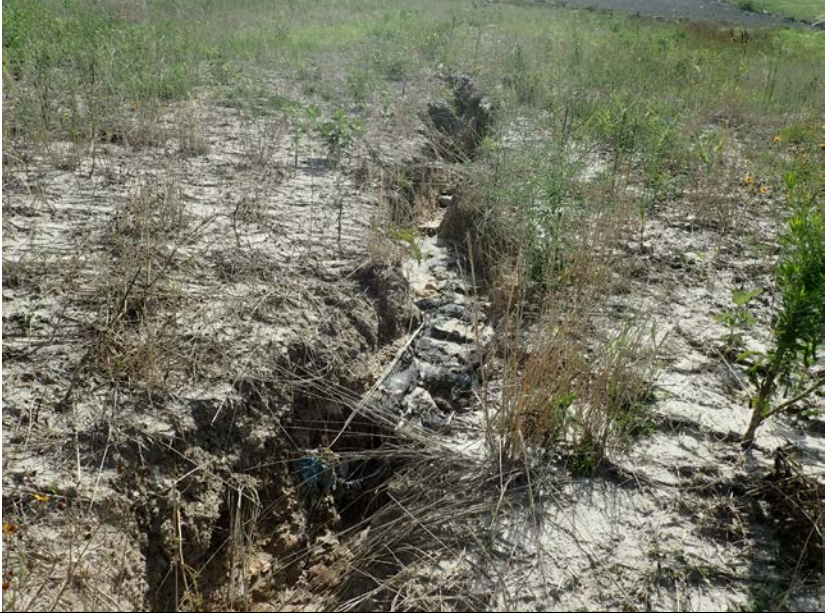
| <b>Photo #</b> | 1 | <b>Of</b> | 3 | | <b>Date</b> | 8/3/2022 | | <b>Time</b> | 1035 | | |

| | <b>Regulation</b> | <b>Item Description</b> | <b>Comments</b> |
|---|---|---|---|
| X | 411(o) | Erosion or Other Cover Defects Resulting in Exposed Refuse | Erosion with exposed waste observed on the west slope of Cell 2. (Refer to Photo #1.) |

| <b>Description</b> | Erosion with exposed waste observed on the west slope of Cell 2. | | | | | | | | | | |

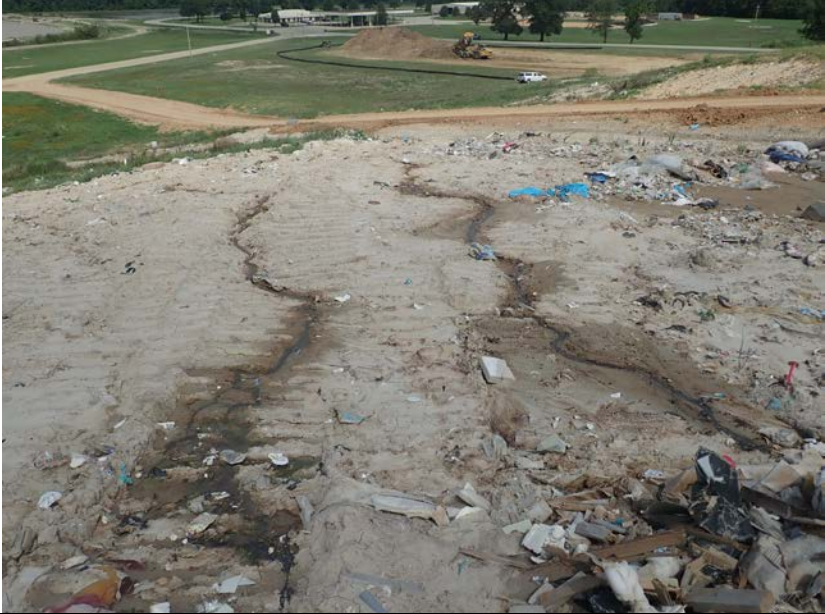
| <b>Photo #</b> | 2 | <b>Of</b> | 3 | | <b>Date</b> | 8/3/2022 | | <b>Time</b> | 1059 | | |

| | <b>Regulation</b> | <b>Item Description</b> | <b>Comments</b> |
|---|---|---|---|
| X | 411(o) | Leachate Leaks or Evidence of Leachate Seepage | Leachate leaks observed on the west slope of Cell 2. (Refer to Photo #2.) |

| <b>Description</b> | Leachate leaks observed on the west slope of Cell 2. | | | | | | | | | | |

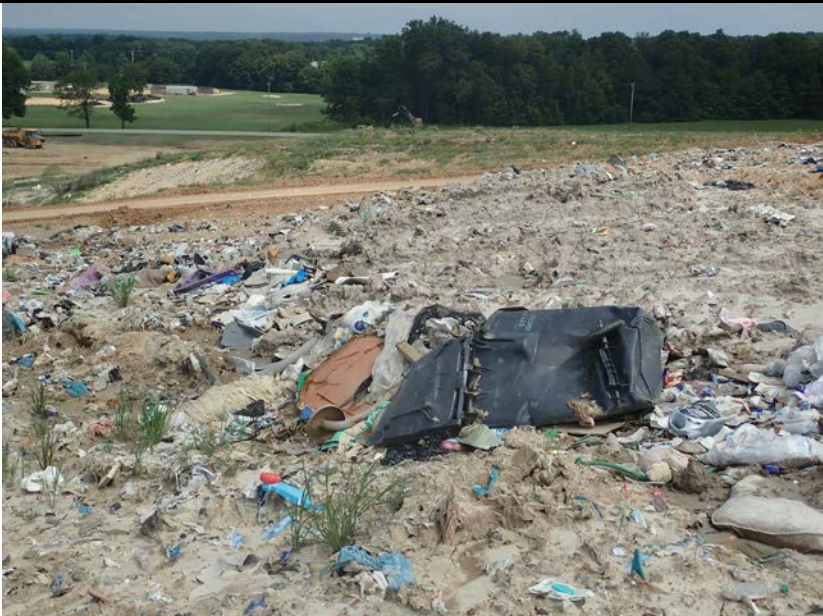
| <b>Photo #</b> | 3 | <b>Of</b> | 3 | | <b>Date</b> | 8/3/2022 | <b>Time</b> | 1101 |

| | <b>Regulation</b> | <b>Item Description</b> | <b>Comments</b> |
|---|---|---|---|
| X | 413(a)(b)(c) | Satisfactory Daily/Alternate/Intermediate Cover | Exposed waste observed on the west slope of Cell 2. (Refer to Photo #3.) |

| <b>Description</b> | Exposed waste observed on the west slope of Cell 2. | | | | | | | |
