RE: Inspection conducted on August 4, 2022
AFIN 60-01071
Permit Number 0266-S4J

**Office of Land Resources
Regulated Waste Operations
Class 4 Landfill Inspection Form**

Site Name	City of Little Rock Class 4 Landfill	County	Pulaski	AFIN	60-01071
Facility Address	10803 Ironton Road, Little Rock, AR	Phone #	501-888-4493	Permit #	0266-S4J
Permittee Address	10803 Ironton Road, Little Rock, AR	Email Address	ncharles@littlerock.gov	PDS #	121363
Date	8/4/2022	Entry Time	0930	Exit Time	1300

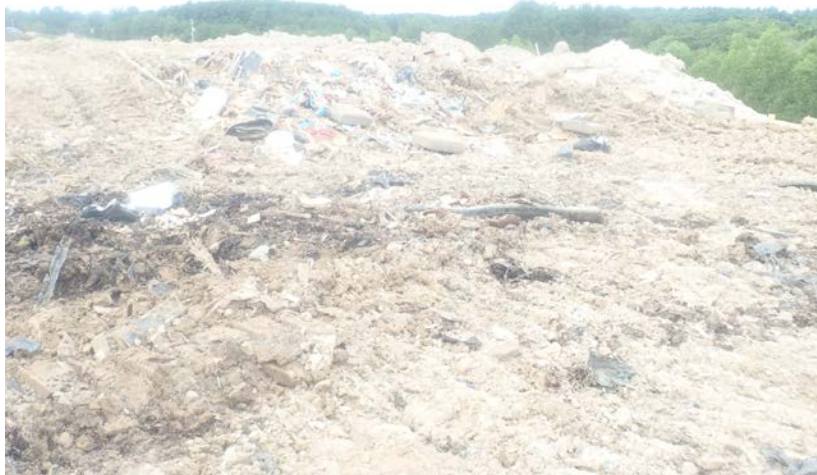
Regulation	Item Description	Comments
	607(a)	Operations in Accordance with Permit Documents	
	613(c)	Adequate All Weather Operational Roads	
X	607(c)(d)	Smallest Practical Area, Single Working Face	Two working faces observed. (Refer to Photos # 1 & #2.)
	607(b)	Operations by Licensed On-site Personnel at All Times	
X	607(g)	Litter Control Provisions Maintained	Litter observed along the southern perimeter of the active area. (Refer to Photo #3.)
	622	Survey Controls	
	623	Surface Water Controls	
	607(h)(1)	Contouring Prevents Surface Water Flowing Into or Through Waste	
	607(h)(2)	Surface Water Control Prevents Off-site Sediment Accumulation	
	607(i)(o)	Adequate Maintenance of Intermediate/Final Cover Vegetation	
X	607(o)	Leachate Leaks or Evidence of Leachate Seepage	Leachate observed on the upper, northern slope of the landfill. (Refer to Photos #4 & #5.)

Location	City of Little Rock Class 4			Permit	0266-S4J	AFIN	60-01071
Photographer	Kim Davenport, Inspector	<i>KD</i>		Witness	Ryan Hayden, Inspector Supervisor		
Photo #	1	Of	7	Date	8/4/2022	Time	1212
Description	Previous working face observed not covered on the northern end of the active area.

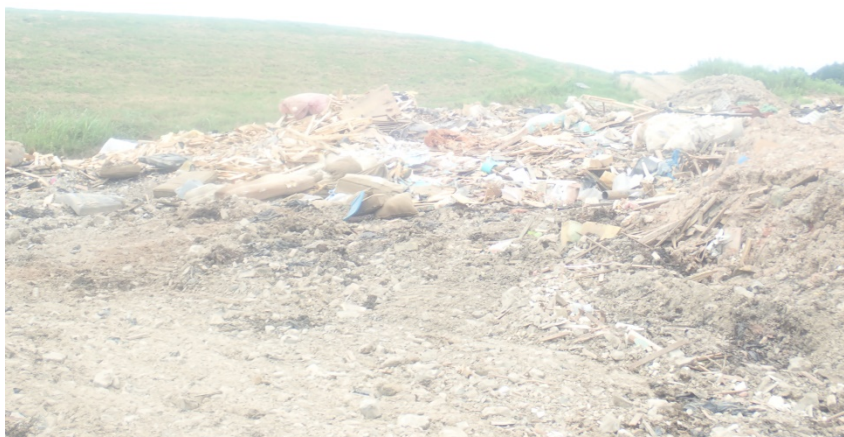
Location	City of Little Rock Class 4			Permit	0266-S4J	AFIN	60-01071
Photographer	Kim Davenport, Inspector	<i>KD</i>		Witness	Ryan Hayden, Inspector Supervisor		
Photo #	2	Of	7	Date	8/4/022	Time	1212
Description	The active working face observed receiving disposal located on the southern end of the active area.

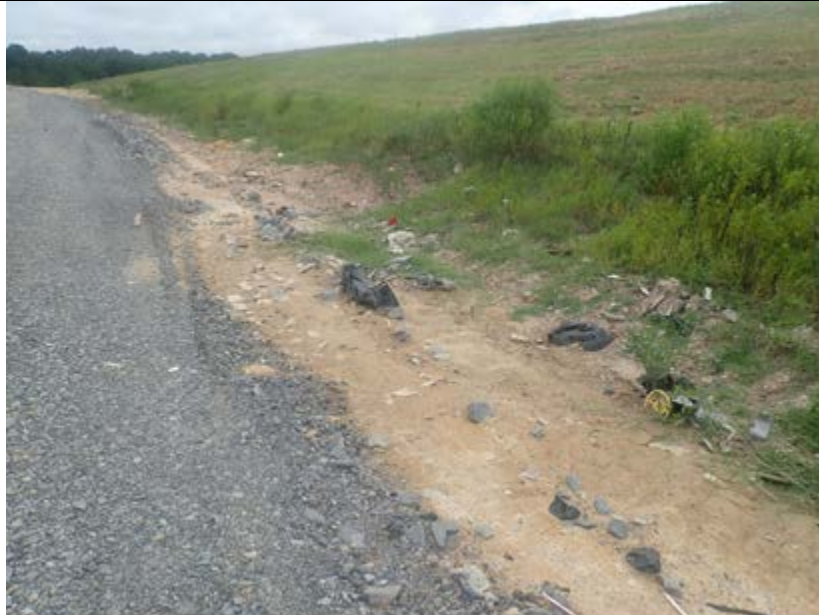
Location	City of Little Rock Class 4			Permit	0266-S4J	AFIN	60-01071
Photographer	Kim Davenport, Inspector	<i>KD</i>		Witness	Ryan Hayden, Inspector Supervisor		
Photo #	3	Of	7	Date	8/4/2022	Time	1209
Description	Litter observed along the southern perimeter of the active area.

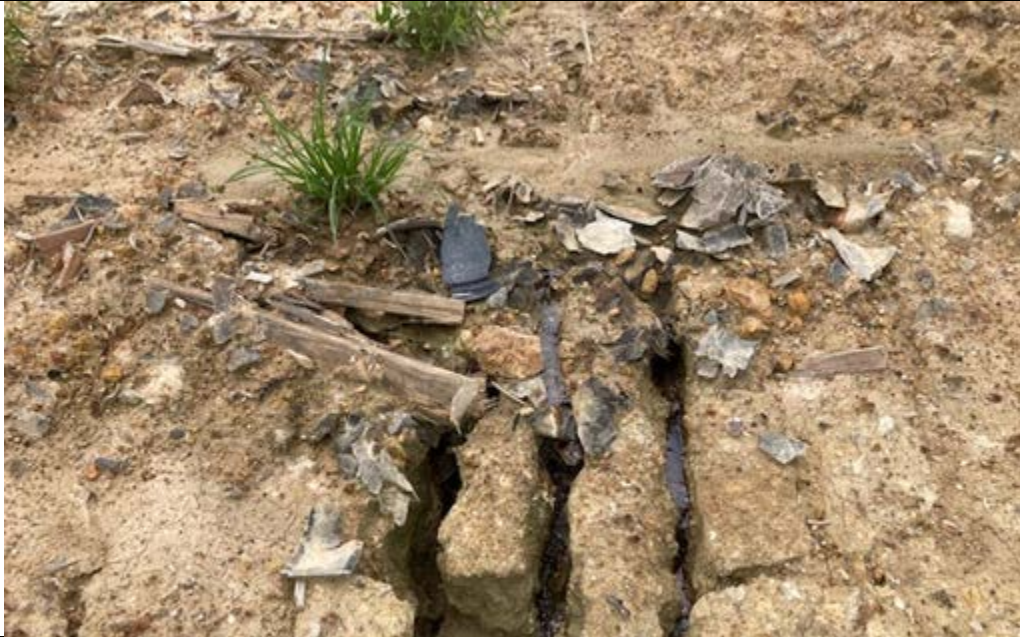
Location	City of Little Rock Class 4			Permit	0266-S4J	AFIN	60-01071
Photographer	Kim Davenport, Inspector	<i>KD</i>		Witness	Ryan Hayden, Inspector Supervisor		
Photo #	4	Of	7	Date	8/4/2022	Time	1217
Description	Leachate and exposed waste observed on the north side of the top deck of the active area.

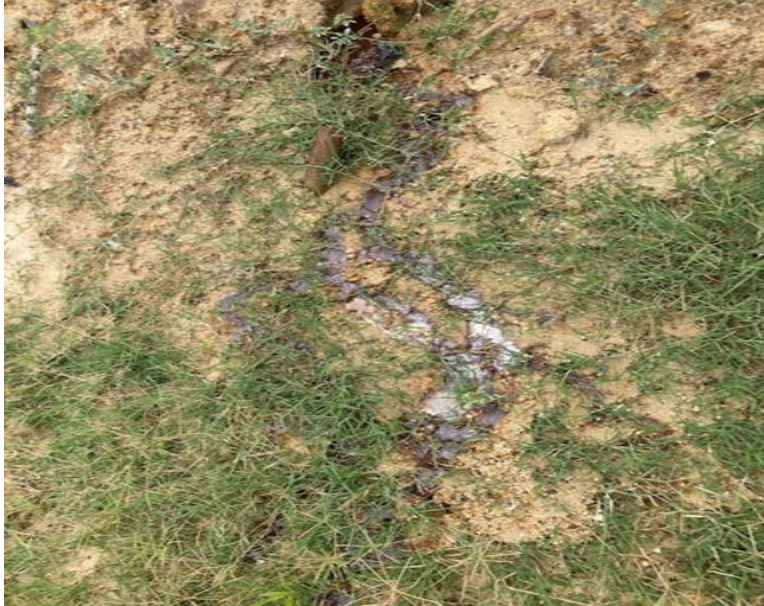
Location	City of Little Rock Class 4			Permit	0266-S4J	AFIN	60-01071
Photographer	Kim Davenport, Inspector	<i>KD</i>		Witness	Ryan Hayden, Inspector Supervisor		
Photo #	5	Of	7	Date	8/4/2022	Time	1217
Description	Leachate flows down the north slope from the erosion rill shown in Photo #4.

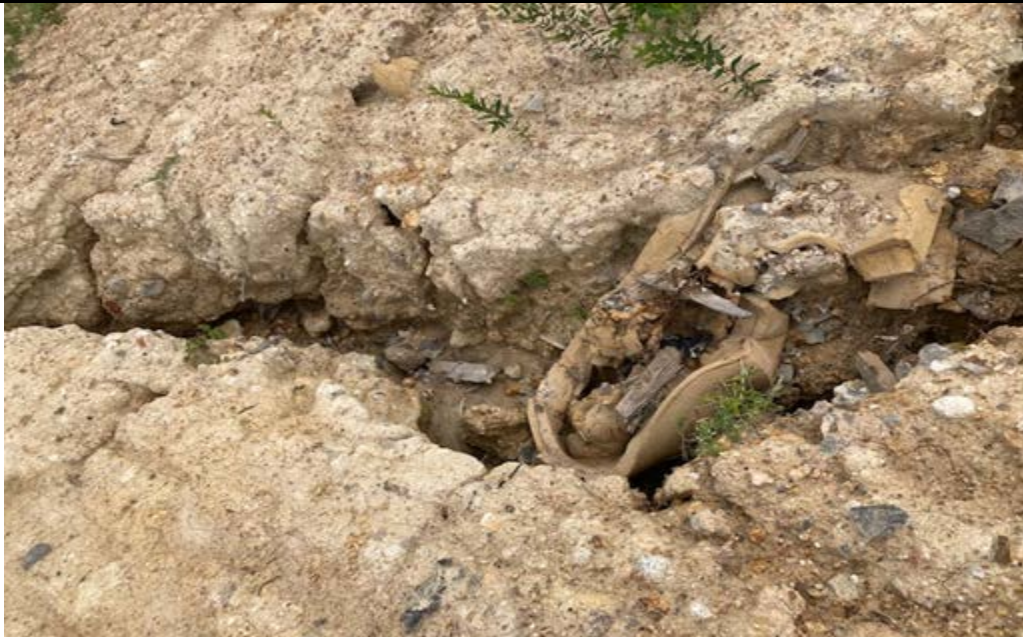
Regulation	Item Description	Comments
	608	Implementation of Hazardous Waste Exclusion Plan	
X	609(a)	Satisfactory Weekly or More Frequent Cover	Cover defects resulting in exposed waste observed across the active area and erosion rills resulting in exposed waste observed on the northern slope. (Refer to Photos # 6 & #7.)
	609(b)	Satisfactory Intermediate Cover	
	615	Cause Discharge/Leachate Discharge Leaving Landfill	
	607(o)	Erosion or Other Cover Defects Resulting in Exposed Refuse	
	309(c)	Overfill/Off Lined Area

Location	City of Little Rock Class 4			Permit	0266-S4J	AFIN	60-01071
Photographer	Kim Davenport, Inspector	<i>KD</i>		Witness	Ryan Hayden, Inspector Supervisor		
Photo #	6	Of	7	Date	8/4/2022	Time	1218
Description	Erosion with exposed waste observed on the northern slope.

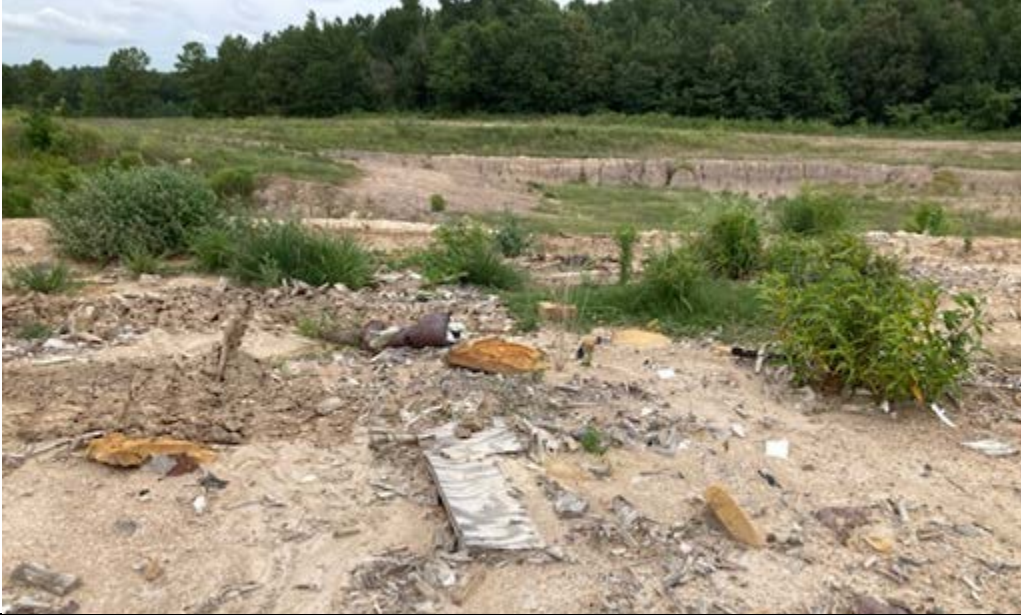
Location	City of Little Rock Class 4			Permit	0266-S4J	AFIN	60-01071
Photographer	Kim Davenport, Inspector		<i>KD</i>	Witness	Ryan Hayden, Inspector Supervisor		
Photo #	7	Of	7	Date	8/4/2022	Time	1216
Description	An example is provided of cover defects resulting in exposed waste observed across the active area.
