RE: Inspection conducted on August 4, 2022
AFIN 60-01071
Permit Number 0266-S1

**Office of Land Resources
Regulated Waste Operations
Class 1 Landfill Inspection Form**

Site Name	City of Little Rock Class 1 Landfill	County	Pulaski	AFIN	60-01071
Facility Address	10803 Ironton Cutoff, Little Rock, AR 72206	Phone #	501-888-74493	Permit #	0266-S1
Permittee Address	10803 Ironton Cutoff, Little Rock, AR 72206	Email Address	ncharles@littlerock.gov	PDS #	121428
Date	8/4/2022	Entry Time	0930	Exit Time	1300

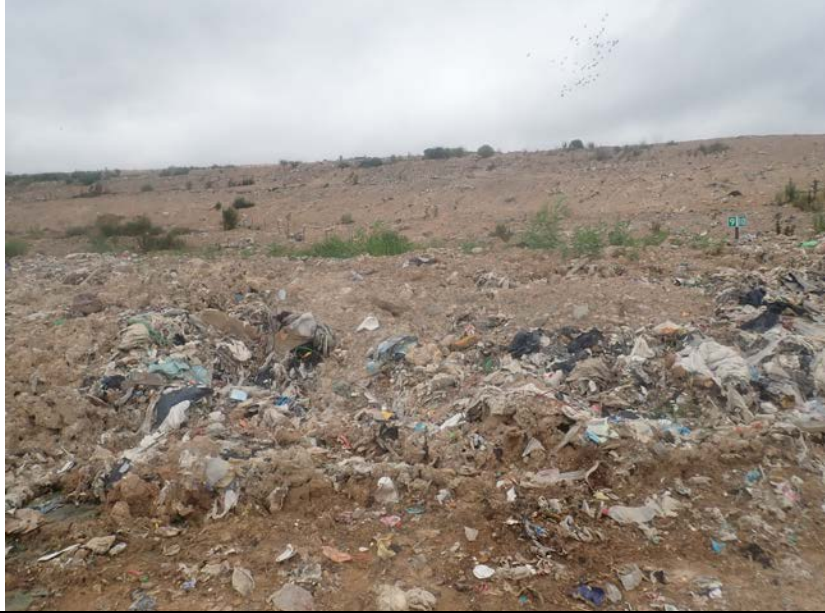
419(a)(5)	Cause Discharge/Leachate Leaving Landfill	
X	411(f)(3)419(a)(4)	Depositing Waste in Standing Water Prohibited	Waste observed in leachate in the interior and at the eastern edge of the active area of Cell #5. (Refer to Photos #4, #6 - #12.)
X	411(o)	Erosion or Other Cover Defects Resulting in Exposed Refuse	Cover defects resulting in exposed waste observed on the west slope of Cell #4, interim cover of Cell #9 over Cell #2, at the toe of Cell #2 (drainage ditch), active Cell 5, and along the eastern edge of Cell 5 (at the sand layer). Waste removed from the trench was observed exposed along the eastern side of Cell 5. (Refer to Photos #1 - #3, #7- #14, & #16 - #18.)
	309(c)	Overfill/Off Lined Area

Location	City of Little Rock Class 1			Permit	0266-S1	AFIN	60-01071
Photographer	Kim Davenport, Inspector	<i>KD</i>		Witness	Ryan Hayden, Inspector Supervisor		
Photo #	1	Of	18	Date	8/4/2022	Time	1046
Description	A view of the west slope of Cell 5 East showing exposed waste and no BMP's in place on the slope.

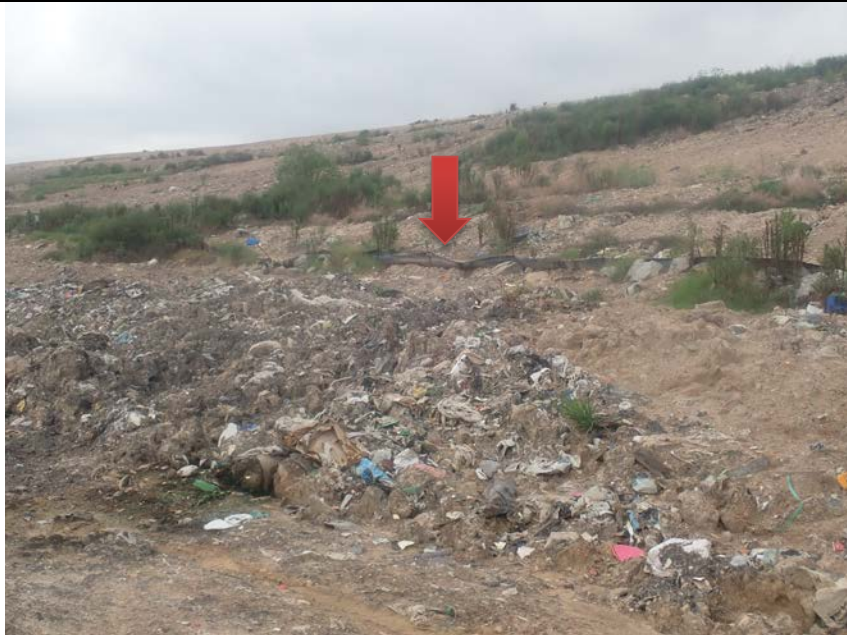
Location	City of Little Rock Class 1			Permit	0266-S1	AFIN	60-01071
Photographer	Kim Davenport, Inspector	<i>KD</i>		Witness	Ryan Hayden, Inspector Supervisor		
Photo #	2	Of	18	Date	8/4/2022	Time	1049
Description	Exposed waste observed along the west slope of Cell 5 East. A collapsed silt fence observed on the slope identified by red arrow.

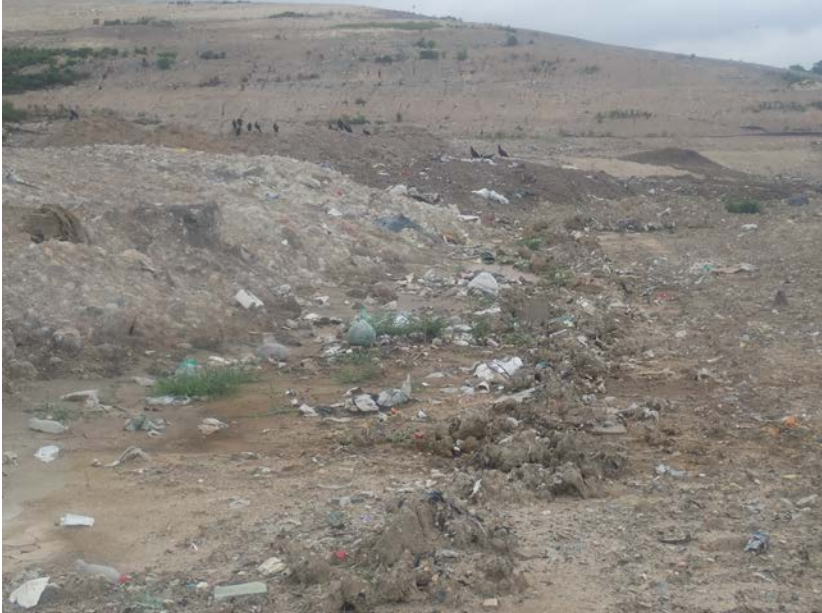
Regulation	Item Description	Comments
X	411(a)	Operations in Accordance with Permit Documents	Operations at the landfill do not reflect Operating Plan on file. Operating plan requires update. One example: Operating Plan Doc #60665, Section 4.0 describes BMP's used to prevent run-on into active portions of the landfill, however, no BMP's were observed in place to manage surface flow into the active area. Instead, a trench was observed, approximately 10' deep by 300' long, to convey leachate from the active area to the open sand layer located on the southern end of Cell 5. This practice is not described in the operating plan, nor is it approved. (Refer to Photos #1 - #10.)
	411(c)	Smallest Practical Area, Unloading Supervised, Single Working Face	
	411(b)	Operations by Licensed On-site Personnel at All Times	
X	411(g)	Litter Control Provisions Maintained	Litter observed across the active area with no litter controls in place. (Refer to Photos #3 - #6 & #15.)

Location	City of Little Rock Class 1			Permit	0266-S1	AFIN	60-01071
Photographer	Kim Davenport, Inspector	<i>KD</i>		Witness	Ryan Hayden, Inspector Supervisor		
Photo #	3	Of	18	Date	8/4/2022	Time	1038
Description	Litter observed on the southern end of Cell 5 with no controls in place.

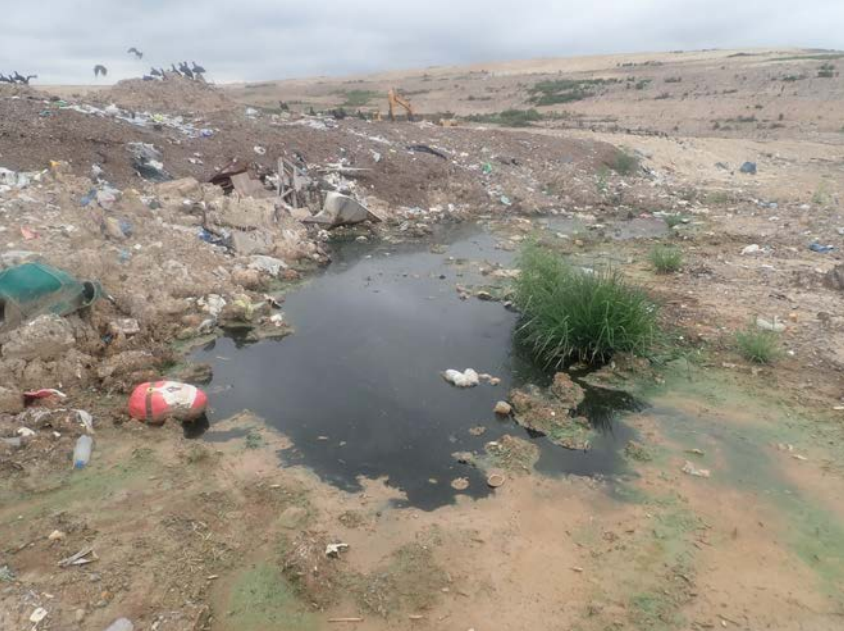
427	Surface Water Controls	
X	411(h)(1)	Contouring Prevents Surface Water Flowing Into or Through Waste	The active area is not contoured to minimize the flow of surface water to flow through waste. (Refer to Photos #11 - #14.)
X	418(a)(b)	Run-on/off Control System Present and Adequate	A storm-water control system is not in place along the interior slopes (Cells 1, 2, 5E & Cell 9W) to prevent run-on onto the active portion of the landfill at Cell 5. (Refer to photos #1 - #10.)
	411(h)(2)	Surface Water Control Prevents Off-site Sediment Accumulation	
	411(i)	Adequate Maintenance of Intermediate/Final Cover Vegetation	
	415	Gas Monitoring Program	
	411(o)	Leachate Leaks or Evidence of Leachate Seepage	
X	429	Leachate Collection System	The leachate collection system does not adequately dewater the waste mass, as evidenced by the operator's statement a trench was needed to remove the waist-high leachate pool that had collected in the working face. (Refer to Photos #4 & #6 - #14.)

Location	City of Little Rock Class 1			Permit	0266-S1	AFIN	60-01071
Photographer	Kim Davenport, Inspector	<i>KD</i>		Witness	Ryan Hayden, Inspector Supervisor		
Photo #	4	Of	18	Date	8/4/2022	Time	1041
Description	Litter observed on the southern end of Cell 5 with no controls in place. Leachate observed pooling.

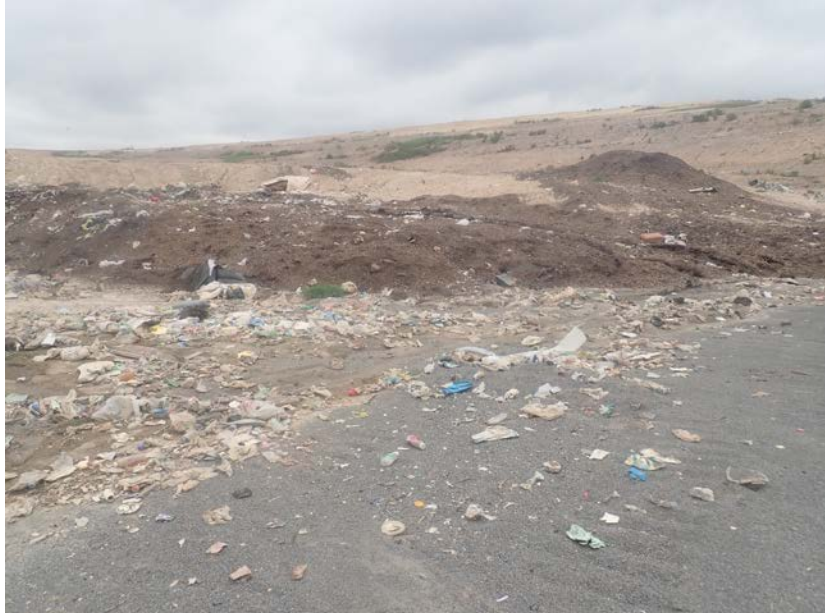
Location	City of Little Rock Class 1			Permit	0266-S1	AFIN	60-01071
Photographer	Kim Davenport, Inspector	<i>KD</i>		Witness	Ryan Hayden, Inspector Supervisor		
Photo #	5	Of	18	Date	8/4/2022	Time	1043
Description	Litter observed on the southern end of Cell 5 with no controls in place.

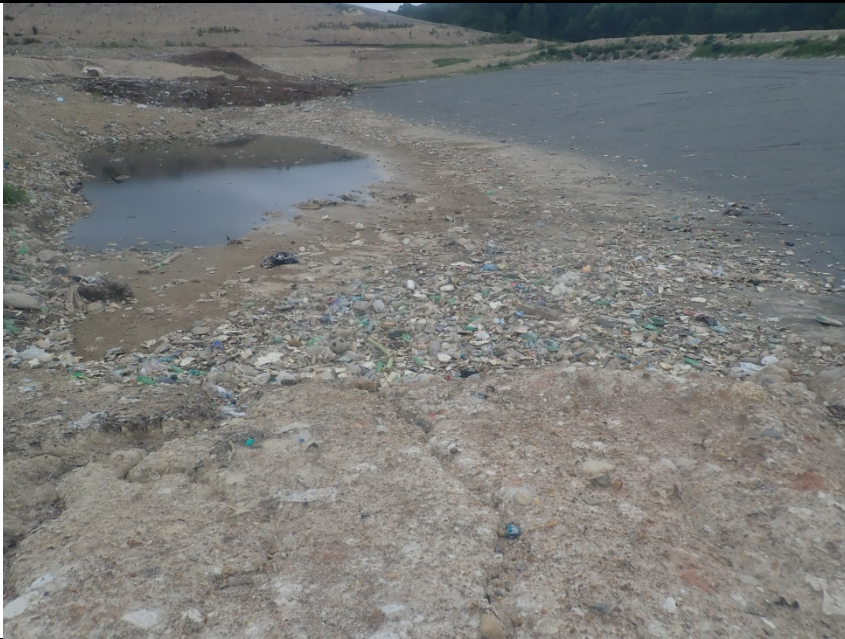
Location	City of Little Rock Class 1			Permit	0266-S1	AFIN	60-01071
Photographer	Kim Davenport, Inspector	<i>KD</i>		Witness	Ryan Hayden, Inspector Supervisor		
Photo #	6	Of	18	Date	8/4/2022	Time	1042
Description	Litter observed on the southern end of Cell 5 with no controls in place. Ponding observed.

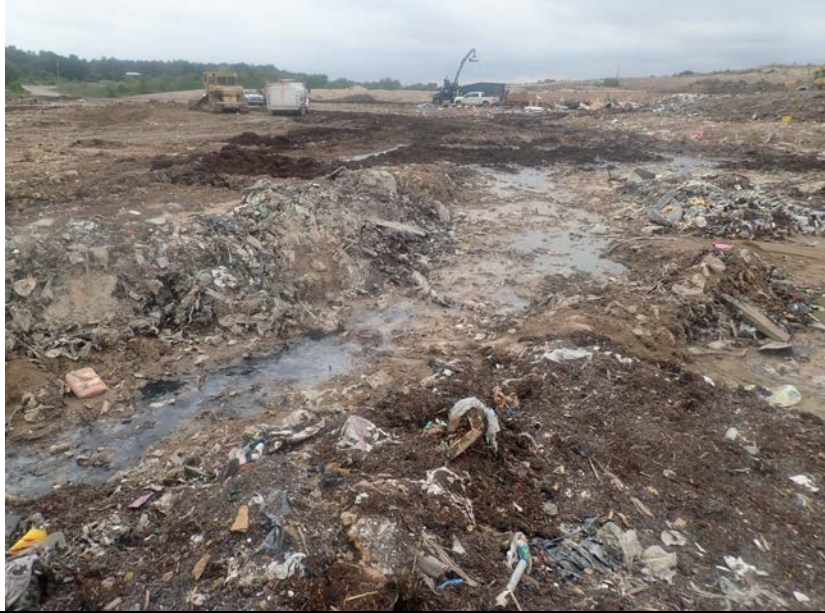
Location	City of Little Rock Class 1	Permit	0266-S1	AFIN	60-01071
Photographer	Kim Davenport, Inspector	<i>KD</i>	Witness	Ryan Hayden, Inspector Supervisor	
Photo #	7	Of	18	Date	8/4/2022
Time	1050				
Description	The beginning of the trench is observed, allowing leachate to flow south from the working face. Exposed waste observed.

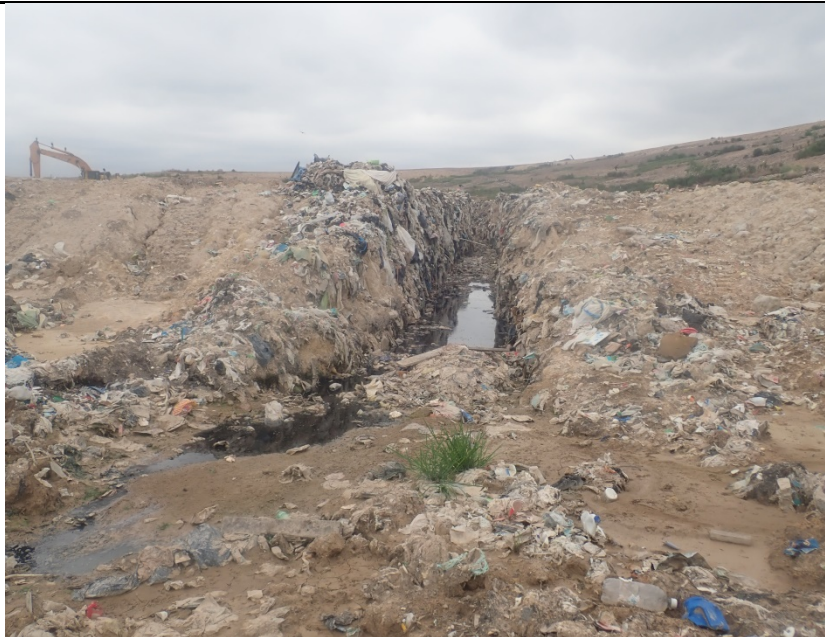
Location	City of Little Rock Class 1	Permit	0266-S1	AFIN	60-01071
Photographer	Kim Davenport, Inspector	<i>KD</i>	Witness	Ryan Hayden, Inspector Supervisor	
Photo #	8	Of	18	Date	8/4/2022
Time	1045				
Description	The trench is observed running north to south on the east side of Cell 5, containing leachate and exposed waste. Depth estimated at 10'.

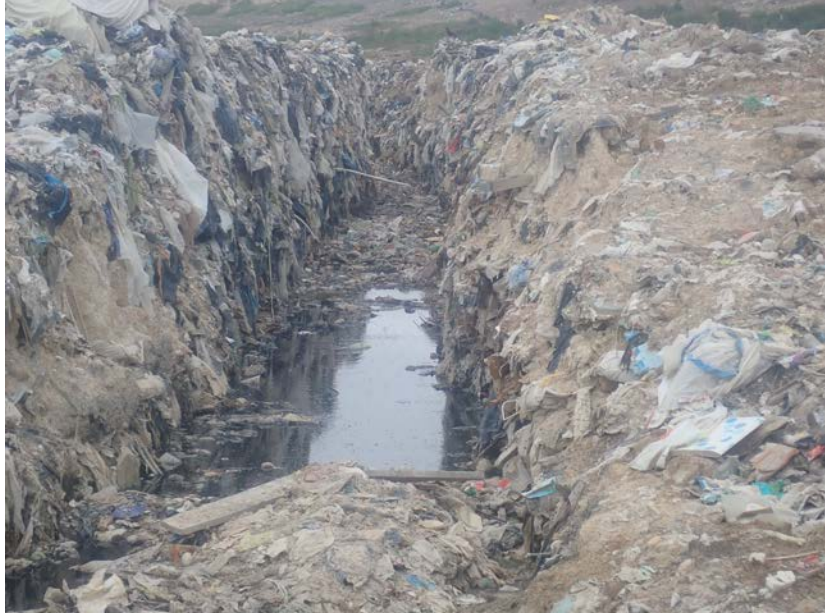
Location	City of Little Rock Class 1			Permit	0266-S1	AFIN	60-01071
Photographer	Kim Davenport, Inspector		<i>KD</i>	Witness	Ryan Hayden, Inspector Supervisor		
Photo #	9	Of	18	Date	8/4/2022	Time	1045
Description	A closer view of the trench is observed, containing leachate and exposed waste.

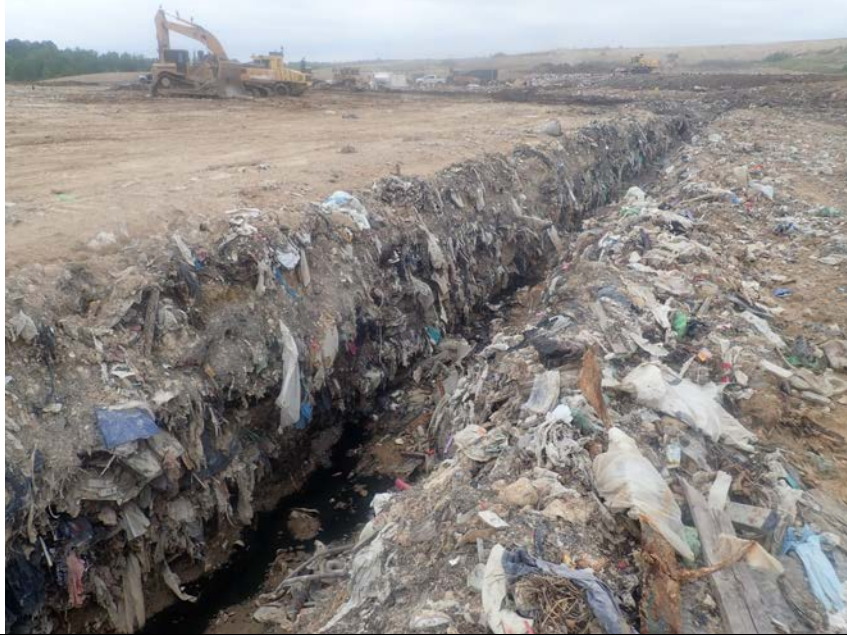
Location	City of Little Rock Class 1			Permit	0266-S1	AFIN	60-01071
Photographer	Kim Davenport, Inspector		<i>KD</i>	Witness	Ryan Hayden, Inspector Supervisor		
Photo #	10	Of	18	Date	8/4/2022	Time	1047
Description	An overview of the trench is observed.

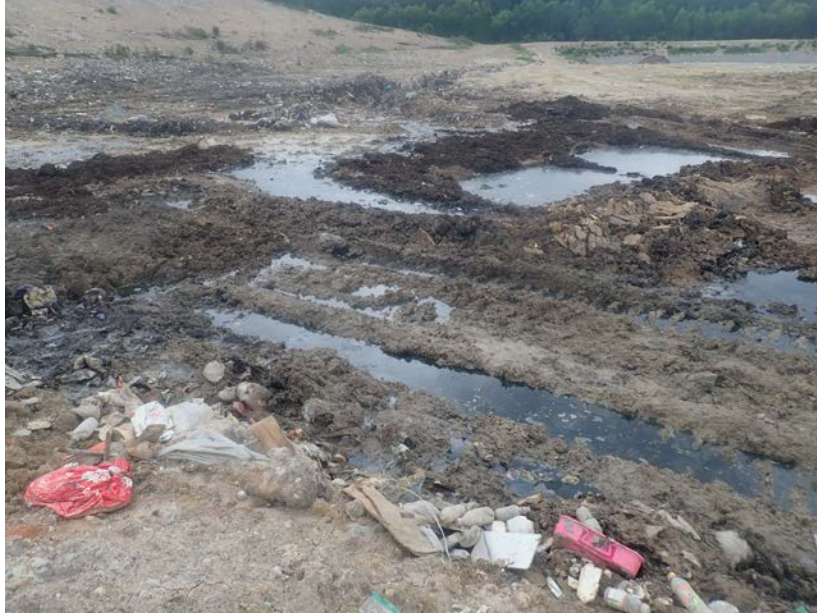
Location	City of Little Rock Class 1			Permit	0266-S1	AFIN	60-01071
Photographer	Kim Davenport, Inspector	<i>KD</i>		Witness	Ryan Hayden, Inspector Supervisor		
Photo #	11	Of	18	Date	8/4/2022	Time	1056
Description	Leachate observed pooling in depressions in Cell 5. Exposed waste and litter observed.

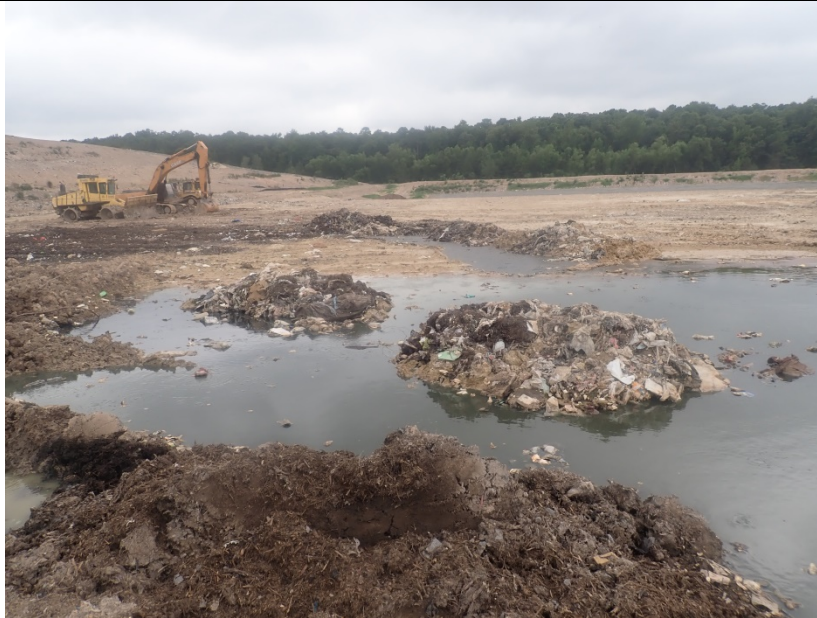
Location	City of Little Rock Class 1			Permit	0266-S1	AFIN	60-01071
Photographer	Kim Davenport, Inspector	<i>KD</i>		Witness	Ryan Hayden, Inspector Supervisor		
Photo #	12	Of	18	Date	8/4/2022	Time	1131
Description	Leachate observed pooling in depressions in Cell 5. Piles of solid waste observed in the water.

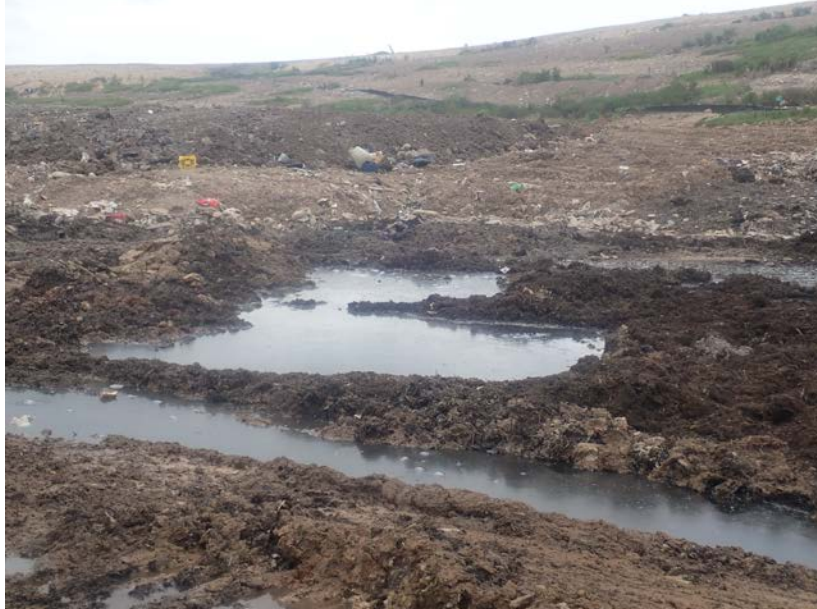
Location	City of Little Rock Class 1			Permit	0266-S1	AFIN	60-01071
Photographer	Kim Davenport, Inspector	<i>KD</i>		Witness	Ryan Hayden, Inspector Supervisor		
Photo #	13	Of	18	Date	8/4/2022	Time	1144
Description	Leachate observed pooling in depressions in Cell 5. Exposed waste observed.

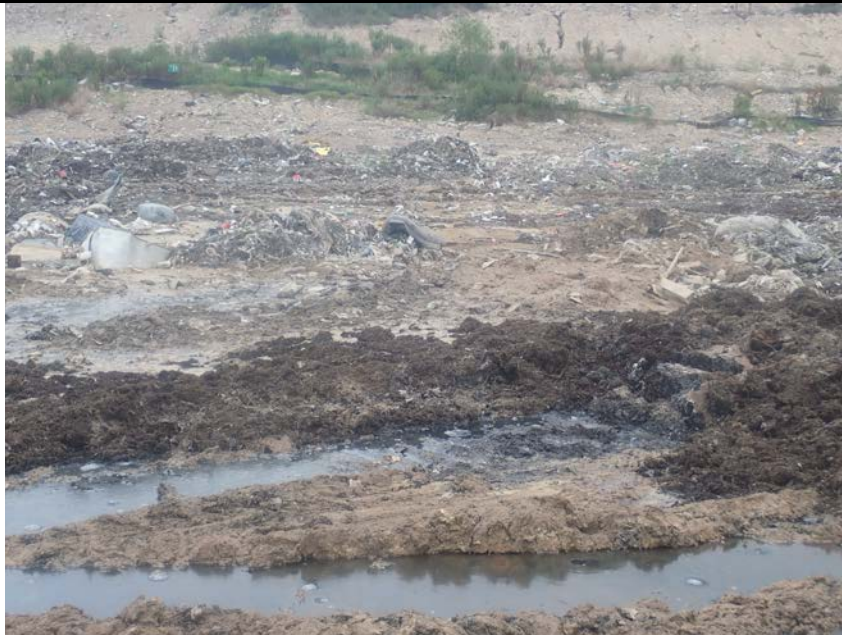
Location	City of Little Rock Class 1			Permit	0266-S1	AFIN	60-01071
Photographer	Kim Davenport, Inspector	<i>KD</i>		Witness	Ryan Hayden, Inspector Supervisor		
Photo #	14	Of	18	Date	8/4/2022	Time	1144
Description	Leachate observed pooling in depressions in Cell 5. Exposed waste from the trench observed along the eastern side of Cell 5.

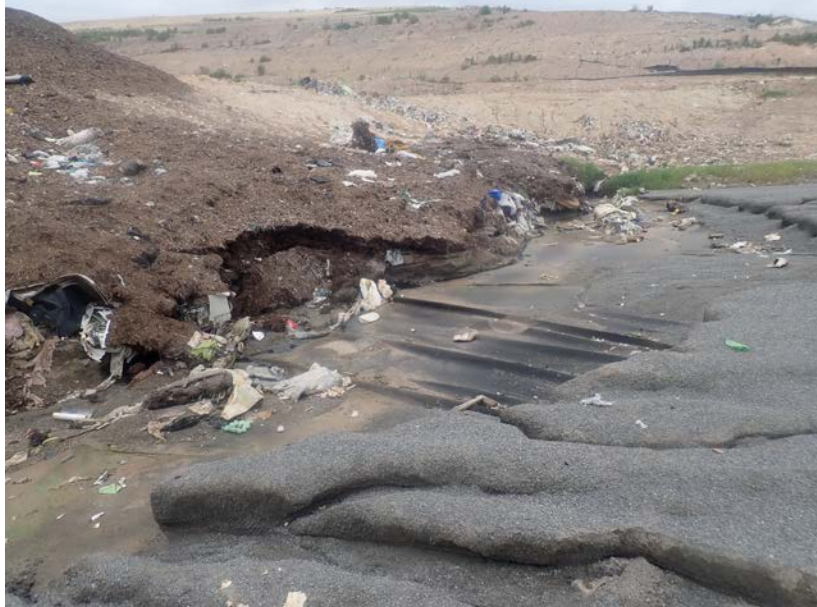
Location	City of Little Rock Class 1			Permit	0266-S1	AFIN	60-01071
Photographer	Kim Davenport, Inspector		<i>KD</i>	Witness	Ryan Hayden, Inspector Supervisor		
Photo #	15	Of	18	Date	8/4/2022	Time	1044
Description	Litter and exposed waste observed at the south end of Cell 5 where the sand barrier is exposed.

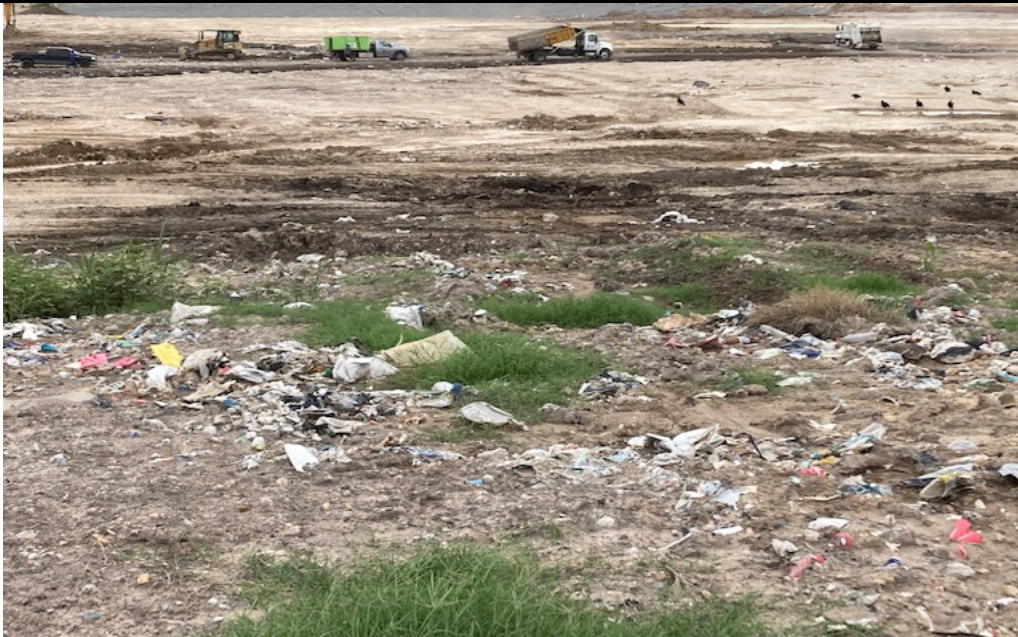
Location	City of Little Rock Class 1			Permit	0266-S1	AFIN	60-01071
Photographer	Kim Davenport, Inspector		<i>KD</i>	Witness	Ryan Hayden, Inspector Supervisor		
Photo #	16	Of	18	Date	8/4/2022	Time	1233
Description	Exposed waste observed on the interim cover of Cell 9 (over Cell 2), looking south.

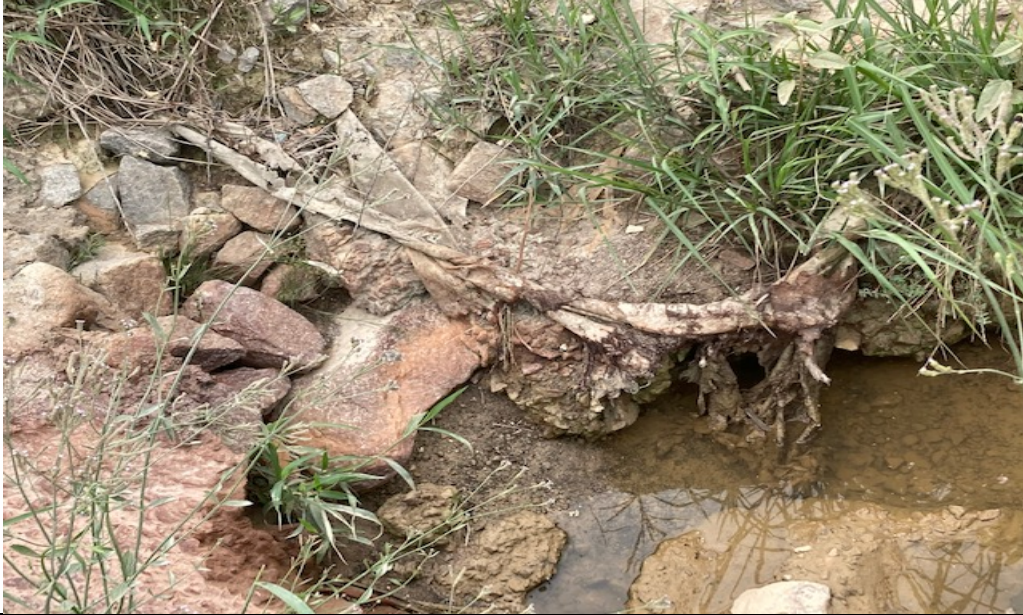
Location	City of Little Rock Class 1			Permit	0266-S1	AFIN	60-01071
Photographer	Kim Davenport, Inspector		<i>KD</i>	Witness	Ryan Hayden, Inspector Supervisor		
Photo #	17	Of	18	Date	8/4/2022	Time	1227
Description	Exposed waste observed at the drainage ditch below Cell 2.

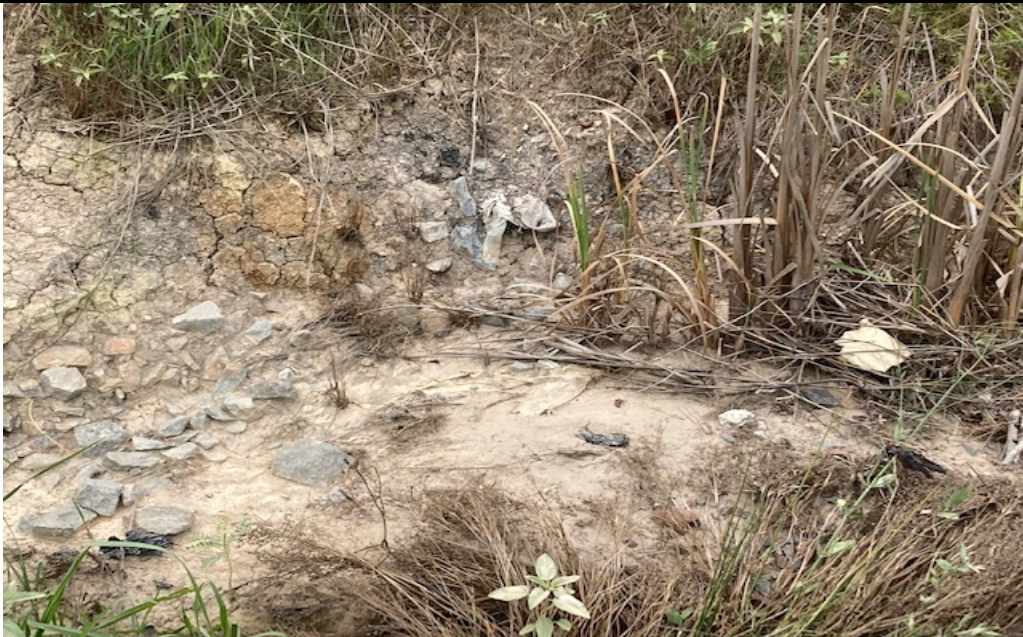
Location	City of Little Rock Class 1			Permit	0266-S1	AFIN	60-01071
Photographer	Kim Davenport, Inspector		<i>KD</i>	Witness	Ryan Hayden, Inspector Supervisor		
Photo #	18	Of	18	Date	8/4/2022	Time	1228
Description	Exposed waste observed at the drainage ditch below Cell 2.
