RE: Inspection conducted on September 21, 2022
AFIN 03-00051
Permit Number 0249-S1-R2

**Office of Land Resources
Regulated Waste Operations
Class 1 Landfill Inspection Form**

Site Name	NABORS Landfill	County	Baxter	AFIN	03-00051
Facility Address	Hwy 5 N to CR 16 to site entrance- Three Brothers	Phone #	870-688-3822	Permit #	0249-S1-R2
Permittee Address	P.O. Box 1669 Harrison, AR 72602	Email Address	Steve.kershaw.engr@gmail.com judge@baxtercounty.org	PDS #	122994
Date	9/21/2022	Entry Time	1008	Exit Time	1228

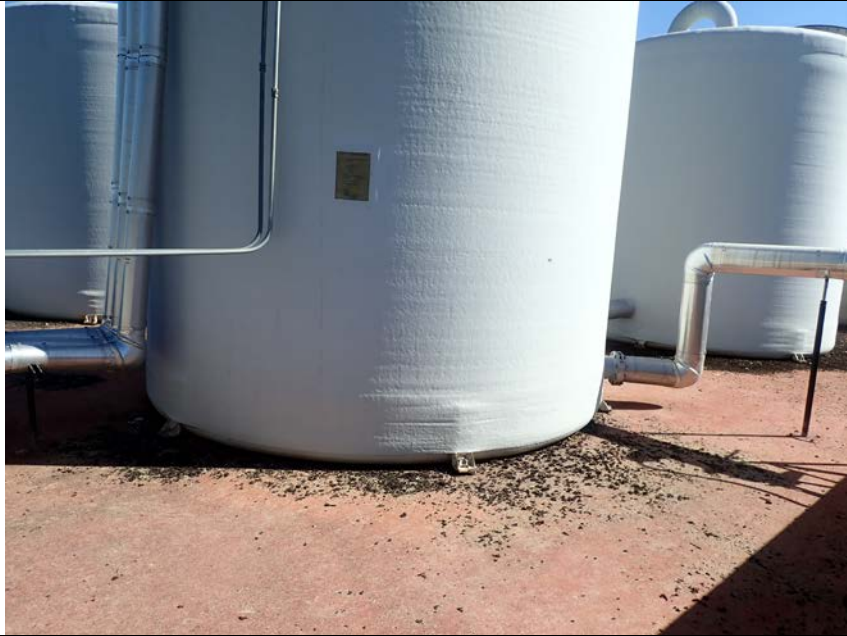
Location	NABORS Class 1			Permit	0249-S1-R2	AFIN	03-00051
Photographer	Darrell Norton, Inspector		<i>DN</i>	Witness	Mason Goheen		
Photo #	1	Of	6	Date	9/21/2022	Time	1036
Description	Secondary containment at tank farm observed.

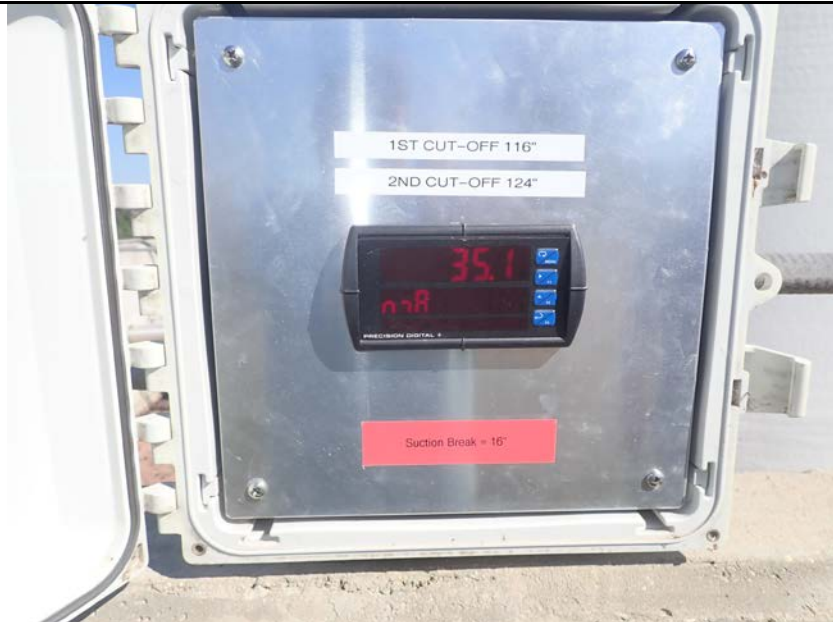
Location	NABORS Class 1			Permit	0249-S1-R2	AFIN	03-00051
Photographer	Darrell Norton, Inspector		<i>DN</i>	Witness	Mason Goheen		
Photo #	2	Of	6	Date	9/21/2022	Time	1036
Description	Level observed at tank farm.

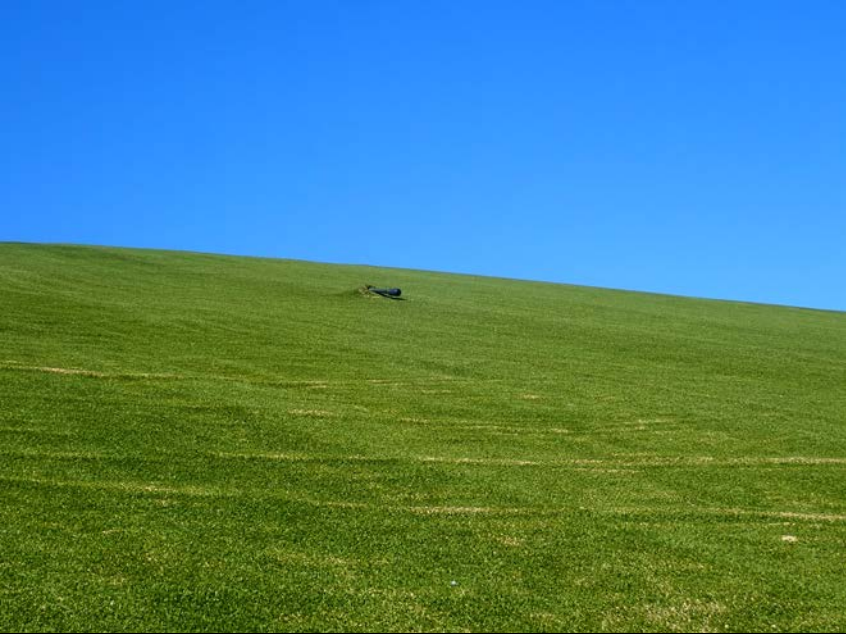
Location	NABORS Class 1			Permit	0249-S1-R2	AFIN	03-00051
Photographer	Darrell Norton, Inspector		<i>DN</i>	Witness	Mason Goheen		
Photo #	3	Of	6	Date	9/21/2022	Time	1042
Description	Turf roll observed near LCS 1. Broken gas vent observed.

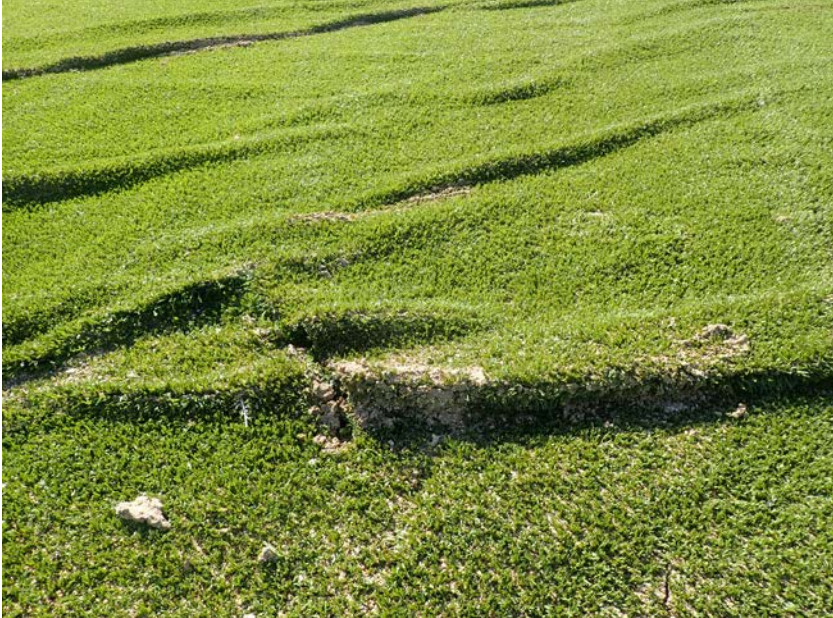
Location	NABORS Class 1			Permit	0249-S1-R2	AFIN	03-00051
Photographer	Darrell Norton, Inspector		<i>DN</i>	Witness	Mason Goheen		
Photo #	4	Of	6	Date	9/21/2022	Time	1050
Description	Turf roll and tears observed near LCS-1.

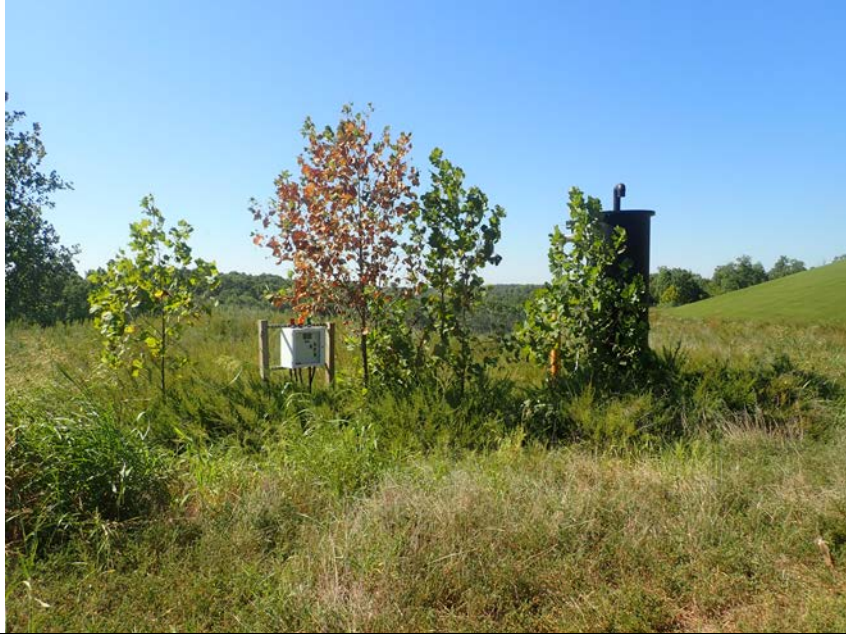
X	417(c) Access and Operational Roads	Road erosion present between LCS-4 and LCS-5. Vegetative control needed along roads and around LCS panels.

Location	NABORS Class 1			Permit	0249-S1-R2	AFIN	03-00051
Photographer	Darrell Norton, Inspector		<i>DN</i>	Witness	Mason Goheen		
Photo #	5	Of	6	Date	9/21/2022	Time	1102
Description	Woody vegetation observed near LCS-3.

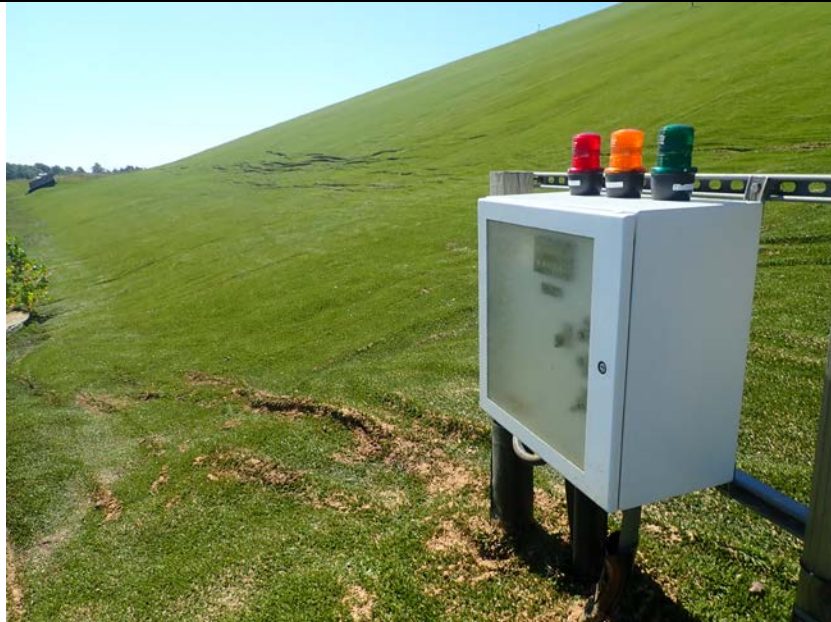
Location	NABORS Class 1			Permit	0249-S1-R2	AFIN	03-00051
Photographer	Darrell Norton, Inspector		<i>DN</i>	Witness	Mason Goheen		
Photo #	6	Of	6	Date	9/21/2022	Time	1124
Description	Turf roll observed near LCS-6, with woody vegetation present.
