OFFICE OF WATER QUALITY INSPECTION REPORT

AFIN: 04-00052	PERMIT #: AR0022292	DATE: 3/16/2022
COUNTY: 04 Benton	PDS #: 123356	MEDIA: WN
GPS LAT: 36.34417 LONG: -94.47271 LOCATION: General Area

FACILITY INFORMATION	INSPECTION INFORMATION
NAME: City of Decatur WWTP LOCATION: 985 Austin Avenue CITY: Decatur	FACILITY TYPE: 1 - Municipal INSPECTOR ID#: 104111 S - State FACILITY EVALUATION RATING: N INSPECTION TYPE: Reconnaissance DATE(S): 3/16/2022 ENTRY TIME: 11:50 EXIT TIME: 13:45 PERMIT EFFECTIVE DATE: 12/1/2020 PERMIT EXPIRATION DATE: 11/30/2025
RESPONSIBLE OFFICIAL	FAYETTEVILLE SHALE RELATED: N FAYETTEVILLE SHALE VIOLATIONS: N
NAME / TITLE: Robert Tharp / Mayor COMPANY: City of Decatur MAILING ADDRESS: PO Box 247 CITY, STATE, ZIP: Decatur AR 72722 PHONE & EXT. / FAX: 479-752-3912 / EMAIL: james.boston@decaturarkansas.us	INSPECTION PARTICIPANTS
CONTACTED DURING INSPECTION: No	NAME/TITLE/PHONE/FAX/EMAIL/ETC.: James Boston, Public Works Director, City of Decatur; Garrett Grimes, District 1 Inspector, DEQ

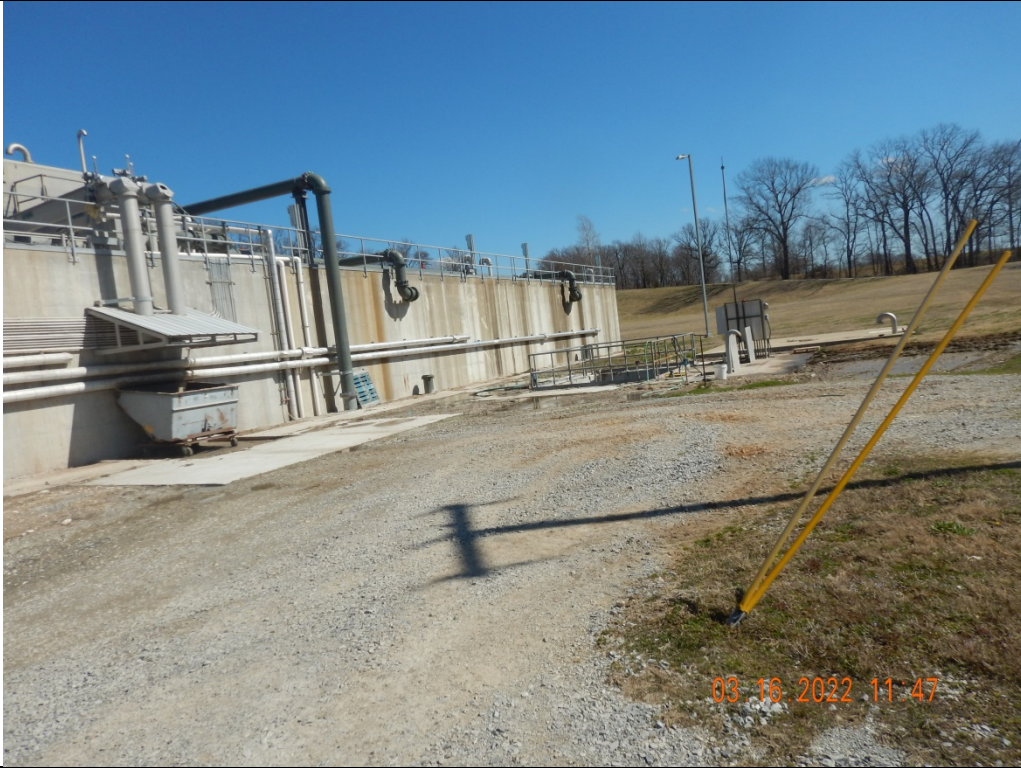
- Overflows are occurring at the plant from a lift station that pumps wastewater to the MBR unit for treatment. Residuals and wastewater were still on the ground at the time of the inspection with wastewater accumulating in a pond west of the unit (Photos #1 – #8). James Boston, Public Works Director, City of Decatur, stated that the overflows were caused by rags entering the lift station and clogging the pumps, and that the City had no plans to remediate the overflows due to the cost and the continual occurrence of overflows. Mr. Boston stated that the overflows initially began at the head of the plant following an upgrade to the plant’s screw screen. According to Mr. Boston, the new screen clogged with rags several hours after being put in use resulting in an overflow and the screen being removed from service (Photos #9 – #10). I asked what changes have occurred in the collection system or plant which resulted in the sudden clogging of the screen, Mr. Boston stated that the previous screen was damaged allowing some rags to pass through. At the time of the inspection, influent was being allowed to bypass the primary and secondary screens at the plant with solids accumulating in the secondary screen (Photo #11).

Location:	City of Decatur WWTP				
Photographer:	Garrett Grimes, District 1 Inspector	Date:	3/16/2022	Time:	12:47
Witness:				Photo #:	1
Description:	Location of overflow south of the MBR unit.

Overflows are not being remediated with wastewater residuals accumulating on the ground and wastewater accumulating in an unpermitted pond where possible groundwater infiltration can occur (Photos #1 – #8). Wastewater is bypassing initial solids screening resulting in clogging of lift station pumps and repeated overflows (Attachment 1). These are violations of Parts III.B.1.A and III.B.3 of the permit. Wastewater must be removed from the unpermitted pond and should be pumped into the head of the plant or MBR unit if appropriate. Solids must be removed from the ground and area remediated

Inspection Report: **City of Decatur WWTP**, AFIN: **04-00052**, Permit #: **AR0022292**
 with disinfection occurring in all affected areas including the pond. All possible measures must be in place to prevent overflows from occurring in the future. This should include cleaning and placing in use the secondary screen if possible.

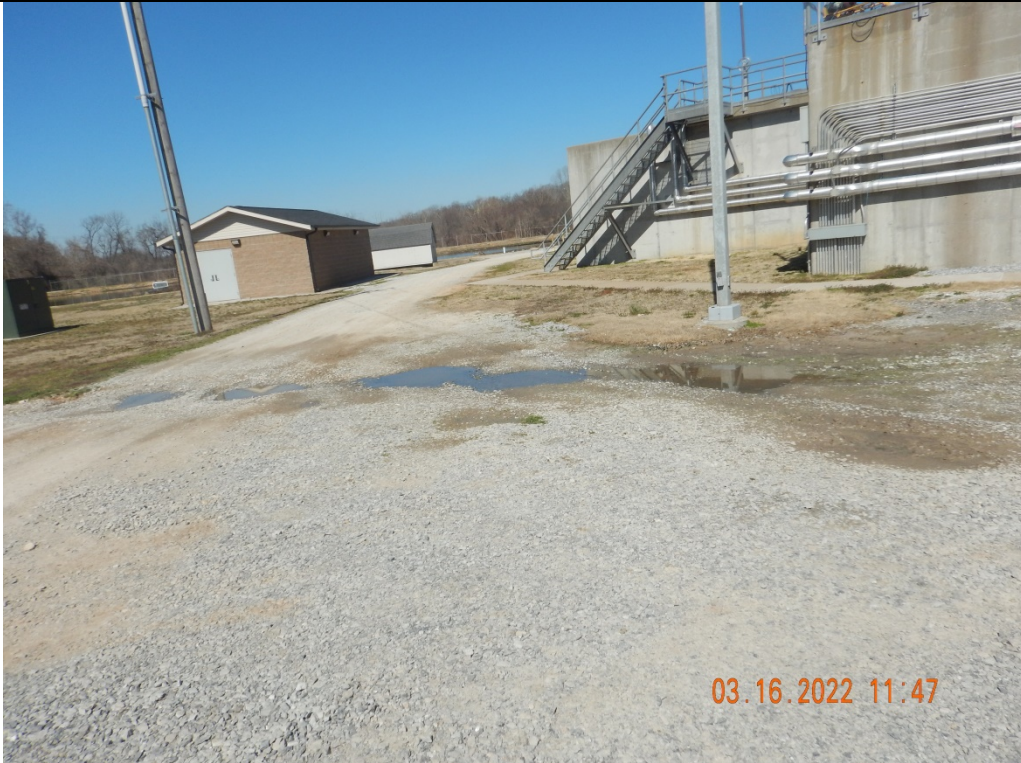
Photographer:	Garrett Grimes, District 1 Inspector	Date:	3/16/2022	Time:	12:47
Witness:				Photo #:	2
Description:	Wastewater on the ground from overflows.

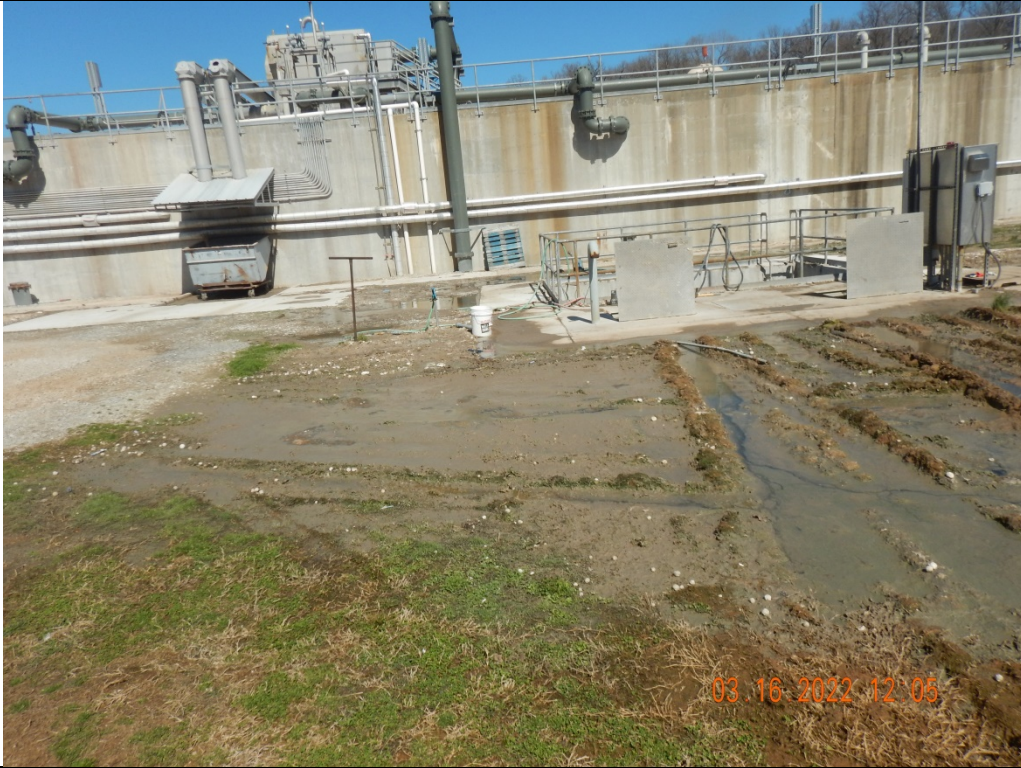
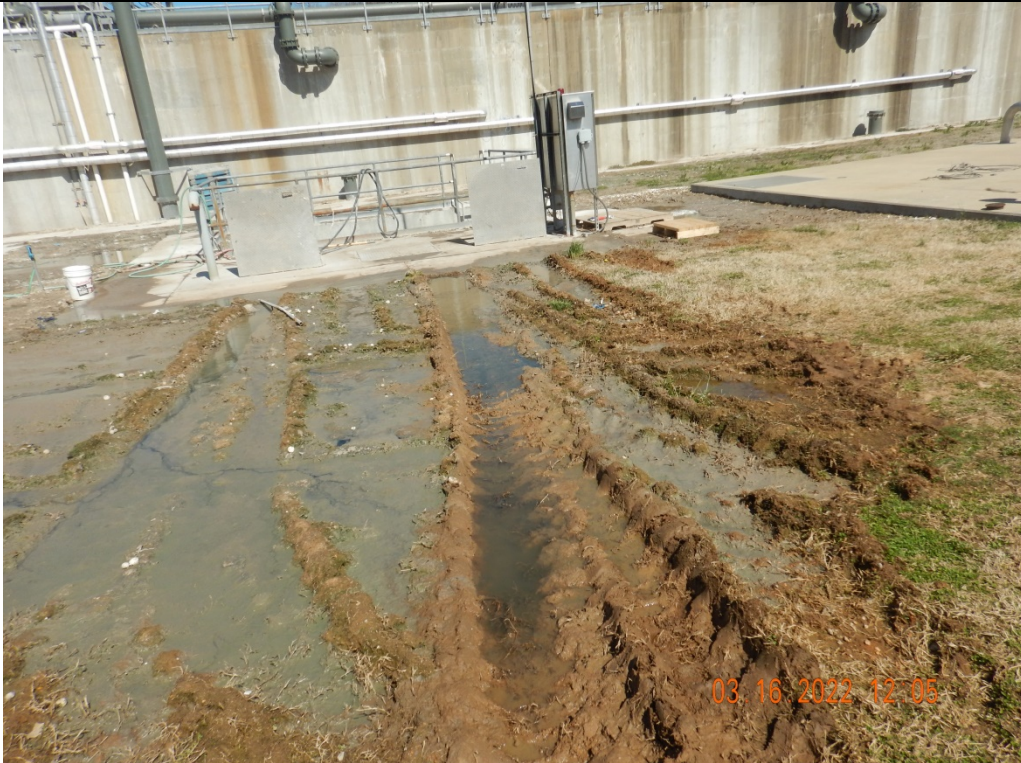
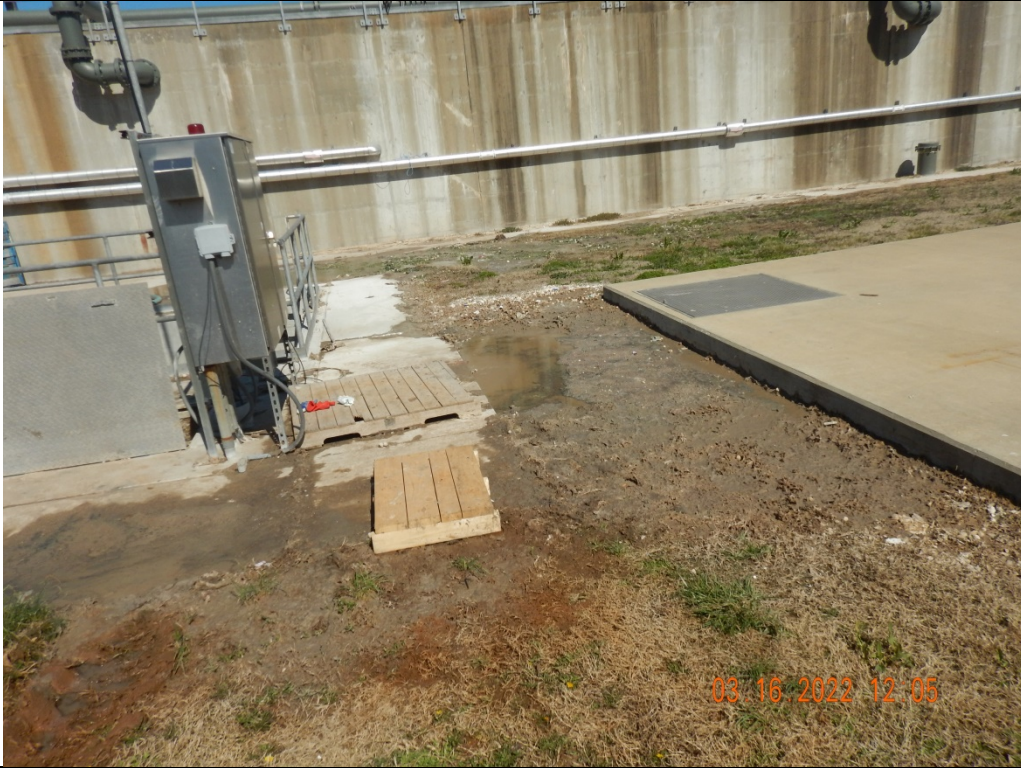
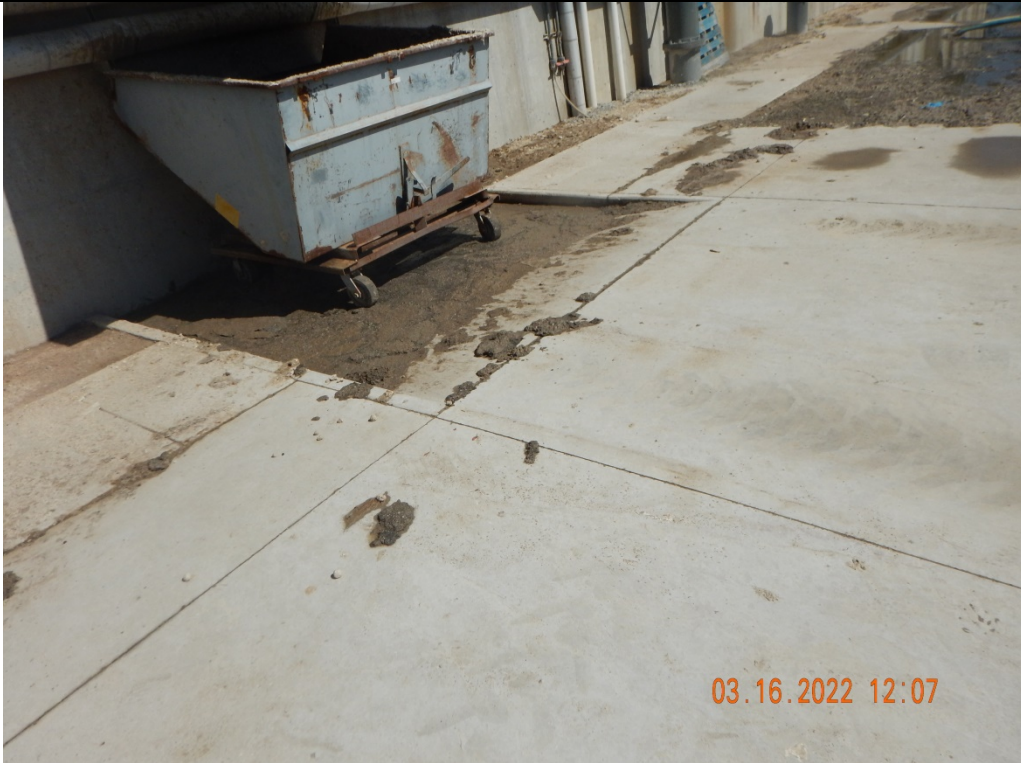
Location:	City of Decatur WWTP		
Photographer:	Garrett Grimes, District 1 Inspector	Date:	3/16/2022
Time:			13:05
Witness:			Photo #: 3
Description:	Residuals and wastewater on the ground from overflows.

Photographer:	Garrett Grimes, District 1 Inspector	Date:	3/16/2022
Time:			13:05
Witness:			Photo #: 4
Description:	Continued from Photo #3.

Location:	City of Decatur WWTP				
Photographer:	Garrett Grimes, District 1 Inspector	Date:	3/16/2022	Time:	13:05
Witness:				Photo #:	5
Description:	Continued from Photo #3.

Photographer:	Garrett Grimes, District 1 Inspector	Date:	3/16/2022	Time:	13:07
Witness:				Photo #:	6
Description:	Continued from Photo #3.

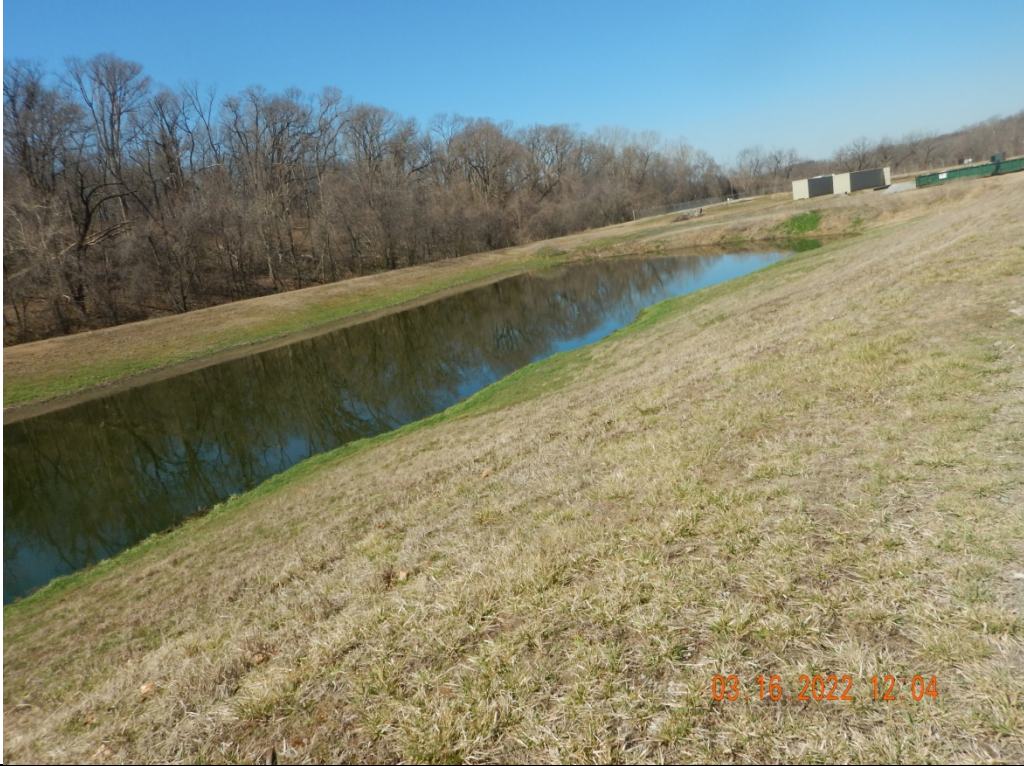
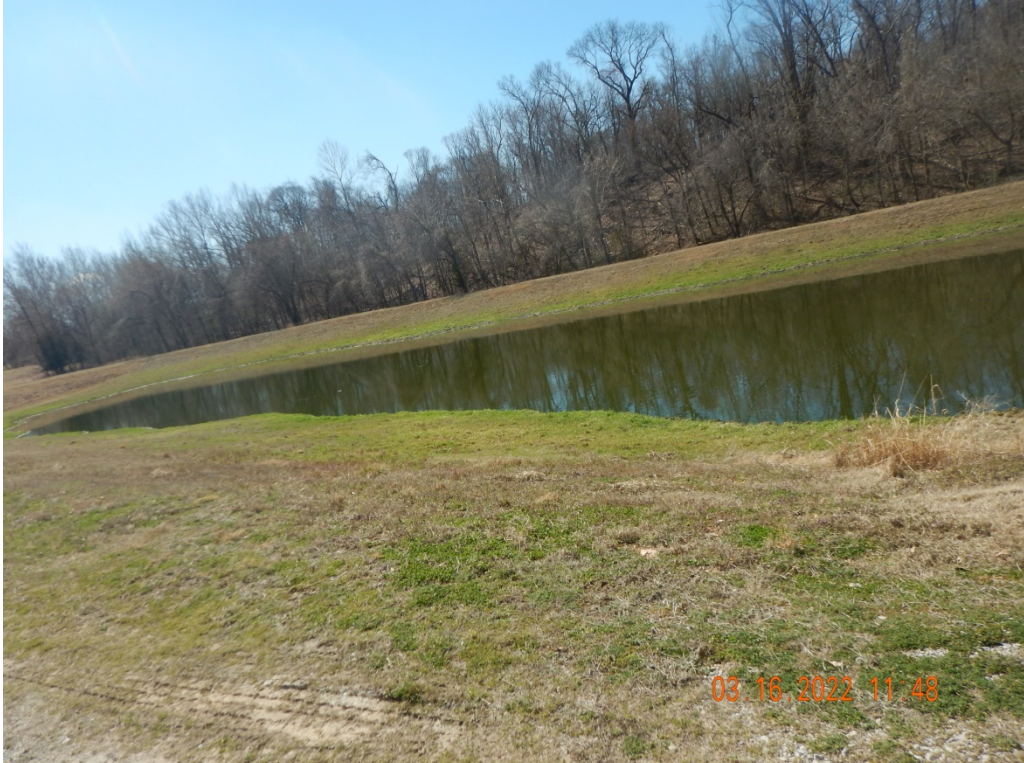
Location:	City of Decatur WWTP		
Photographer:	Garrett Grimes, District 1 Inspector	Date:	3/16/2022
Time:	13:04	Witness:	
Photo #:	7	Description:	Wastewater accumulating in the pond.

Photographer:	Garrett Grimes, District 1 Inspector	Date:	3/16/2022
Time:	12:48	Witness:	
Photo #:	8	Description:	Continued from Photo #7.

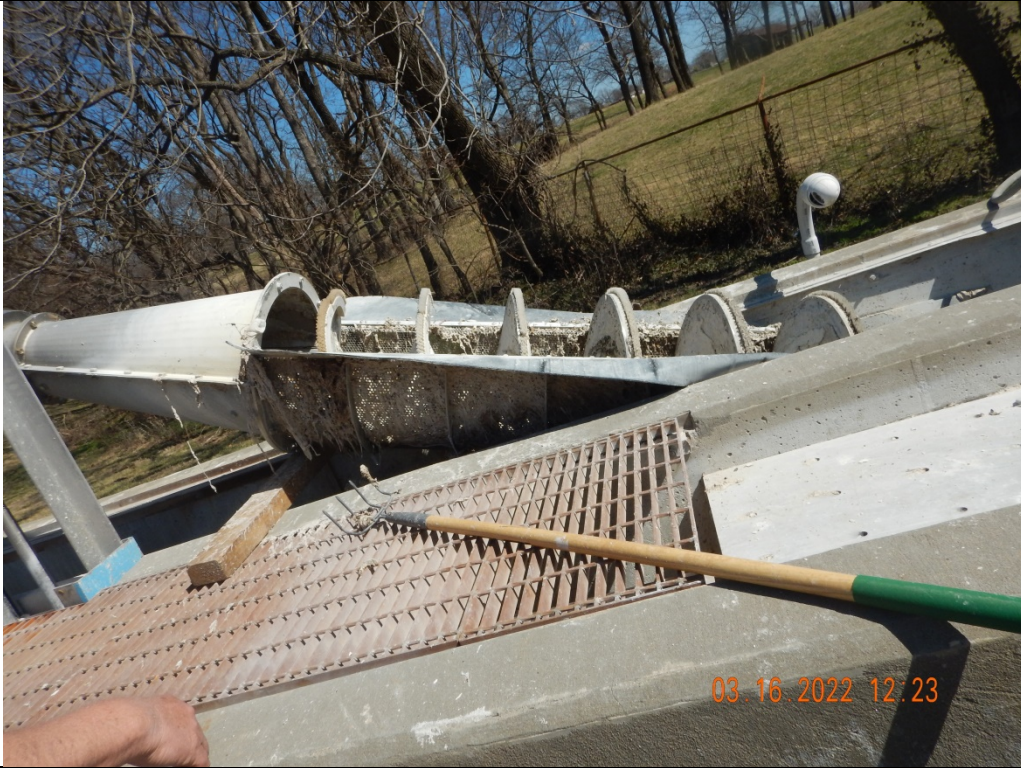
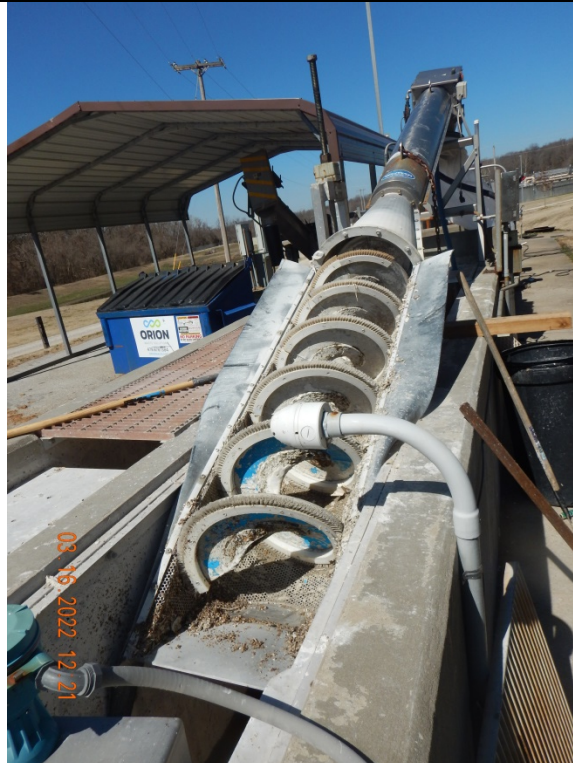
Location:	City of Decatur WWTP		
Photographer:	Garrett Grimes, District 1 Inspector	Date:	3/16/2022
Time:	13:23	Witness:	
Photo #:	9	Description:	Screw screen showing the screen is clogged and removed from service.

Photographer:	Garrett Grimes, District 1 Inspector	Date:	3/16/2022
Time:	13:21	Witness:	
Photo #:	10	Description:	Continued from Photo #9. Influent was allowed to pass under the screen.

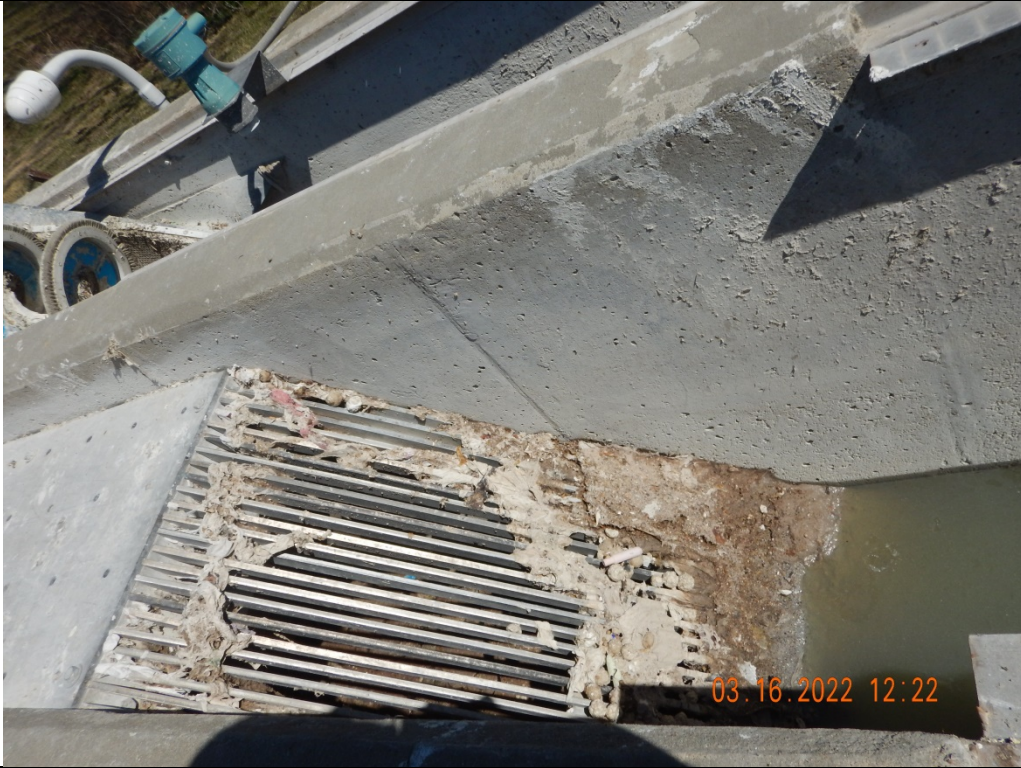
Location:	City of Decatur WWTP				
Photographer:	Garrett Grimes, District 1 Inspector	Date:	3/16/2022	Time:	13:22
Witness:				Photo #:	11
Description:	Secondary screen not in use with accumulated solids.

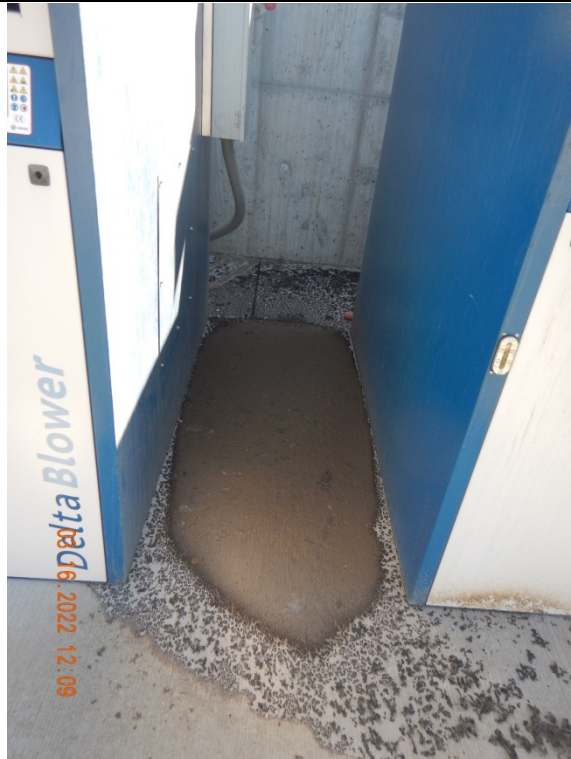
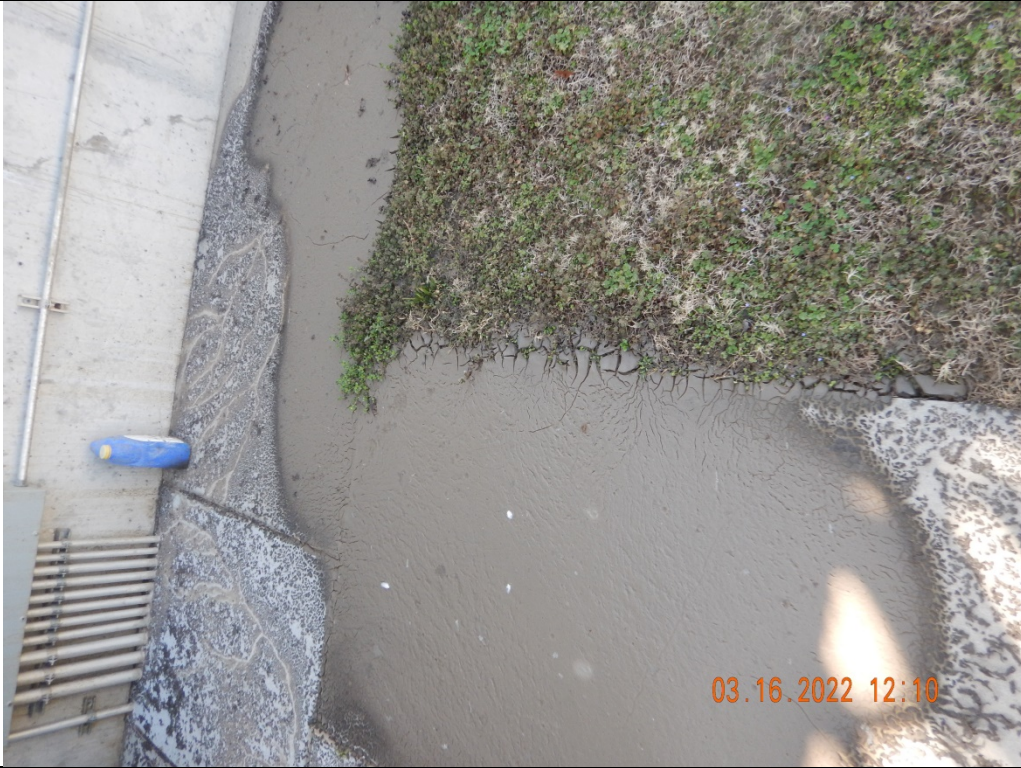
2. Evidence of overflow with wastewater residuals on the ground were noted at the north side of the MBR unit (Photos #12 – #13). Mr. Boston stated he was unaware of this and believed it may have been from maintenance work conducted prior to the inspection. This is an additional violation of Parts III.B.1.A and III.B.3 of the permit. Residuals must be removed and the area remediated.

Photographer:	Garrett Grimes, District 1 Inspector	Date:	3/16/2022	Time:	13:09
Witness:				Photo #:	12
Description:	Residuals on ground on the north side of the MBR unit.

Location:	City of Decatur WWTP		
Photographer:	Garrett Grimes, District 1 Inspector	Date:	3/16/2022
Time:	13:10	Witness:	
Photo #:	13	Description:	Continued from Photo #12.

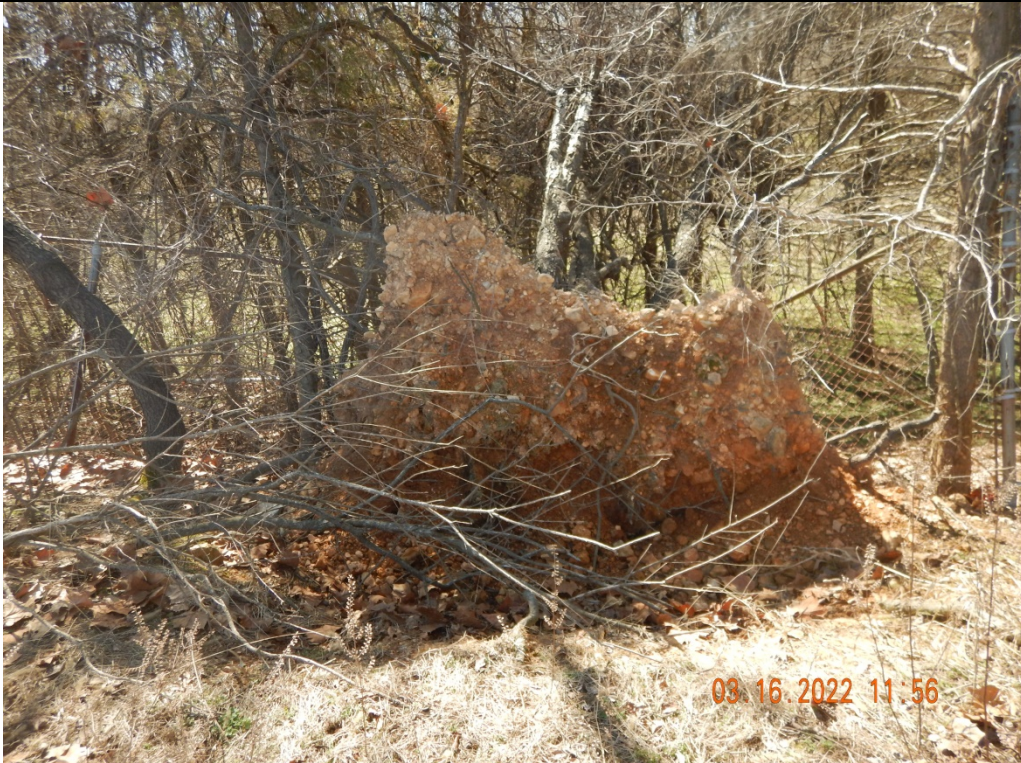
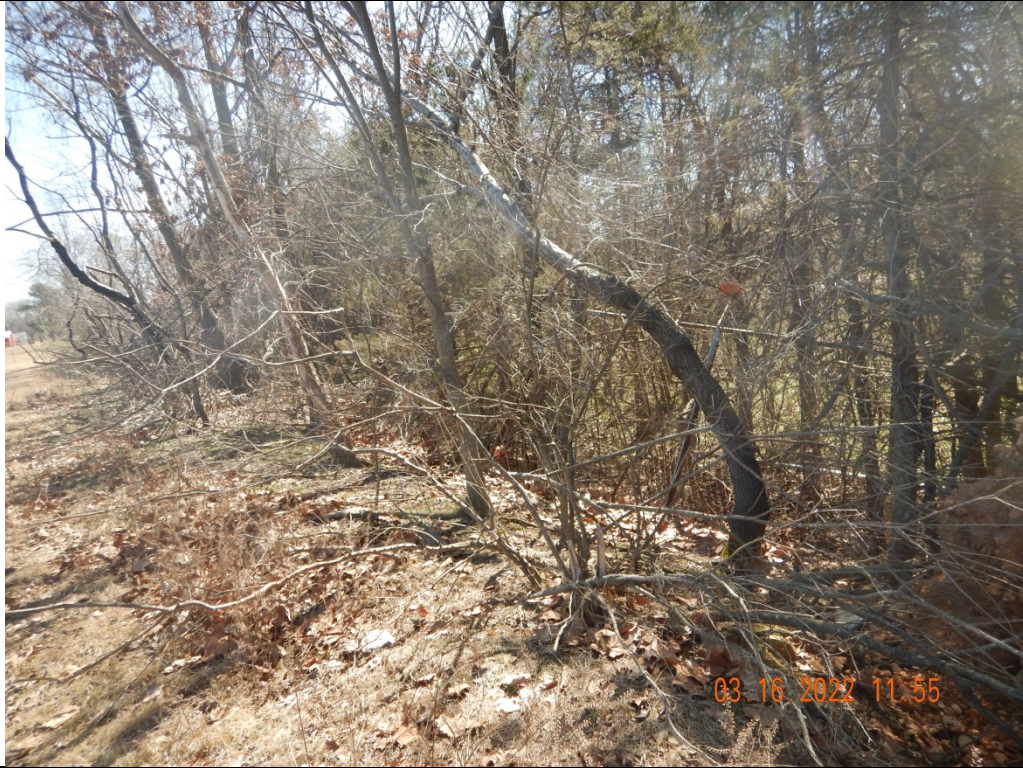
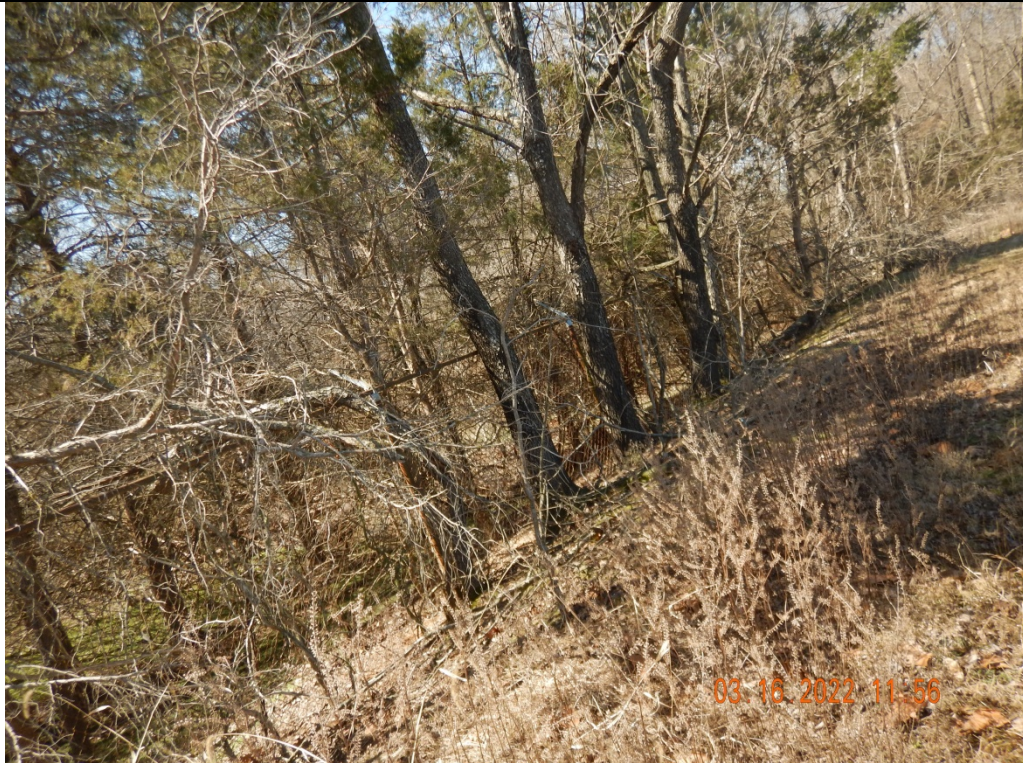
3. This follow-up inspection was conducted in response to a complaint alleging strong odors coming from the treatment plant. Mr. Boston stated he was aware of an instance where strong odors were coming from the equalization basin and believed it to be possibly caused by turnover. The equalization pond was inspected during the facility walkthrough. Strong odor was not present during this inspection, but concerns were raised of a damaged berm on the west side of the pond caused by a downed tree (Photo #14). In addition to this downed tree, large woody vegetation (trees) were observed growing along the berm slope facing away from the pond (Photos #14 – #16). Sloped areas within the pond were not stabilized at the time of the inspection (Photos #17 – #19). The City of Decatur has previously removed excessive vegetation within the pond as a result of observations from prior inspections. Damages to the structure of the pond must be repaired. This is a violation of Part III.B.1.A of the permit. Furthermore, the City of Decatur should come up with a management plan to address potentially damaging vegetation as well as stabilization following the guidelines for the wastewater treatment ponds noted in Chapter 93 of the Recommended Standards for Wastewater Treatment Facilities (10 States Standards).

Photographer:	Garrett Grimes, District 1 Inspector	Date:	3/16/2022
Time:	12:56	Witness:	
Photo #:	14	Description:	Downed tree on the south berm of the equalization pond.

Location:	City of Decatur WWTP		
Photographer:	Garrett Grimes, District 1 Inspector	Date:	3/16/2022
Time:	12:55	Witness:	
Photo #:	15	Description:	Continued from Photo #14 facing south east showing large woody vegetation.

Photographer:	Garrett Grimes, District 1 Inspector	Date:	3/16/2022
Time:	12:56	Witness:	
Photo #:	16	Description:	Continued from Photo #14 facing north west showing large woody vegetation.

Report Item 3: Your response states that vegetation has been removed from the EQ pond bank and completed work in the area noted in the report. The photograph shows bare earth along the outward side of the berm and inward slopes. Please state if the city will stabilize the bare areas with grass or other short rooted vegetation. Please state when this will occur.

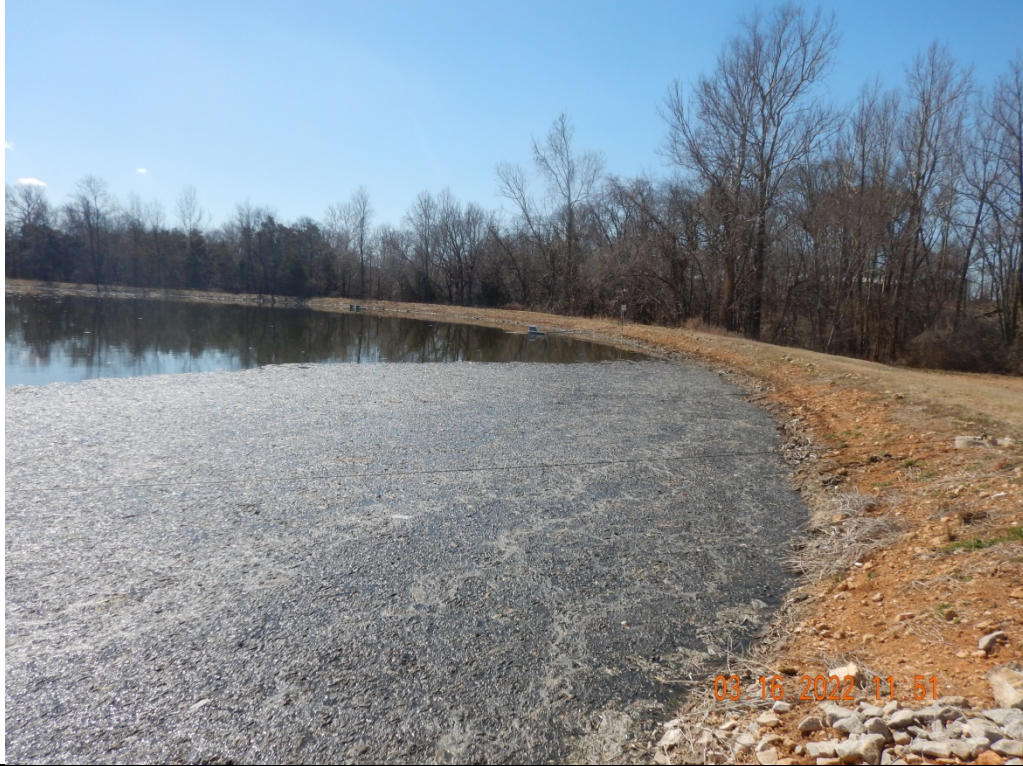
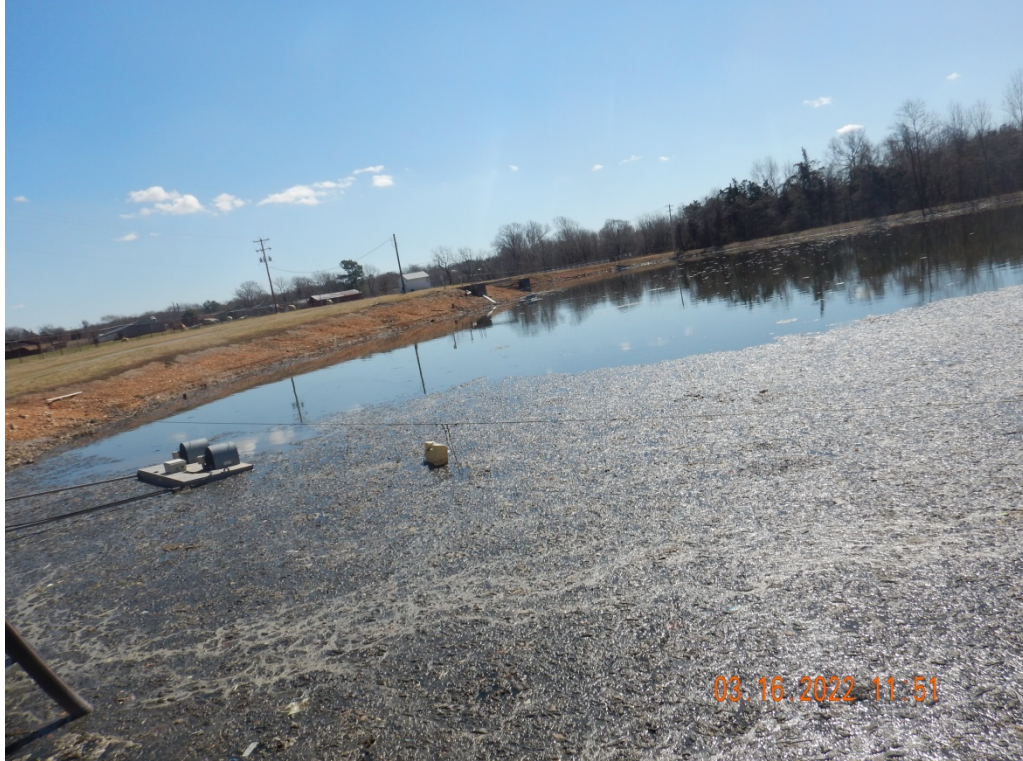
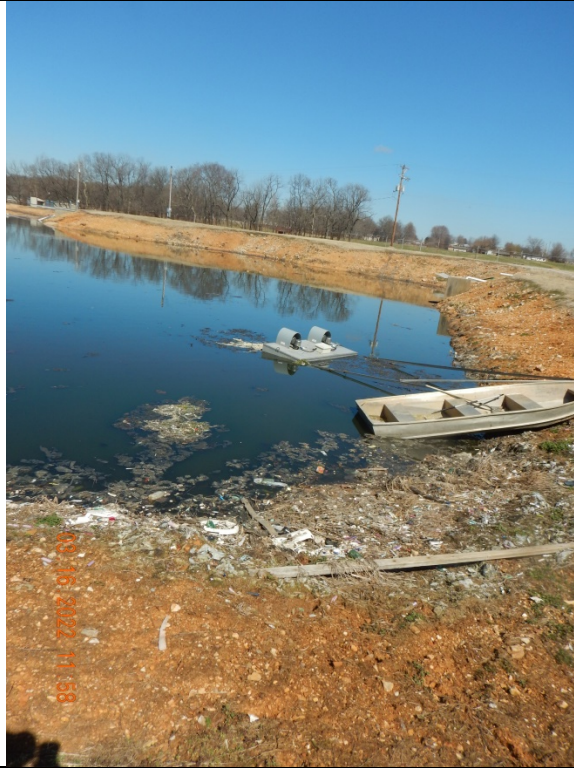
Location:	City of Decatur WWTP		
Photographer:	Garrett Grimes, District 1 Inspector	Date:	3/16/2022
Time:	12:51		
Witness:		Photo #:	17
Description:	Equalization pond showing bare interior slopes.

Photographer:	Garrett Grimes, District 1 Inspector	Date:	3/16/2022
Time:	12:51		
Witness:		Photo #:	18
Description:	Continued from Photo #17.

Location:	City of Decatur WWTP				
Photographer:	Garrett Grimes, District 1 Inspector	Date:	3/16/2022	Time:	12:58
Witness:				Photo #:	19
Description:	Continued from Photo #17.
