RE: Inspection conducted on November 8, 2022
AFIN 60-01071
Permit Number 0266-S1

**Office of Land Resources
Regulated Waste Operations
Class 1 Landfill Inspection Form**

Site Name	City of Little Rock Class 1 Landfill	County	Pulaski	AFIN	60-01071
Facility Address	10803 Ironton Cutoff, Little Rock, AR 72206	Phone #	501-888-74493	Permit #	0266-S1
Permittee Address	10803 Ironton Cutoff, Little Rock, AR 72206	Email Address	ncharles@littlerock.gov	PDS #	123664
Date	11/8/2022	Entry Time	1040	Exit Time	1220

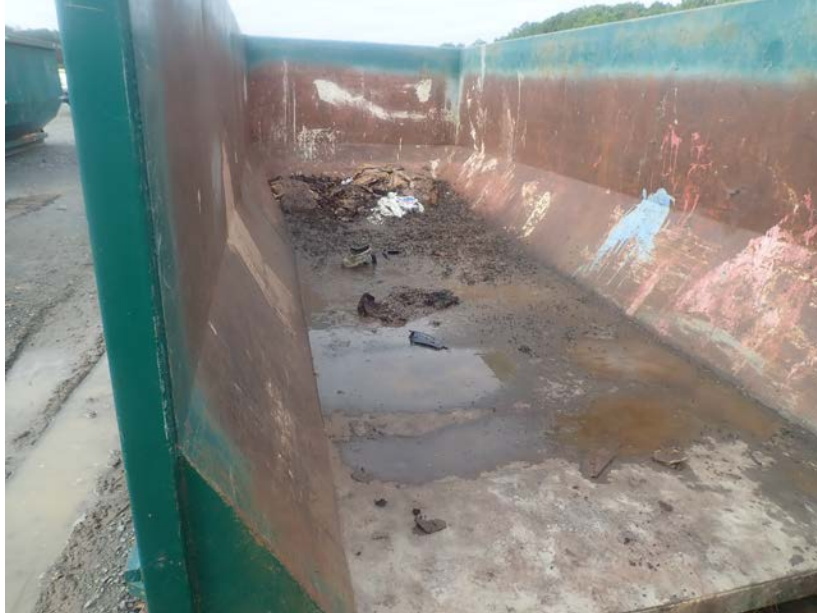
Regulation	Item Description	Comments
X	413(a)	Satisfactory Daily Cover	Solid waste observed stored outdoors in the undefined roll-off storage area was not incorporated into the working face and covered by the end of the work day. (Refer to Photos #1 - #3.) This also is a violation of Rule 22.411(d).
	419(a)(5)	Cause Discharge/Leachate Leaving Landfill	
	411(f)(3)	Depositing Waste in Standing Water Prohibited	
X	411(o)	Erosion or Other Cover Defects Resulting in Exposed Refuse	Erosion with exposed waste was observed on the west slope of Cell 5E. (Refer to Photos #7 - #9.)
	309(c)	Overfill/Off Lined Area

Location	City of Little Rock Class 1			Permit	0266-S1	AFIN	60-01071
Photographer	Kim Davenport, Inspector	<i>KD</i>		Witness	N/A		
Photo #	1	Of	12	Date	11/8/2022	Time	1048
Description	A roll-off container was observed with putrescible waste (as evidenced by presence of vectors) and water. A strong odor was present.

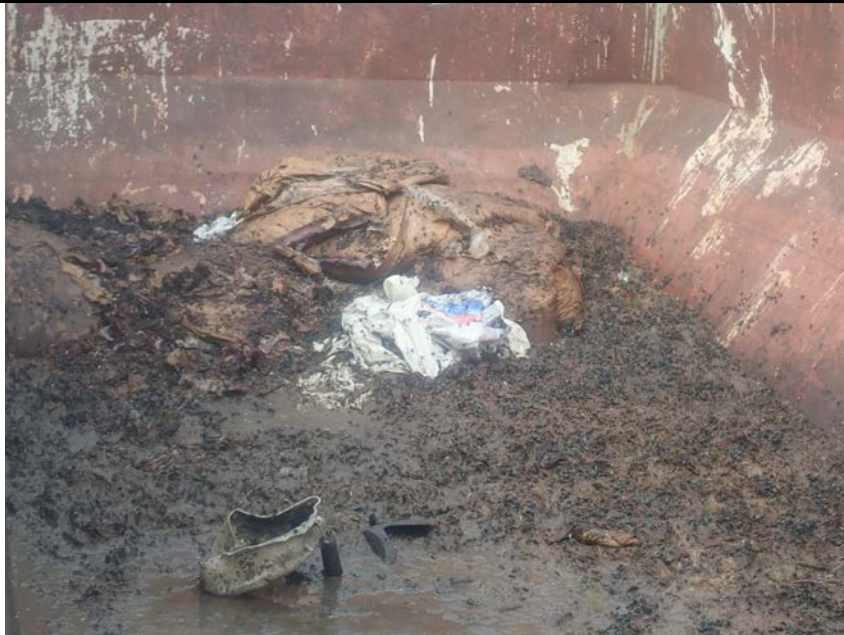
Location	City of Little Rock Class 1			Permit	0266-S1	AFIN	60-01071
Photographer	Kim Davenport, Inspector	<i>KD</i>		Witness	N/A		
Photo #	2	Of	12	Date	11/8/2022	Time	1049
Description	A closer view of the solid waste having an odor and attracting vectors (black dots).

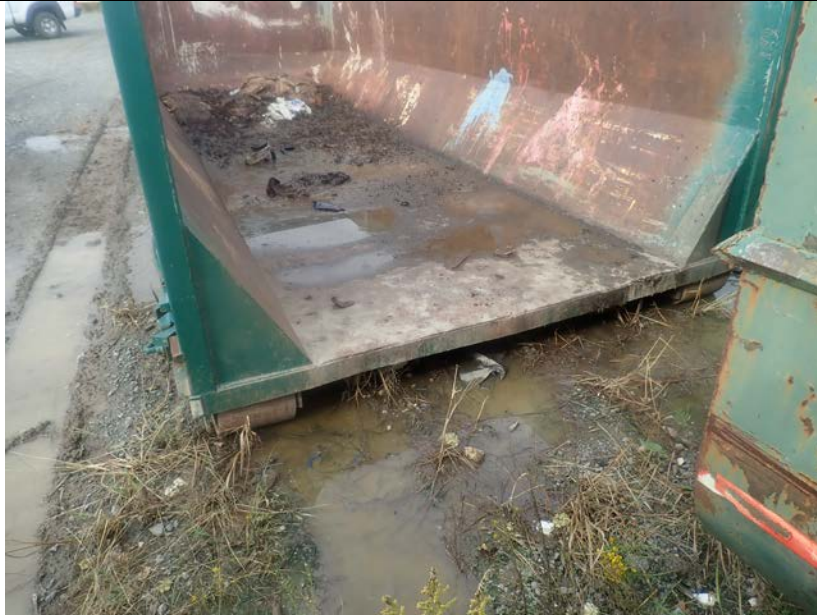
Location	City of Little Rock Class 1			Permit	0266-S1	AFIN	60-01071
Photographer	Kim Davenport, Inspector	<i>KD</i>		Witness	N/A		
Photo #	3	Of	12	Date	11/8/2022	Time	1049
Description	Run-off from the container was observed.

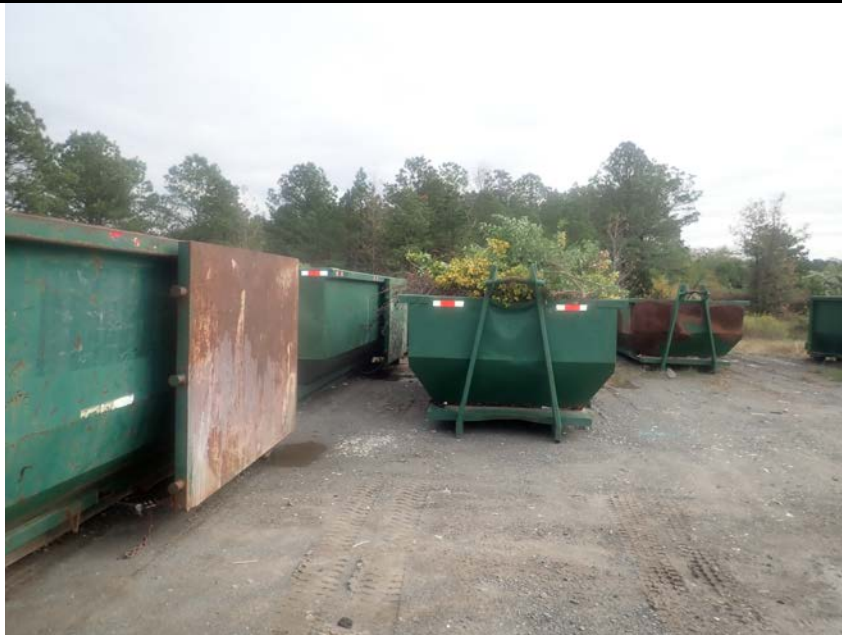
Regulation	Item Description	Comments
X	411(a)	Operations in Accordance with Permit Documents	A multi-use area was observed used for storage of uncovered roll-off containers containing putrescible waste and yard waste. Odor, vectors, and run-off were observed in this area. This storage area is not defined on any site map (Class 1, Class 4, or Compost Yard). (Refer to Photos #1 - #4.)
	411(c)	Smallest Practical Area, Unloading Supervised, Single Working Face	
	411(b)	Operations by Licensed On-site Personnel at All Times	
X	411(g)	Litter Control Provisions Maintained	Litter was observed along the west side of the landfill access road, the north end of the active area, and the stormwater collection area had no controls in place. (Refer to Photos #5 - #10.)
	427	Surface Water Controls	
	411(h)(1)	Contouring Prevents Surface Water Flowing Into or Through Waste	
	418(a)(b)	Run-on/off Control System Present and Adequate

Location	City of Little Rock Class 1			Permit	0266-S1	AFIN	60-01071
Photographer	Kim Davenport, Inspector	<i>KD</i>		Witness	N/A		
Photo #	4	Of	12	Date	11/8/2022	Time	1050
Description	Yard waste was observed stored in roll-offs and not incorporated with waste at any permitted area.

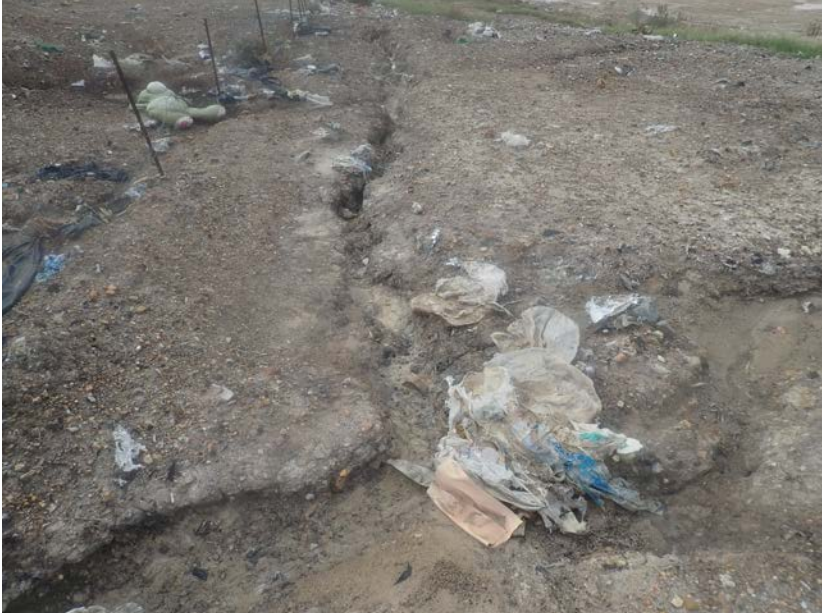
Location	City of Little Rock Class 1			Permit	0266-S1	AFIN	60-01071
Photographer	Kim Davenport, Inspector	<i>KD</i>		Witness	N/A		
Photo #	7	Of	12	Date	11/8/2022	Time	1125
Description	Litter and erosion were observed on the west slope of Cell 5E.

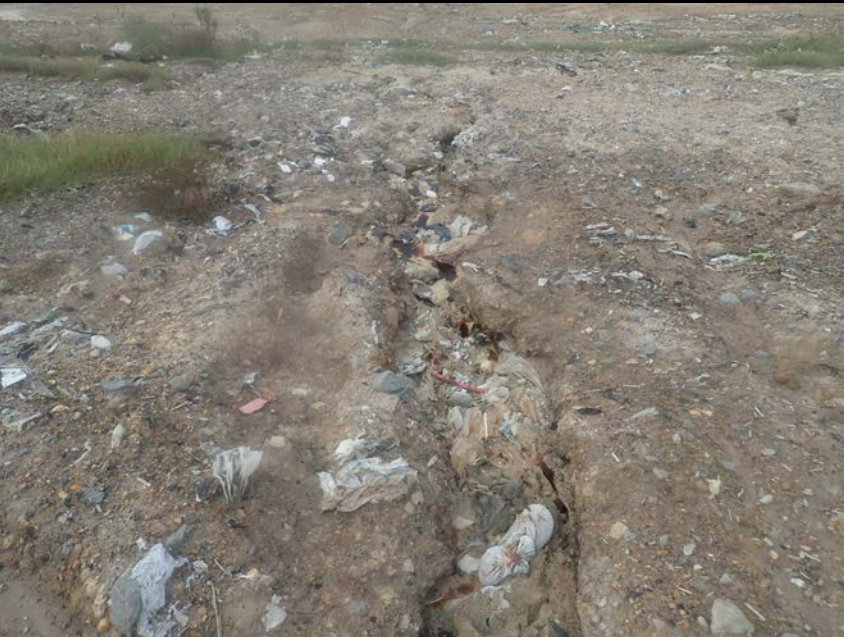
Location	City of Little Rock Class 1			Permit	0266-S1	AFIN	60-01071
Photographer	Kim Davenport, Inspector	<i>KD</i>		Witness	N/A		
Photo #	8	Of	12	Date	11/8/2022	Time	1126
Description	Erosion with exposed waste was observed on the west slope of Cell 5E.

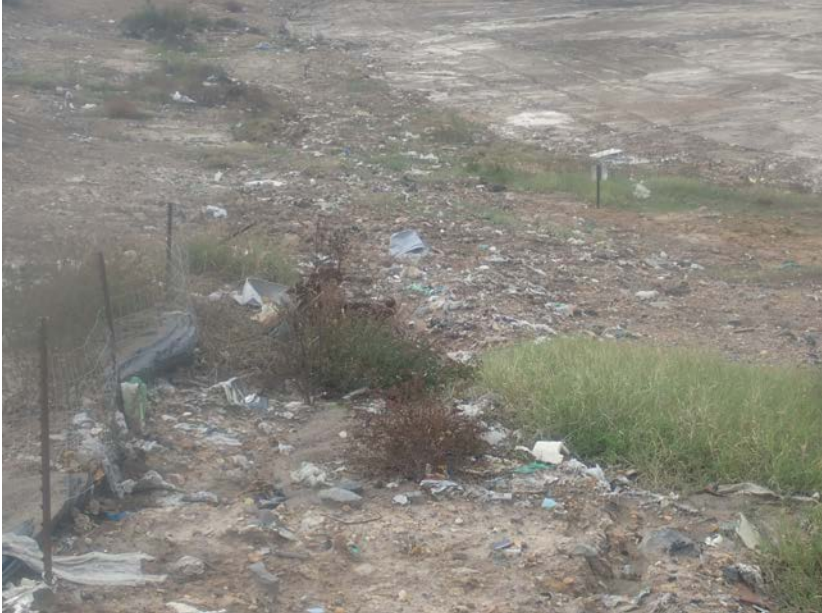
Location	City of Little Rock Class 1			Permit	0266-S1	AFIN	60-01071
Photographer	Kim Davenport, Inspector	<i>KD</i>		Witness	N/A		
Photo #	9	Of	12	Date	11/8/2022	Time	1126
Description	Litter was observed on the northern end of the active cell at the toe of the western slope of Cell 5E.

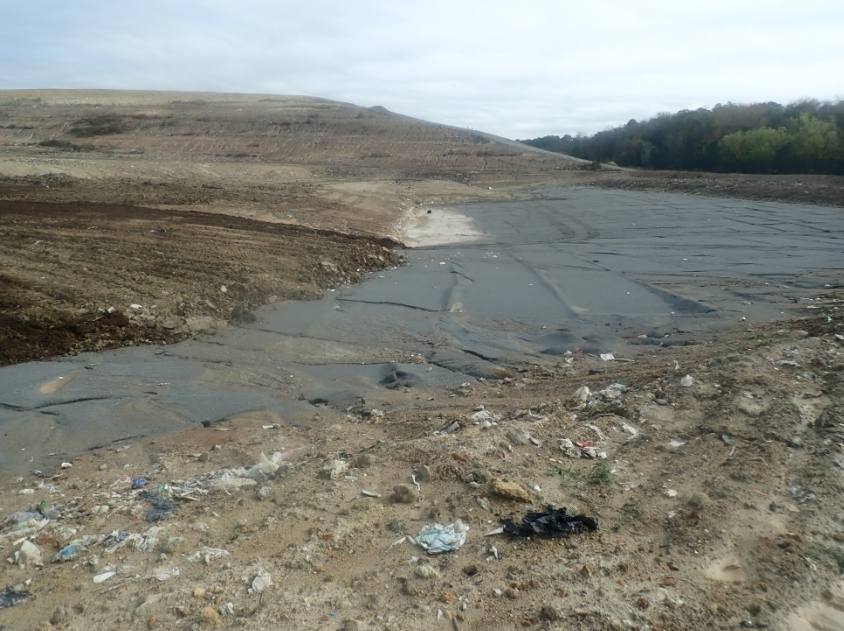
Location	City of Little Rock Class 1			Permit	0266-S1	AFIN	60-01071
Photographer	Kim Davenport, Inspector	<i>KD</i>		Witness	N/A		
Photo #	10	Of	12	Date	11/8/2022	Time	1206
Description	Litter was observed on the outer perimeter of the active cell, looking east.

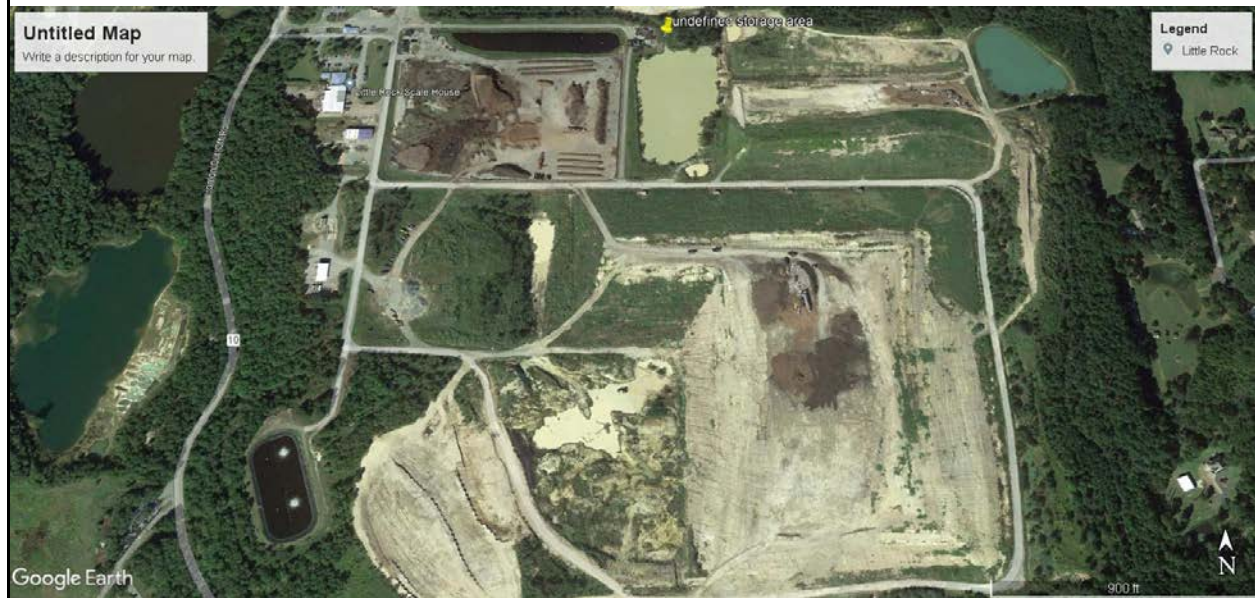
Location	City of Little Rock Class 1	Permit	0266-S1	AFIN	60-01071
Photographer	Kim Davenport, Inspector	<i>KD</i>	Witness	N/A	
Photo #	11	Of	12	Date	11/8/2022
Description	Google Earth image showing location of multi-use area.

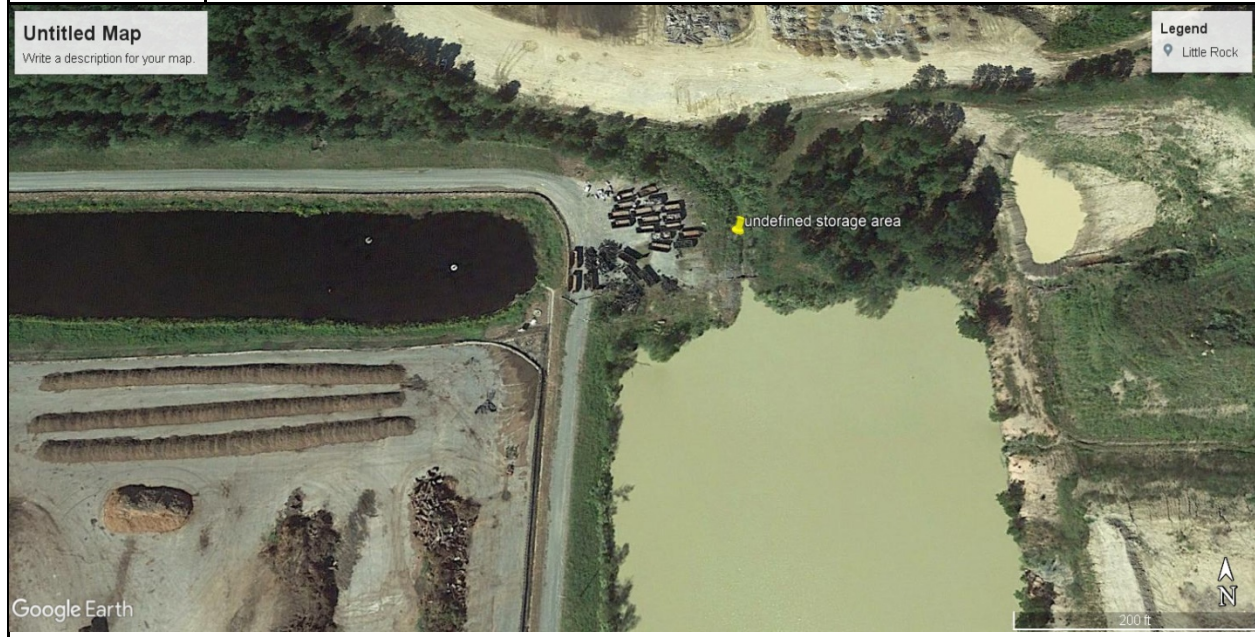
Location	City of Little Rock Class 1	Permit	0266-S1	AFIN	60-01071
Photographer	Kim Davenport, Inspector	<i>KD</i>	Witness	N/A	
Photo #	12	Of	12	Date	11/8/2022
Description	Google Earth image showing zoomed in location of multi-use area shown in Photo #11.
