RE: Inspection conducted on November 28, 2022
AFIN 03-00051
Permit Number 0249-S1-R2

**Office of Land Resources
Regulated Waste Operations
Class 1 Landfill Inspection Form**

| Site Name | NABORS Landfill | County | Baxter | AFIN | 03-00051 |

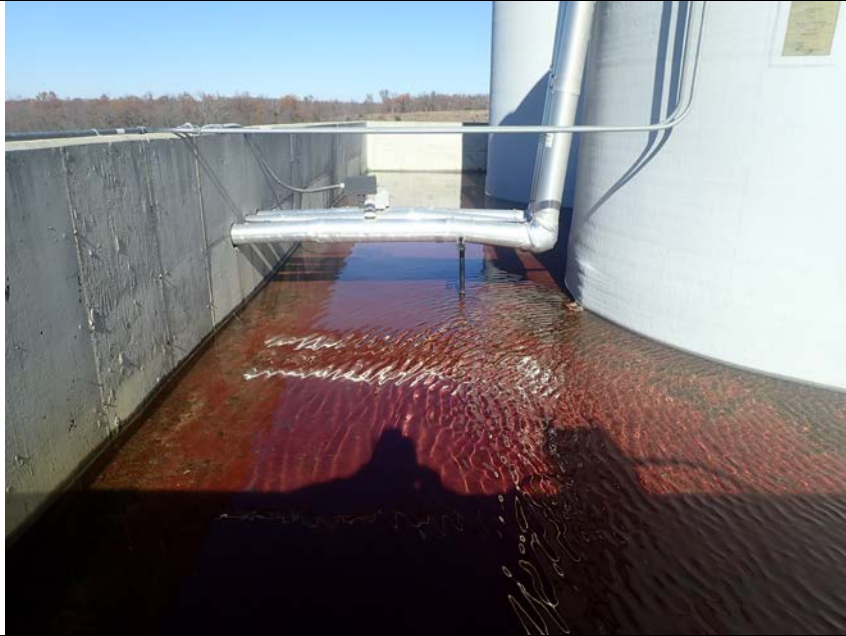
| Photo # | 1 | Of | 6 | Date | 11/28/2022 | Time | 1148 |

| Description | Secondary containment at tank farm observed. | | | | | | |

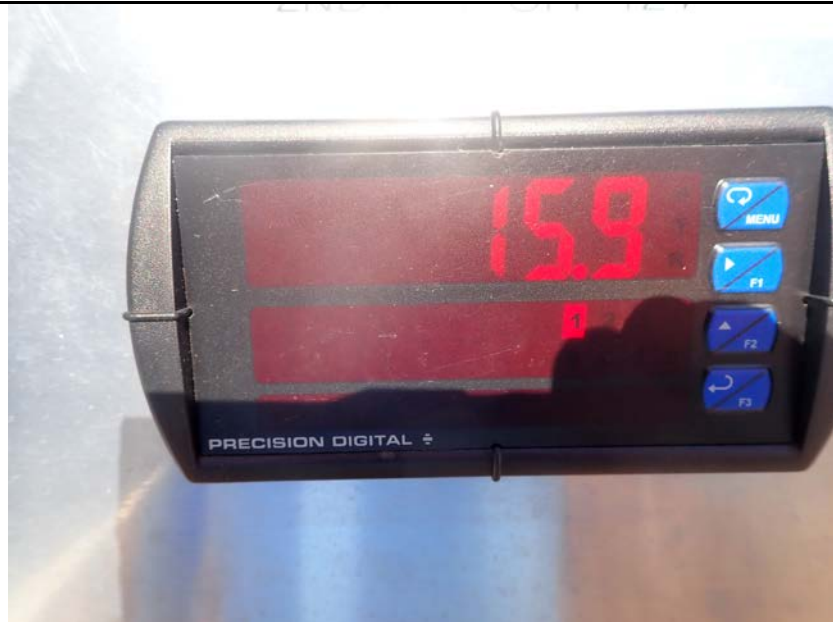
| Photo # | 2 | Of | 6 | Date | 11/28/2022 | Time | 1148 |

| Description | Leachate level observed at tank farm. | | | | | | |

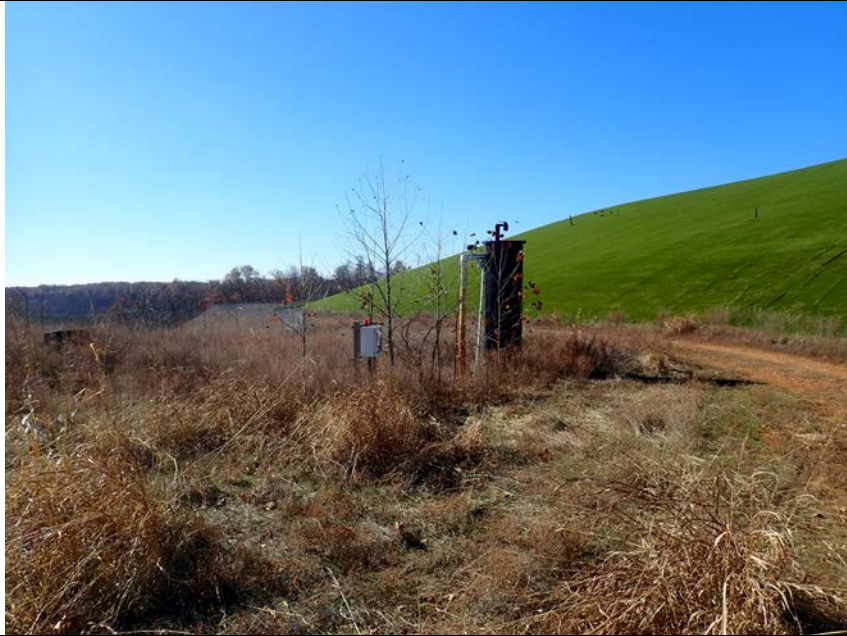
| Photo # | 5 | Of | 6 | Date | 11/28/2022 | Time | 1204 |

| Regulation | Item Description | Comments |
|---|--|--|
| X | 411(i) Adequate Maintenance of Intermediate/Final Cover Vegetation | Turf roll and damage observed in multiple areas. Woody vegetation observed in final cover system near LCS 6 (Refer to Photos #4-#6.) |
| X | 417(c) Access and Operational Roads | Road erosion present between LCS-4 and LCS-5. Vegetative control needed along roads and around LCS 3. (Refer to Photo #5.) |

| Description | Woody vegetation observed near LCS 3. | | | | | | |

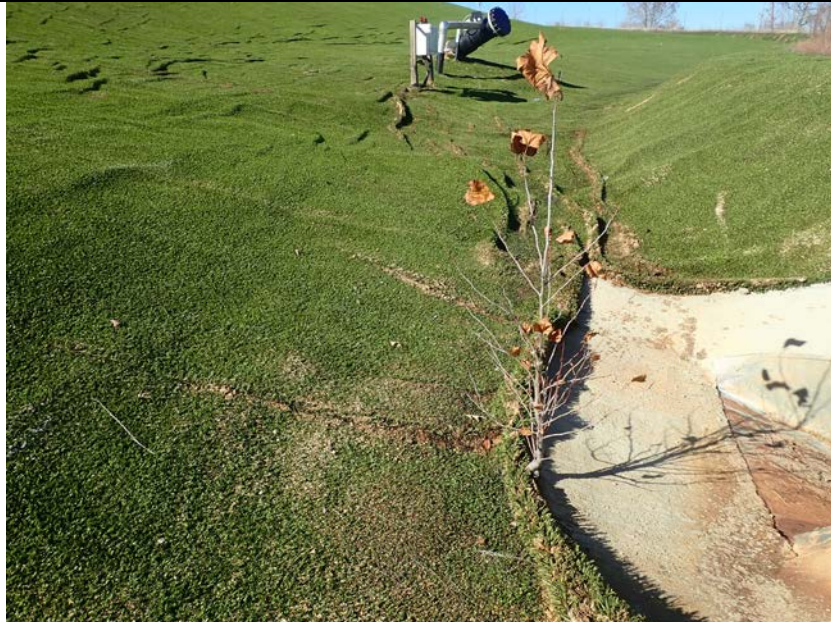
| Photo # | 6 | Of | 6 | Date | 11/28/2022 | Time | 1232 |

| Description | Woody vegetation and turf roll observed near LCS 6. | | | | | | |
