## ARKANSAS ENERGY & ENVIRONMENT

**RE: Inspection conducted on February 13, 2023**  
**AFIN 16-00199**  
**Permit Number 0254-S1-R4**

**Office of Land Resources  
Regulated Waste Operations  
Class 1 Landfill Inspection Form**

| <b>Site Name</b> | Craighead County SWDA Class 1 | <b>County</b> | Craighead | <b>AFIN</b> | 16-00199 |

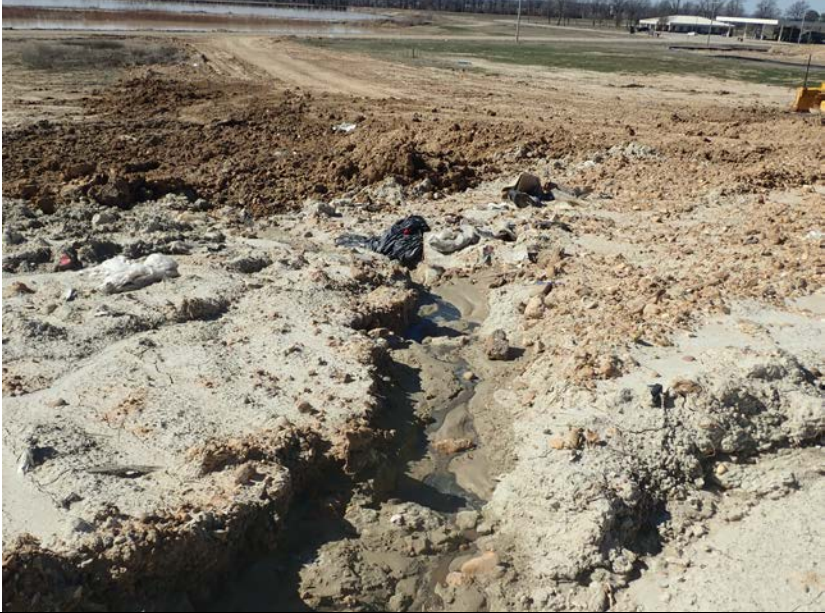
| <b>Photo #</b> | 1 | <b>Of</b> | 4 | | <b>Date</b> | 2/13/2023 | <b>Time</b> | 1319 |

| | <b>Regulation</b> | <b>Item Description</b> | <b>Comments</b> |
|---|---|---|---|
| X | 411(o) | Leachate Leaks or Evidence of Leachate Seepage | Leachate leaks observed on the east and west slopes of the landfill. (Refer to Photos #1 & #4.) |

| <b>Description</b> | Leachate leaks observed on the west slope of the landfill. | | | | | | | |

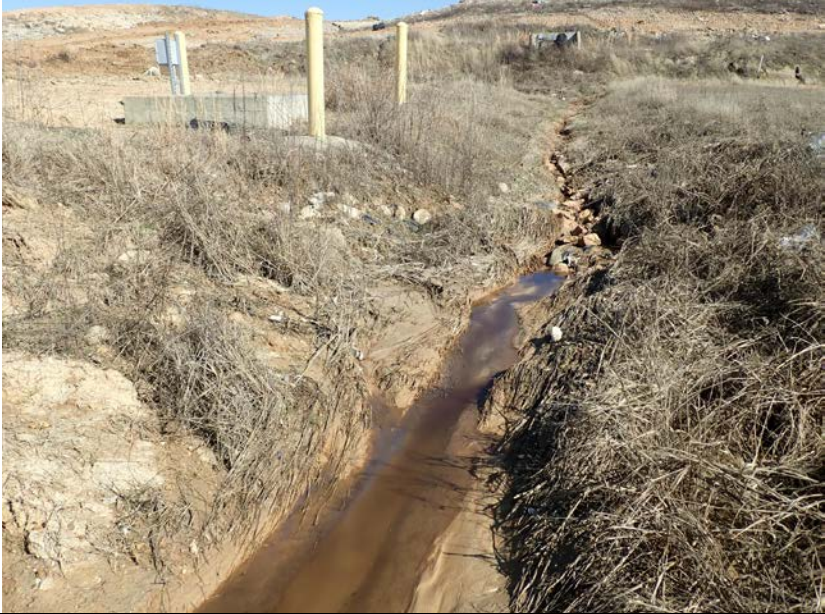
| <b>Photo #</b> | 2 | <b>Of</b> | 4 | | <b>Date</b> | 2/13/2023 | <b>Time</b> | 1326 |

| | <b>Regulation</b> | <b>Item Description</b> | <b>Comments</b> |
|---|---|---|---|
| X | 419(a)(5) | Cause Discharge/Leachate Leaving Landfill | Leachate leaving the landfill observed on the west side of the landfill. (Refer to Photo #2.) |

| <b>Description</b> | Leachate leaving the landfill observed on the west side of the landfill. | | | | | | | |

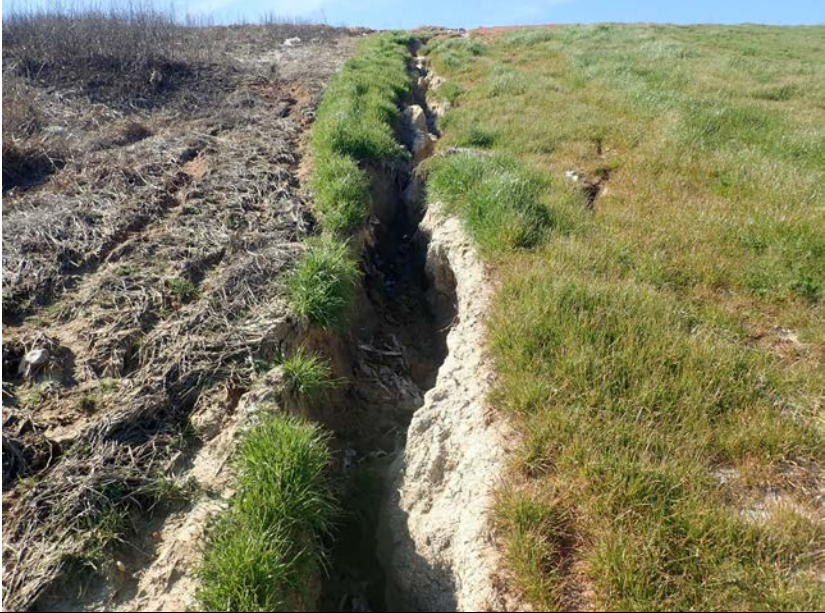
| <b>Photo #</b> | 3 | <b>Of</b> | 4 | | <b>Date</b> | 2/13/2023 | <b>Time</b> | 1337 |

| | <b>Regulation</b> | <b>Item Description</b> | <b>Comments</b> |
|---|---|---|---|
| X | 411(o) | Erosion or Other Cover Defects Resulting in Exposed Refuse | Erosion with exposed waste observed on the east slope of the landfill. (Refer to Photo #3.) |

| <b>Description</b> | Erosion with exposed waste observed on the east slope of the landfill. | | | | | | | |

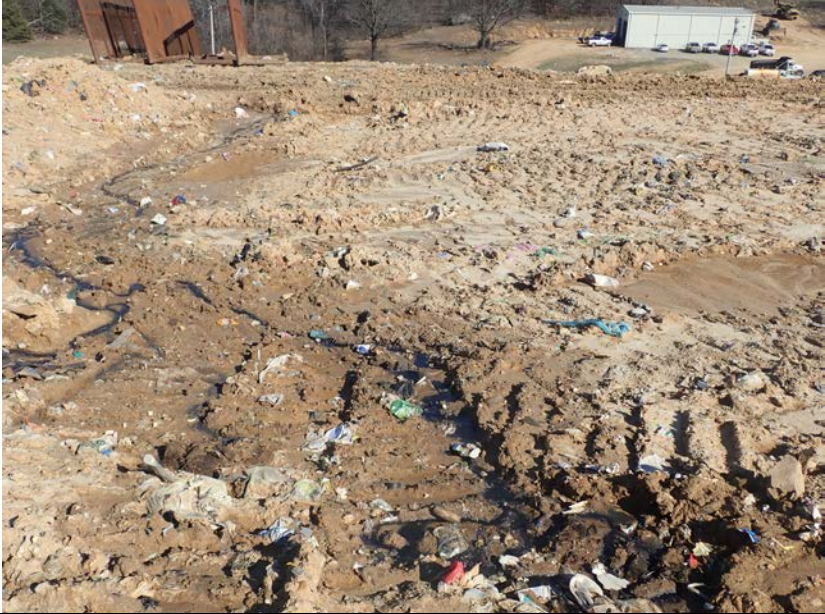
| <b>Photo #</b> | 4 | <b>Of</b> | 4 | | <b>Date</b> | 2/13/2023 | <b>Time</b> | 1406 |

| <b>Description</b> | Leachate leaks observed on the east side of the landfill. | | | | | | | |
