RE: Inspection conducted on February 15, 2023
AFIN 60-01071
Permit Number 0266-S1

**Office of Land Resources
Regulated Waste Operations
Class 1 Landfill Inspection Form**

| Site Name | City of Little Rock Class 1 Landfill | County | Pulaski | AFIN | 60-01071 |

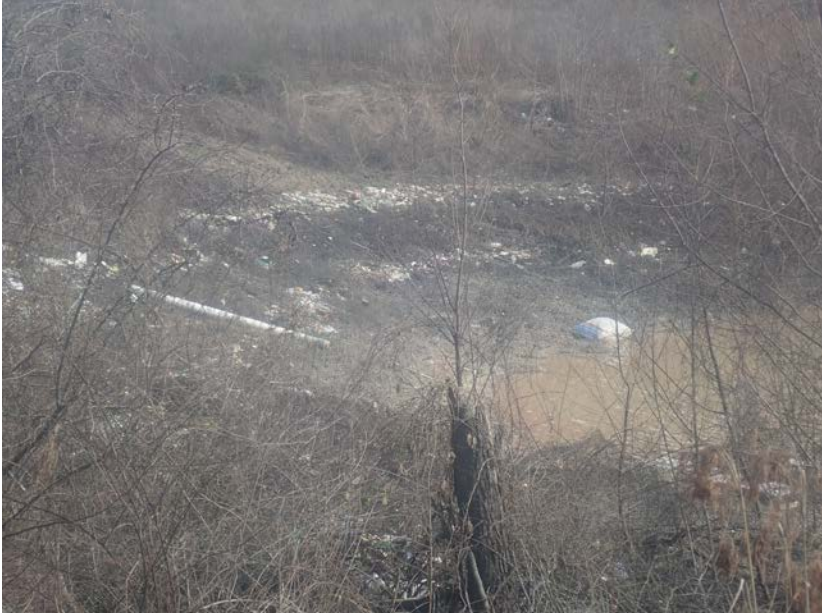
| Photo # | 3 | Of | 6 | Date | 2/15/2023 | Time | 1335 |

| | Regulation | Item Description | Comments |
|---|---|--|---|
| X | 411(g) | Litter Control Provisions Maintained | Litter was observed surrounding the unlined stormwater collection area, located between Cell 2 and unconstructed Cell 3, with no controls in place. (Refer to Photos # 2 & #3.) |

| Description | Litter was observed at the north end of the unlined stormwater collection area. | | | | | | |

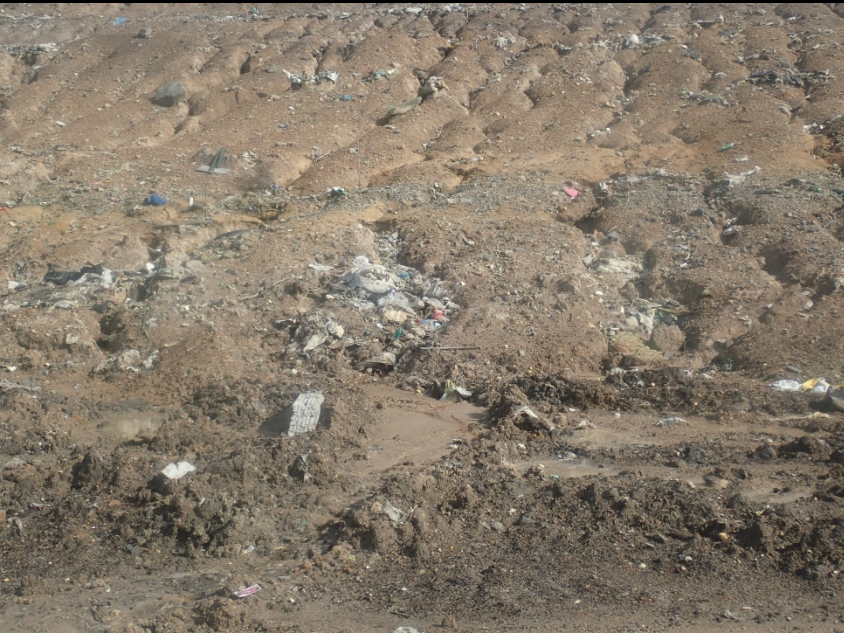
| Photo # | 4 | Of | 6 | Date | 2/15/2023 | Time | 1416 |

| | Regulation | Item Description | Comments |
|---|---|--|--|
| X | 411(o) | Erosion or Other Cover Defects Resulting in Exposed Refuse | Erosion with exposed waste was observed on the west slope of Cell 5E. (Refer to Photo #4.) Cover defects resulting in exposed waste were observed across the southern active area of Cell 5W. (Refer to Photos #5 & #6.) |

| Description | Erosion with exposed waste observed on the west slope of Cell 5E. | | | | | | |

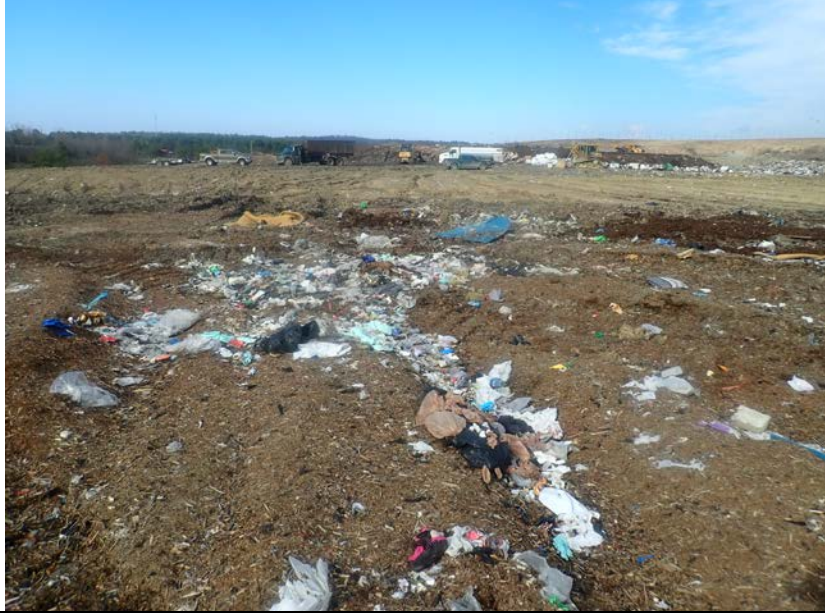
| Photo # | 5 | Of | 6 | Date | 2/15/2023 |

| Description | An example is provided of the cover defects observed on the south end of Cell 5E, looking north. | | | | |

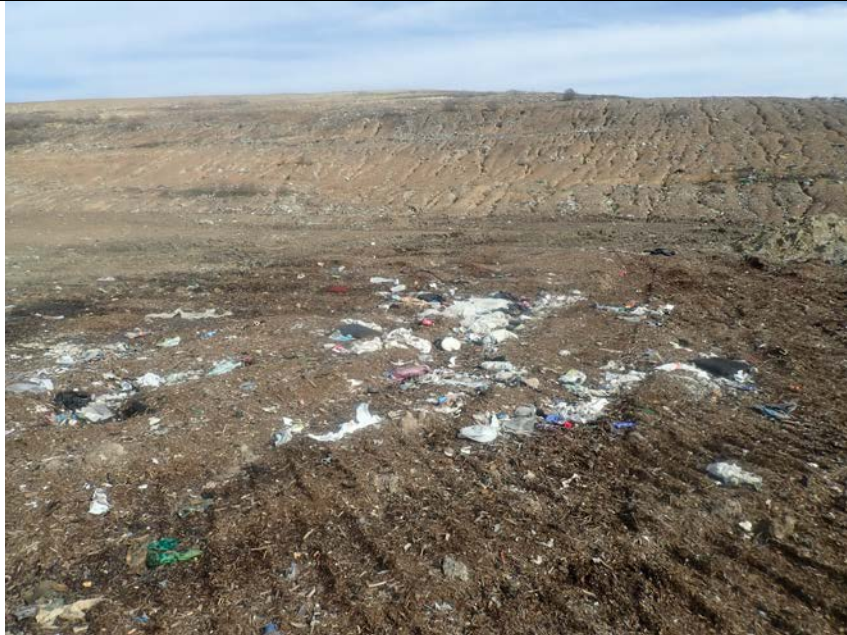
| Photo # | 6 | Of | 6 | Date | 2/15/2023 |

| Description | An example is provided of the cover defects observed on the south end of Cell 5, looking east. | | | | |
