RE: Q1 Follow-up #5 conducted on March 13, 2023
AFIN 72-00144
Permit Number 0290-S1-R3

**Office of Land Resources
Regulated Waste Operations
Class 1 Landfill Inspection Form**

Site Name	Eco-Vista Class 1 Landfill	County	Washington	AFIN	72-00144
Facility Address	2210 Waste Management Drive, Springdale, AR 72762	Phone #	870-510-0174	Permit #	0290-S1-R3
Permittee Address	2210 Waste Management Drive, Springdale, AR 72762	Email Address	bsmall@wm.com	PDS #	125009
Date	03/13/2023	Entry Time	0437	Exit Time	0918

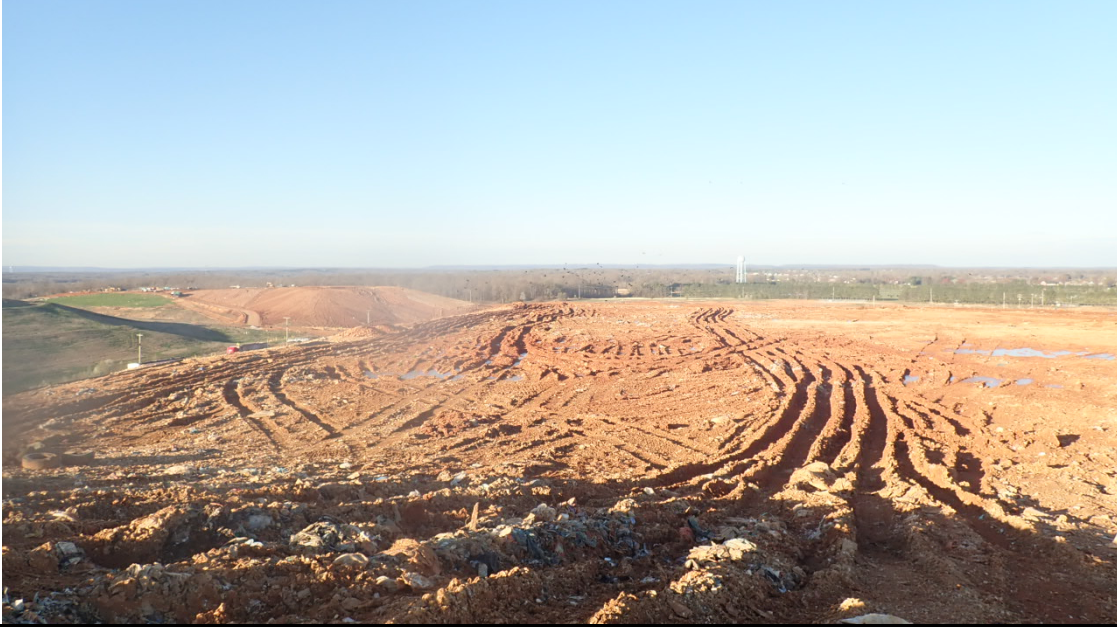
Regulation	Item Description	Comments
413(a)	Satisfactory Daily Cover	
419(a)(5)	Cause Discharge/Leachate Leaving Landfill	
411(f)(3)	Depositing Waste in Standing Water Prohibited	
X 411(o)	Erosion or Other Cover Defects Resulting in Exposed Refuse	Depressions and exposed waste caused by a truck used for hauling cover material were observed in the daily cover across the tops of Cells 10 & 11. (Refer to Photos #1 & #2.)
309(c)	Overfill/Off Lined Area

Location	Eco-Vista Class 1 Landfill				Permit	0290-S1-R3	AFIN	72-00144
Photographer	Jason Gilkey, Inspector			JEG	Witness	N/A		
Photo #	1	Of	2		Date	03/13/23	Time	0821
Description	Depressions and exposed waste caused by a truck used for hauling cover material were observed in the daily cover across the tops of Cells 10 & 11.

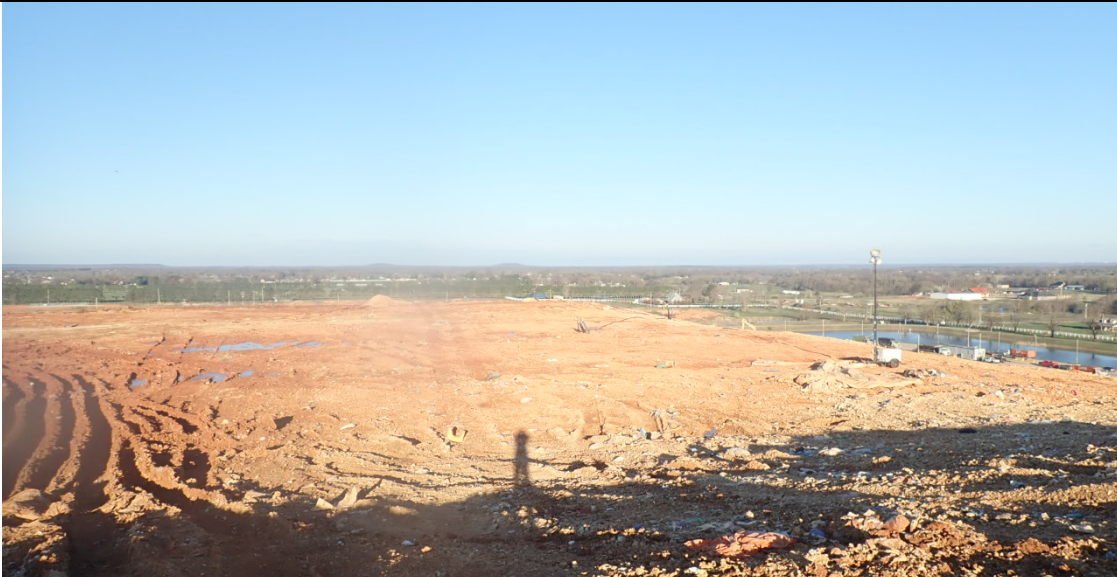
Location	Eco-Vista Class 1 Landfill				Permit	0290-S1-R3	AFIN	72-00144
Photographer	Jason Gilkey, Inspector			JEG	Witness	N/A		
Photo #	2	Of	2		Date	03/13/23	Time	0821
Description	Depressions and exposed waste caused by a truck used for hauling cover material were observed in the daily cover across the tops of Cells 10 & 11.
