ARKANSAS ENERGY & ENVIRONMENT

RE: Q1 Follow-up #7 conducted on March 15, 2023
AFIN 72-00144
Permit Number 0290-S1-R3

**Office of Land Resources
Regulated Waste Operations
Class 1 Landfill Inspection Form**

Site Name	Eco-Vista Class 1 Landfill	County	Washington	AFIN	72-00144
Facility Address	2210 Waste Management Drive, Springdale, AR 72762	Phone #	870-510-0174	Permit #	0290-S1-R3
Permittee Address	2210 Waste Management Drive, Springdale, AR 72762	Email Address	bsmall@wm.com dtenniso@wm.com	PDS #	125070
Date	03/15/2023	Entry Time	1044	Exit Time	1405

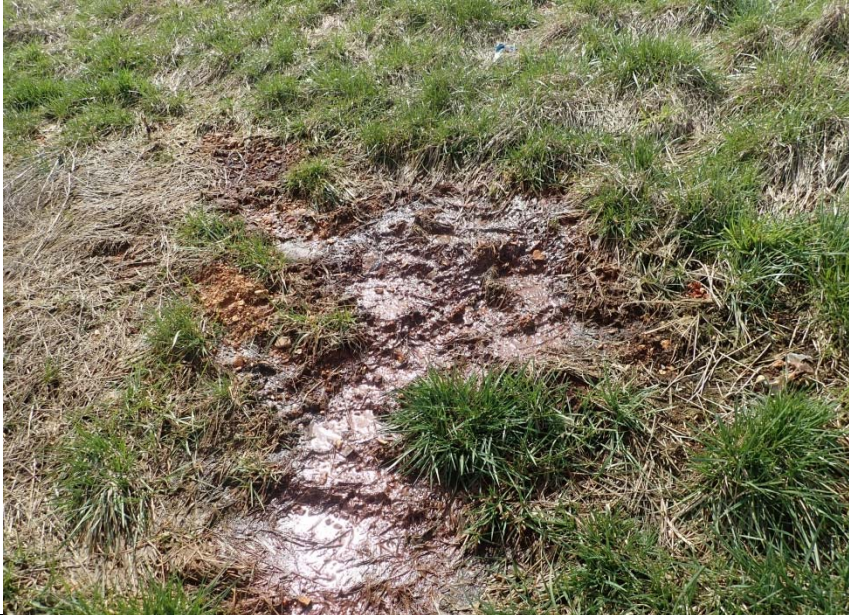
Regulation	Item Description	Comments
	411(a)	Operations in Accordance with Permit Documents	
	411(c)	Smallest Practical Area, Unloading Supervised, Single Working Face	
	411(b)	Operations by Licensed On-site Personnel at All Times	
	411(g)	Litter Control Provisions Maintained	
	427	Surface Water Controls	
	411(h)(1)	Contouring Prevents Surface Water Flowing Into or Through Waste	
	418(a)(b)	Run-on/off Control System Present and Adequate	
	411(h)(2)	Surface Water Control Prevents Off-site Sediment Accumulation	
	411(i)	Adequate Maintenance of Intermediate/Final Cover Vegetation	
	415	Gas Monitoring Program	
X	411(o)	Leachate Leaks or Evidence of Leachate Seepage	Leachate leaks were observed on the east slope of Phase 2 Cell 5 and north slope of Phase 2 Cells 5, 8, 9, & 10. (Refer to Photos #1 - #4.)
	429	Leachate Collection System

Location	Eco-Vista Class 1 Landfill				Permit	0290-S1-R3	AFIN	72-00144
Photographer	Gerry Eddy, Inspector			AE	Witness	Don Tennison, Landfill Manager Ryan Hayden, Inspector Supervisor		
Photo #	1	Of	6		Date	03/15/2023	Time	1259
Description	Leachate observed on the west slope of Phase 2 Cell 5.

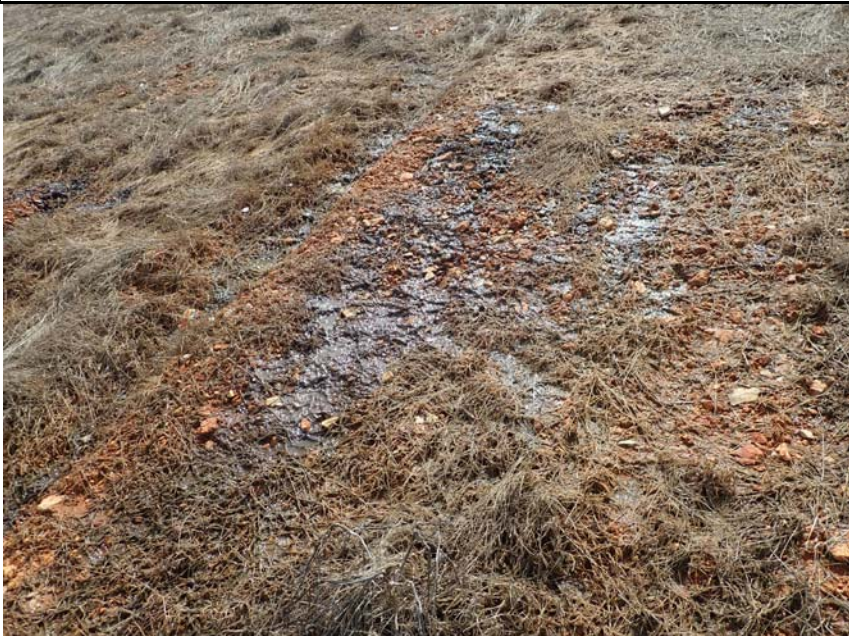
Location	Eco-Vista Class 1 Landfill				Permit	0290-S1-R3	AFIN	72-00144
Photographer	Gerry Eddy, Inspector			AE	Witness	Don Tennison, Landfill Manager Ryan Hayden, Inspector Supervisor		
Photo #	2	Of	6		Date	03/15/2023	Time	1314
Description	Leachate observed on the north slope of Phase 2 Cell 8.

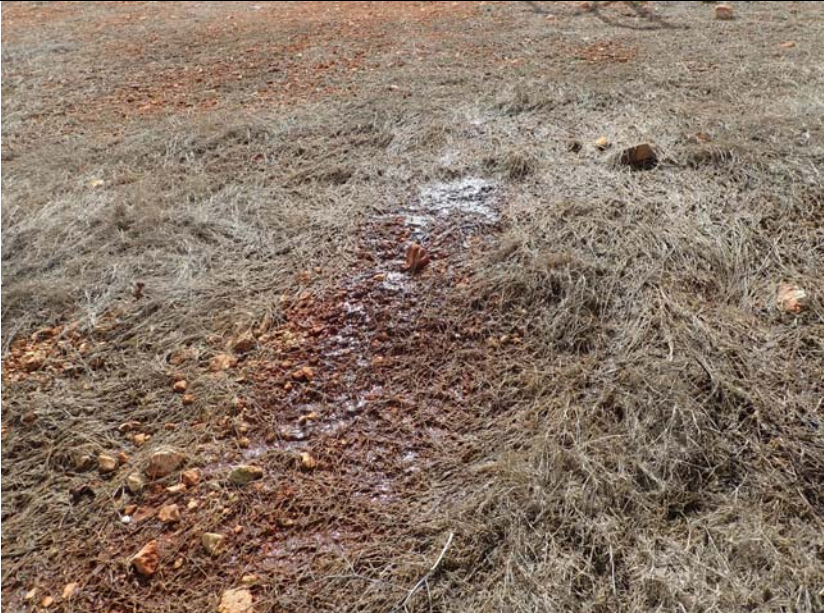
Location	Eco-Vista Class 1 Landfill				Permit	0290-S1-R3	AFIN	72-00144	
Photographer	Gerry Eddy, Inspector		AE		Witness	Don Tennison, Landfill Manager Ryan Hayden, Inspector Supervisor			
Photo #	3	Of	6		Date	03/15/2023	Time	1316	
Description	Leachate observed on the west slope of Phase 2 Cell 9.

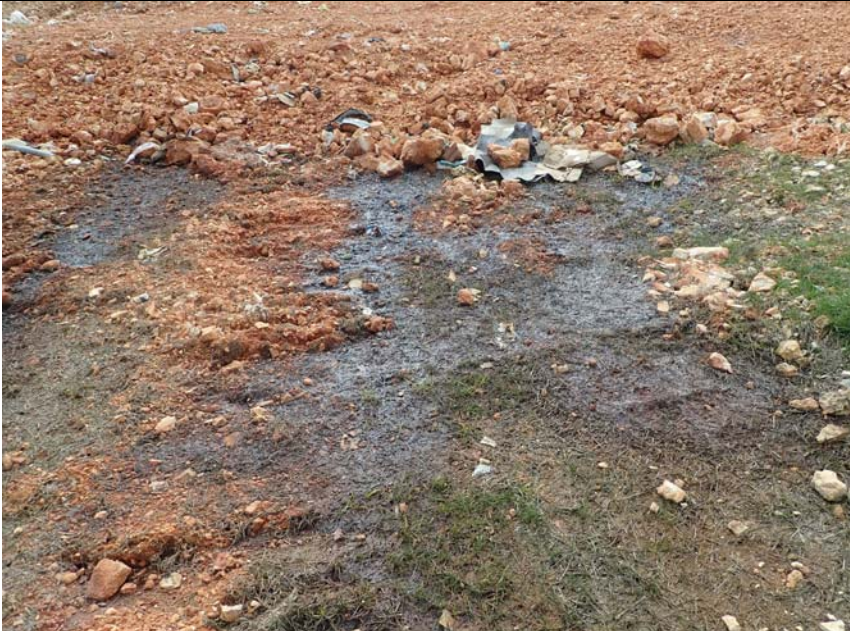
Location	Eco-Vista Class 1 Landfill				Permit	0290-S1-R3	AFIN	72-00144	
Photographer	Gerry Eddy, Inspector		AE		Witness	Don Tennison, Landfill Manager Ryan Hayden, Inspector Supervisor			
Photo #	4	Of	6		Date	03/15/2023	Time	1326	
Description	Leachate observed on the west slope of Phase 2 Cell 10.

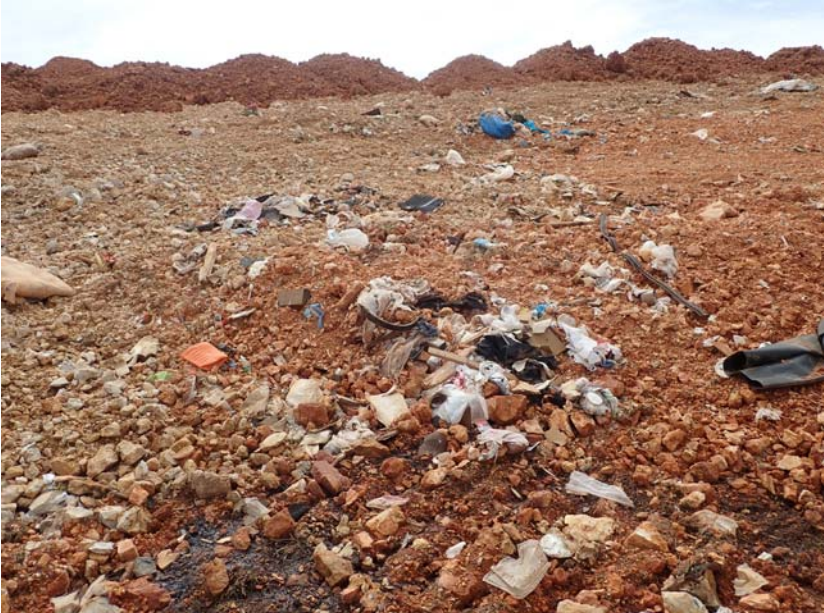
Regulation	Item Description	Comments
	413(a)	Satisfactory Daily Cover	
	419(a)(5)	Cause Discharge/Leachate Leaving Landfill	
	411(f)(3)	Depositing Waste in Standing Water Prohibited	
X	411(o)	Erosion or Other Cover Defects Resulting in Exposed Refuse	Exposed waste was observed on the daily cover across the top of Cells 10 & 11. (Refer to Photos #5 and #6.)

Location	Eco-Vista Class 1 Landfill				Permit	0290-S1-R3	AFIN	72-00144
Photographer	Gerry Eddy, Inspector		AS		Witness	Don Tennison, Landfill Manager Ryan Hayden, Inspector Supervisor		
Photo #	5	Of	6		Date	03/15/2023	Time	1328
Description	Exposed waste observed in the daily cover on top of Phase 2 Cell 10.
