RE: Q1 Follow-up #8 conducted on March 21, 2023
AFIN 72-00144
Permit Number 0290-S1-R3

**Office of Land Resources
Regulated Waste Operations
Class 1 Landfill Inspection Form**

Site Name	Eco-Vista Class 1 Landfill	County	Washington	AFIN	72-00144
Facility Address	2210 Waste Management Drive, Springdale, AR 72762	Phone #	870-510-0174	Permit #	0290-S1-R3
Permittee Address	2210 Waste Management Drive, Springdale, AR 72762	Email Address	bsmall@wm.com	PDS #	125090
Date	03/21/2023	Entry Time	0933	Exit Time	1320

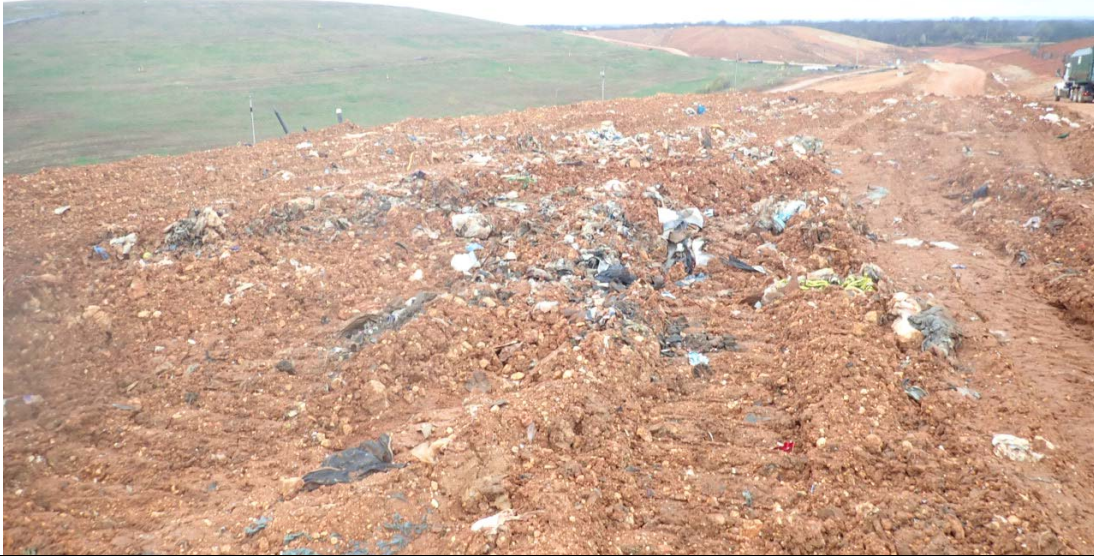
Regulation	Item Description	Comments
	413(a)	Satisfactory Daily Cover	
	419(a)(5)	Cause Discharge/Leachate Leaving Landfill	
	411(f)(3)	Depositing Waste in Standing Water Prohibited	
X	411(o)	Erosion or Other Cover Defects Resulting in Exposed Refuse	Depressions and exposed waste caused by a truck used for hauling cover material were observed in the daily cover across the tops of Cells 9 & 12. (Refer to Photos #1 & #2.)
	309(c)	Overfill/Off Lined Area

Location	Eco-Vista Class 1 Landfill				Permit	0290-S1-R3	AFIN	72-00144
Photographer	Jason Gilkey, Inspector			JLG	Witness	N/A		
Photo #	1	Of	8		Date	3/21/2023	Time	1133
Description	Depressions and exposed waste caused by truck used for hauling cover material observed at the southern area of Cell 9.

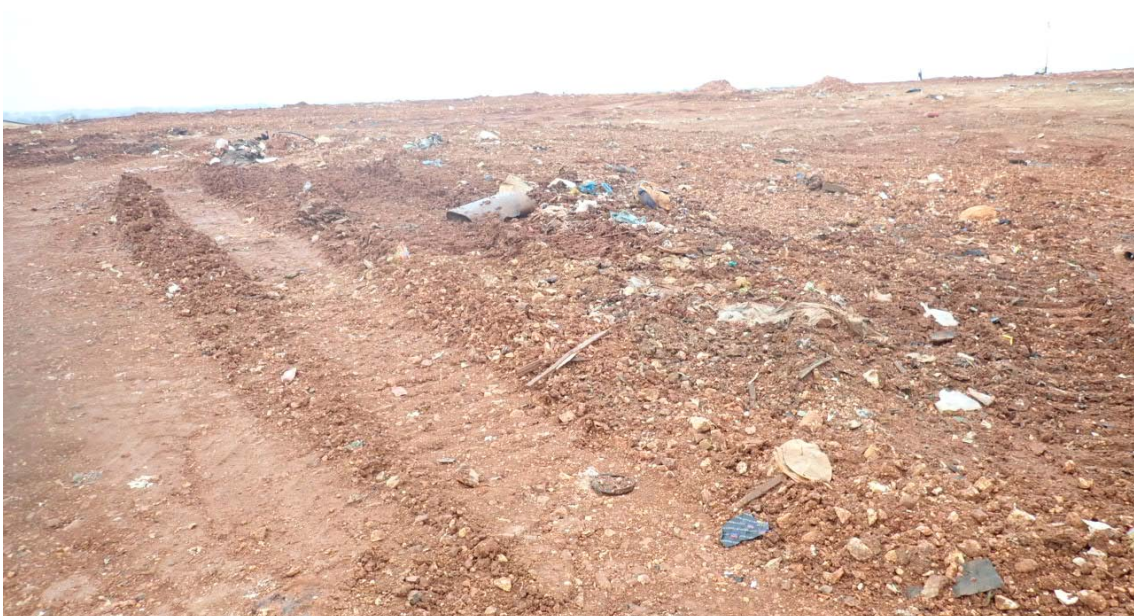
Location	Eco-Vista Class 1 Landfill				Permit	0290-S1-R3	AFIN	72-00144
Photographer	Jason Gilkey, Inspector			JLG	Witness	N/A		
Photo #	2	Of	8		Date	3/21/2023	Time	1214
Description	Depressions and exposed waste caused by truck used for hauling cover material observed at the eastern area of Cell 12.

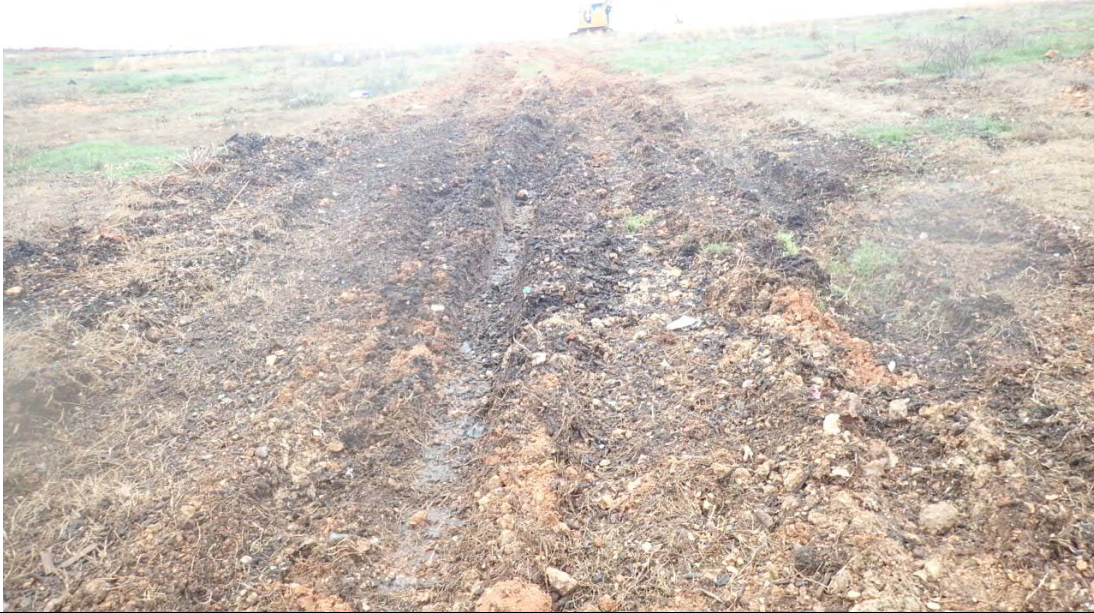
Regulation	Item Description	Comments
	411(a)	Operations in Accordance with Permit Documents	
	411(c)	Smallest Practical Area, Unloading Supervised, Single Working Face	
	411(b)	Operations by Licensed On-site Personnel at All Times	
	411(g)	Litter Control Provisions Maintained	
	427	Surface Water Controls	
	411(h)(1)	Contouring Prevents Surface Water Flowing Into or Through Waste	
	418(a)(b)	Run-on/off Control System Present and Adequate	
	411(h)(2)	Surface Water Control Prevents Off-site Sediment Accumulation	
	411(i)	Adequate Maintenance of Intermediate/Final Cover Vegetation	
	415	Gas Monitoring Program	
X	411(o)	Leachate Leaks or Evidence of Leachate Seepage	Leachate leaks were observed on Cells 4, 9, 10, 11, and 12. (Refer to Photos #3 - #8.)
	429	Leachate Collection System

Location	Eco-Vista Class 1 Landfill				Permit	0290-S1-R3	AFIN	72-00144
Photographer	Jason Gilkey, Inspector			JLG	Witness	N/A		
Photo #	3	Of	8		Date	3/21/2023	Time	1122
Description	Leachate seep observed on the western slope of Cell 4.

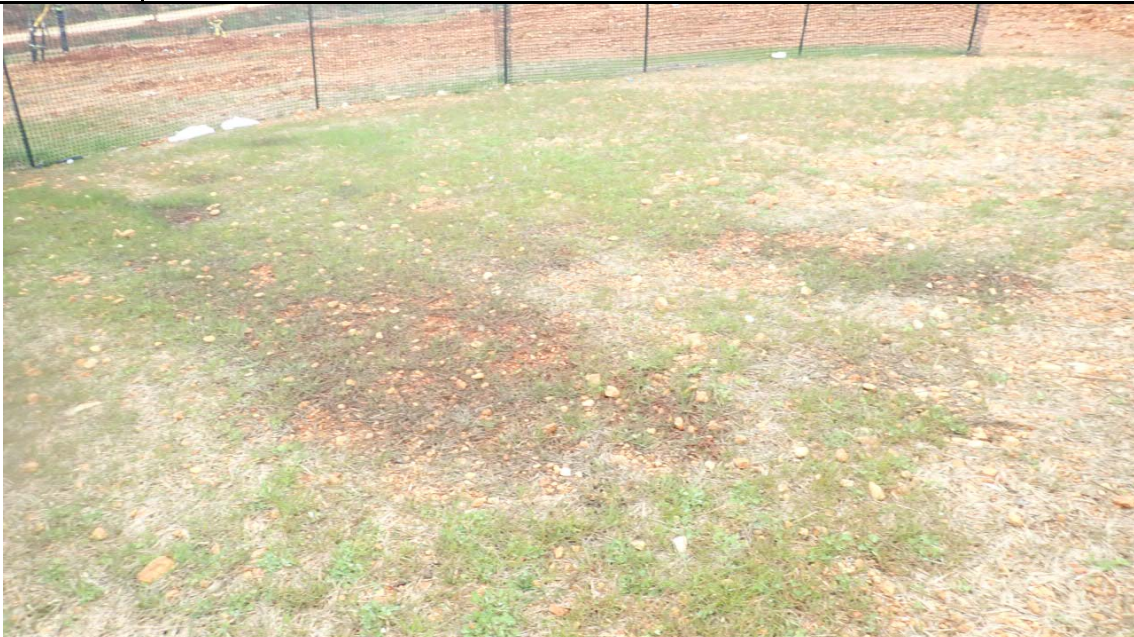
Location	Eco-Vista Class 1 Landfill				Permit	0290-S1-R3	AFIN	72-00144
Photographer	Jason Gilkey, Inspector			JLG	Witness	N/A		
Photo #	4	Of	8		Date	3/21/2023	Time	1149
Description	Leachate leak observed on the northern slope of Cell 9.

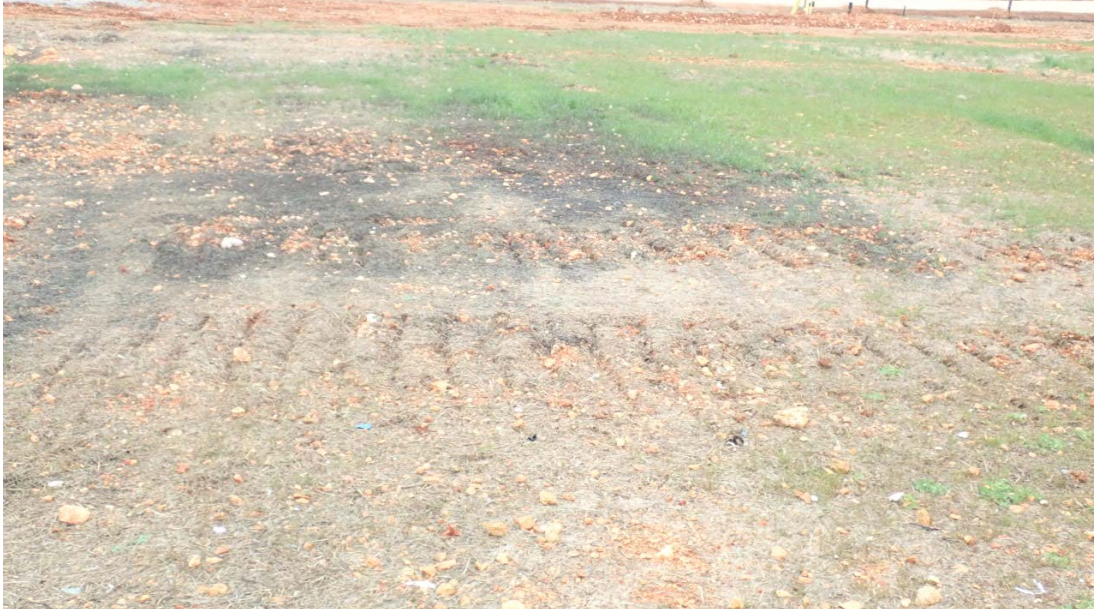
Location	Eco-Vista Class 1 Landfill				Permit	0290-S1-R3	AFIN	72-00144
Photographer	Jason Gilkey, Inspector			<i>JLG</i>	Witness	N/A		
Photo #	5	Of	8		Date	3/21/2023	Time	1150
Description	Leachate leak observed on the northern slope of Cell 10.

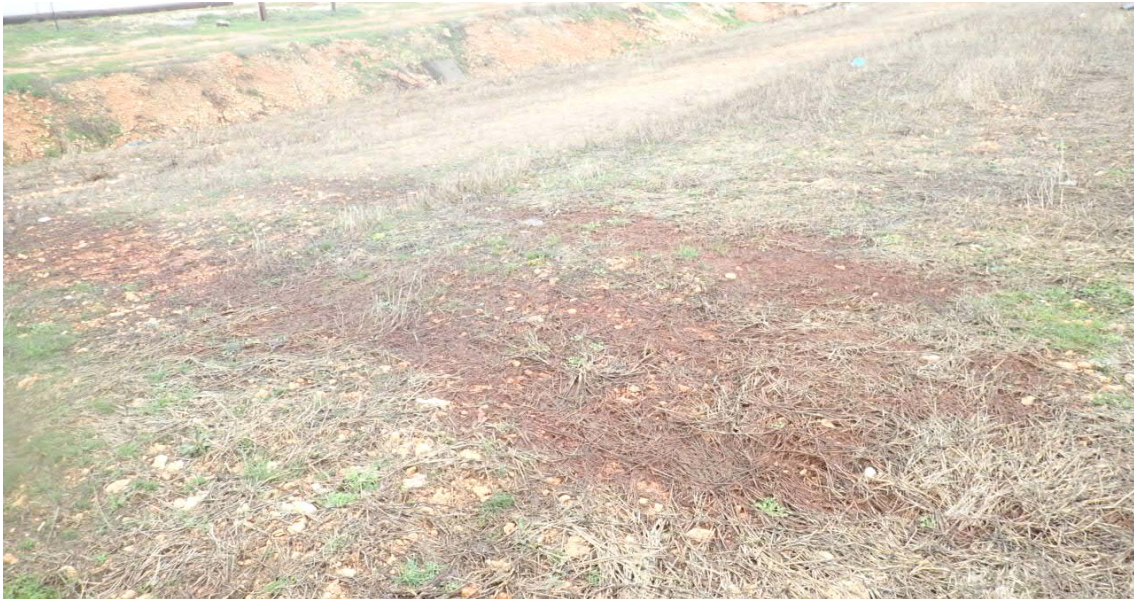
Location	Eco-Vista Class 1 Landfill				Permit	0290-S1-R3	AFIN	72-00144
Photographer	Jason Gilkey, Inspector			<i>JLG</i>	Witness	N/A		
Photo #	6	Of	8		Date	3/21/2023	Time	1206
Description	Leachate leak observed on the northern slope of Cell 11.

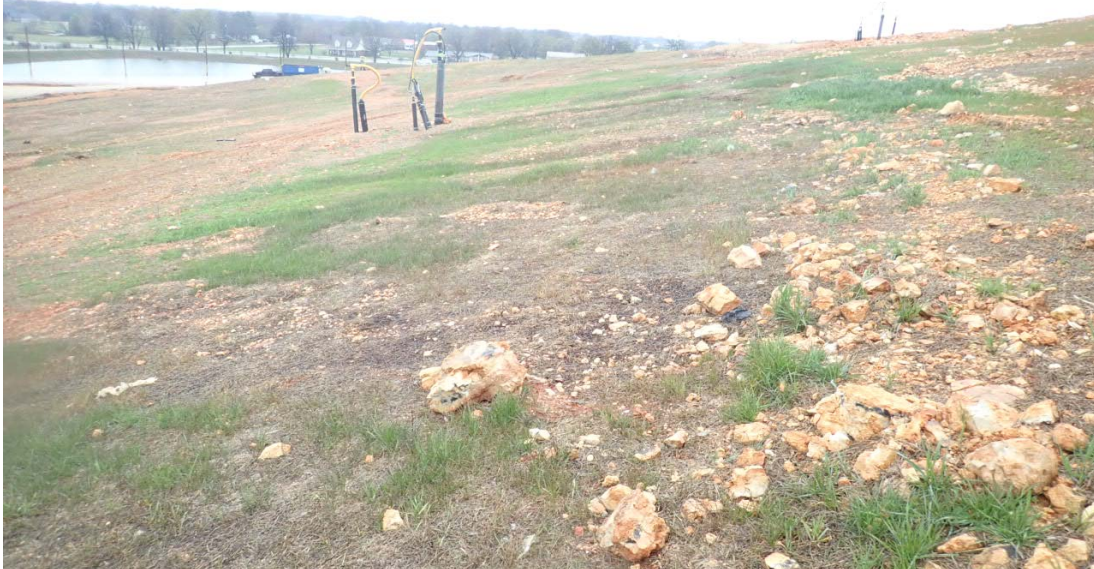
Location	Eco-Vista Class 1 Landfill				Permit	0290-S1-R3	AFIN	72-00144
Photographer	Jason Gilkey, Inspector			JLG	Witness	N/A		
Photo #	7	Of	8		Date	3/21/2023	Time	1222
Description	Leachate leak observed on the western slope of Cell 12.

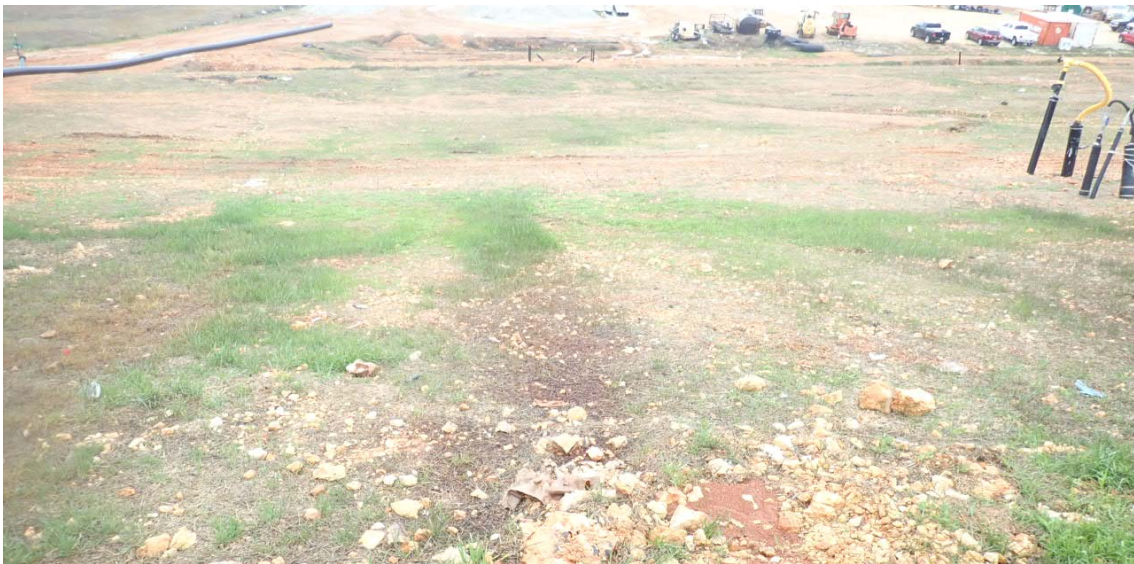
Location	Eco-Vista Class 1 Landfill				Permit	0290-S1-R3	AFIN	72-00144
Photographer	Jason Gilkey, Inspector			JLG	Witness	N/A		
Photo #	8	Of	8		Date	3/21/2023	Time	1223
Description	Leachate leak observed on the western slope of Cell 12.
