ARKANSAS ENERGY & ENVIRONMENT

RE: Inspection conducted on March 14, 2023
AFIN 63-00155
Permit Number 0261-S1-R3

Office of Land Resources
Regulated Waste Operations
Class 1 Landfill Inspection Form

Site Name	BFI Waste Systems of Arkansas	County	Saline	AFIN	63-00155
Facility Address	18511 W Sardis Road, Bauxite, AR	Phone #	859-227-3861 (Jerry Coleman) 901-873-8334 (Brad Zimmerman)	Permit #	0261-S1-R3
Permittee Address	18511 W Sardis Road, Bauxite, AR	Email Address	jcoleman2@republicservices.com Bzimmerman2@republicservices.com	PDS #	125120
Date	3/14/2023	Entry Time	1410	Exit Time	1620

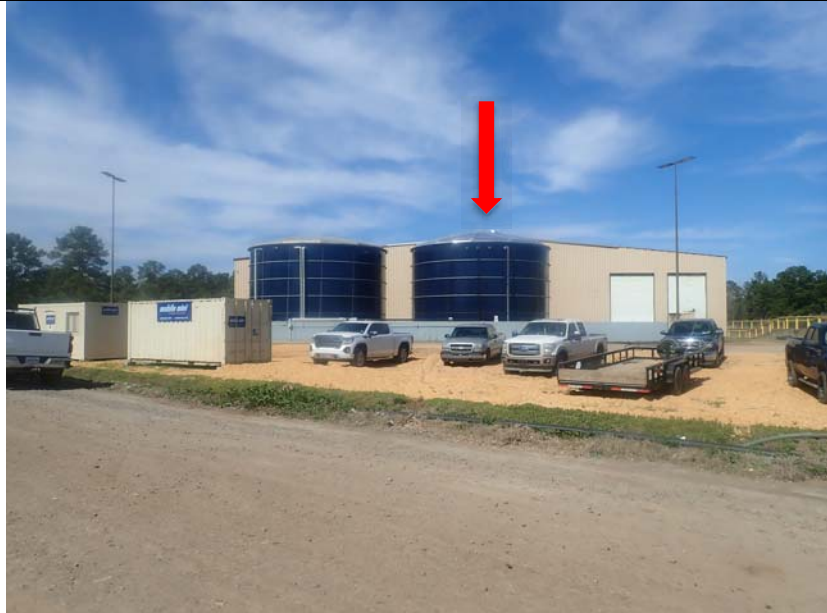
415	Gas Monitoring Program	
	411(o)	Leachate Leaks or Evidence of Leachate Seepage	
X	429(j)	Leachate Collection System	A new leachate tank has been installed. (Refer to Photo #1.) Certified Quality Assurance (CQA) documentation was not found in the database.
	421(a)(8)(b)

Location	BFI Waste Systems of Arkansas			Permit	0261-S1-R3	AFIN	63-00155
Photographer	Kim Davenport, DEQ Inspector		<i>KD</i>	Witness	N/A		
Photo #	1	Of	4	Date	3/14/2023	Time	1350
Description	A new leachate tank has been installed (red arrow). CQA documentation was not found in the database.

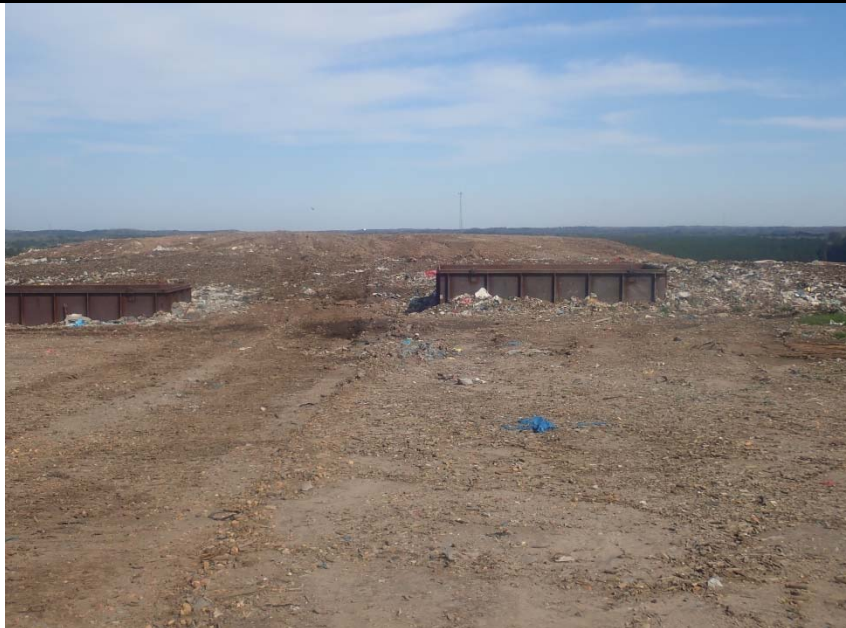
Regulation	Item Description	Comments
	413(a)(b)(c)	Satisfactory Daily/Alternate/Intermediate Cover	
	419(a)(5)	Cause Discharge/Leachate Leaving Landfill	
	411(f)(3)	Depositing Waste in Standing Water Prohibited	
X	411(o)	Erosion or Other Cover Defects Resulting in Exposed Refuse	Cover defects resulting in exposed waste were observed on the top deck near the junctions of Cells 3, 4, & 5, in close proximity to the solidification pits. Exposed waste was also observed near a gas line repair on the south slope on Cell 1 and on Cell 2 above the solidification pits.

Location	BFI Waste Systems of Arkansas			Permit	0261-S1-R3	AFIN	63-00155
Photographer	Kim Davenport, DEQ Inspector		<i>KD</i>	Witness	N/A		
Photo #	2	Of	4	Date	3/14/2023	Time	1443
Description	Cover defects resulting in exposed waste was observed on the top deck near the junctions of Cells 3, 4, & 5, in close proximity to the solidification pits.

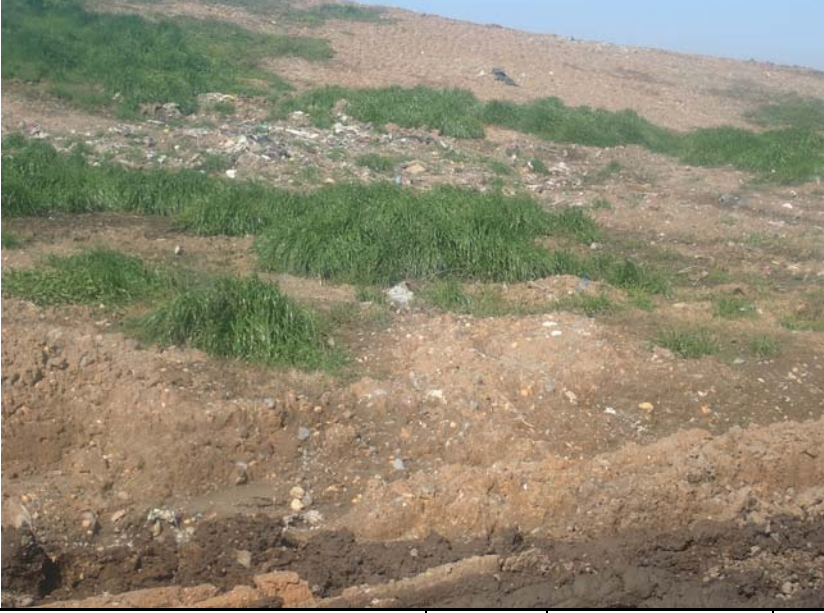
Witness	N/A		
Photo #	3	Of	4		Date	3/14/2023	Time	1427
Description	Cover defects resulting in exposed waste observed on Cell 2 above the solidification pits.
