**RE: Inspection conducted on April 4, 2023**  
**AFIN 16-00199**  
**Permit Number 0254-S1-R4**

**Office of Land Resources  
Regulated Waste Operations  
Class 1 Landfill Inspection Form**

| <b>Site Name</b> | Craighead County SWDA Class 1 | <b>County</b> | Craighead | <b>AFIN</b> | 16-00199 |

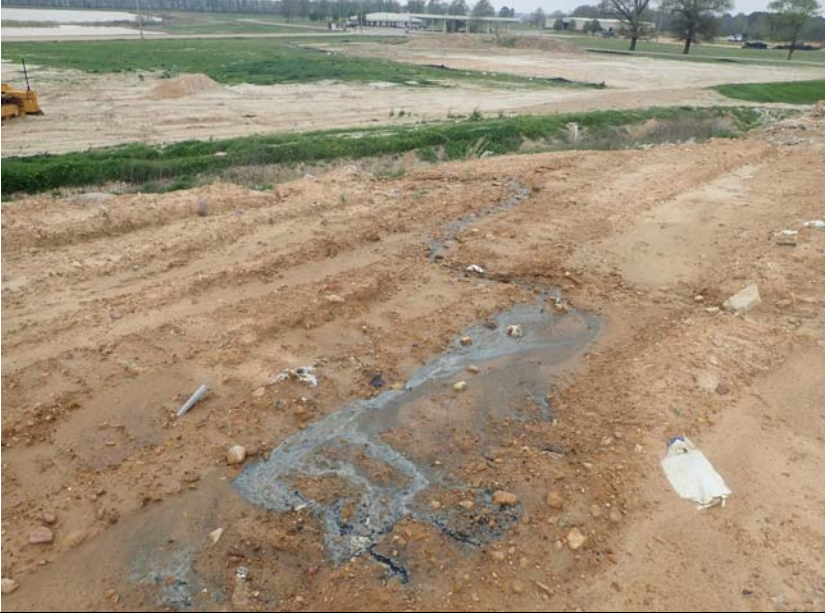
| <b>Photo #</b> | 1 | <b>Of</b> | 5 | | <b>Date</b> | 4/4/2023 | | <b>Time</b> | 0923 | |

| | <b>Regulation</b> | <b>Item Description</b> | <b>Comments</b> |
|---|---|---|---|
| X | 411(o) | Leachate Leaks or Evidence of Leachate Seepage | Leachate leaks observed on the east, west, and north slopes of the landfill. (Refer to Photos #1-2 & #4-5.) |

| <b>Description</b> | | Leachate leaks observed on the west slope of the landfill. | | | | | | | | |

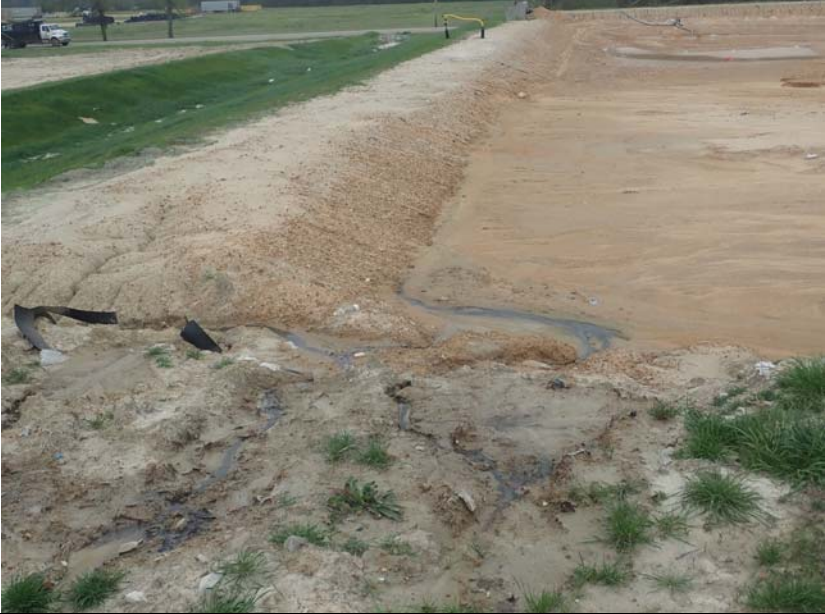
| <b>Photo #</b> | 2 | <b>Of</b> | 5 | | <b>Date</b> | 4/4/2023 | | <b>Time</b> | 0924 | |

| <b>Description</b> | | Leachate leaks observed on the north slope of the landfill. | | | | | | | | |

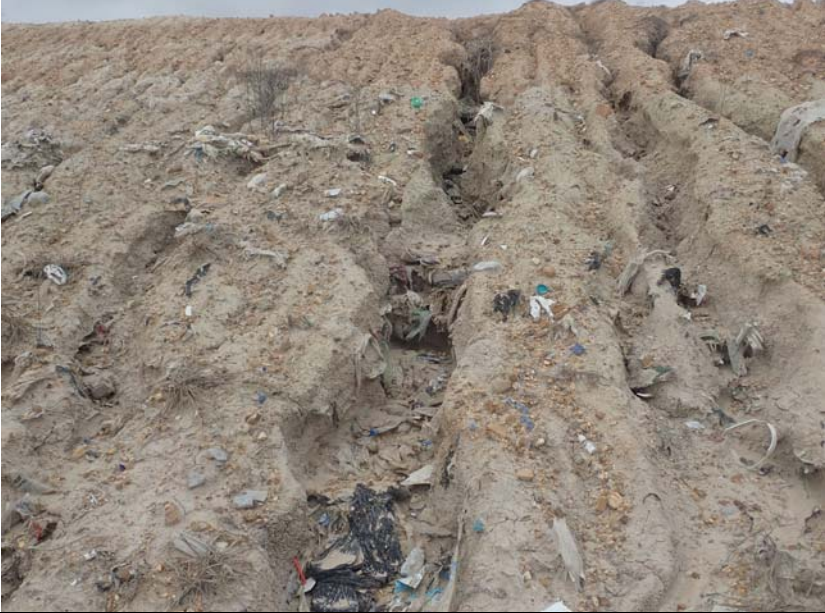
| <b>Photo #</b> | 3 | <b>Of</b> | 5 | | <b>Date</b> | 4/4/2023 | <b>Time</b> | 0949 |

| | <b>Regulation</b> | <b>Item Description</b> | <b>Comments</b> |
|---|---|---|---|
| X | 411(o) | Erosion or Other Cover Defects Resulting in Exposed Refuse | Erosion with exposed waste observed on the east slope of the landfill. (Refer to Photo #3.) |

| <b>Description</b> | Erosion with exposed waste observed on the east slope of the landfill. | | | | | | | |

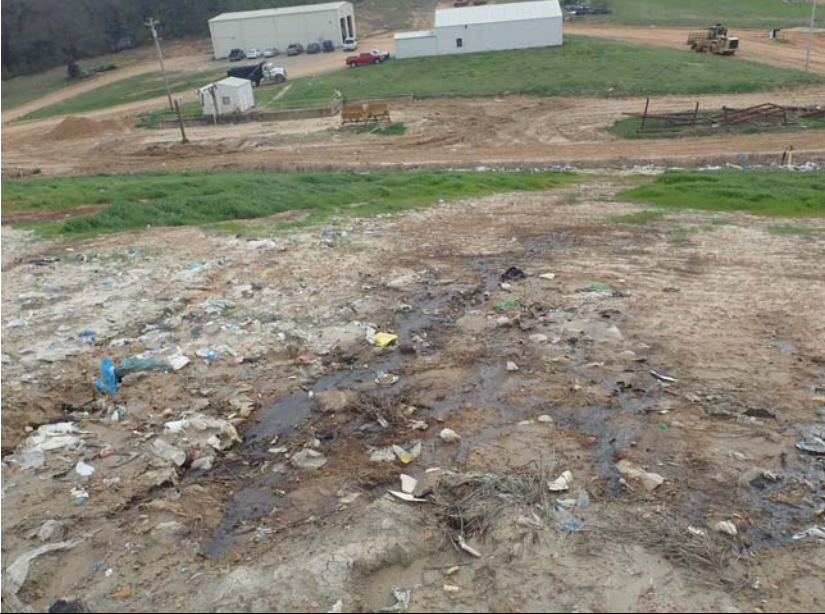
| <b>Photo #</b> | 4 | <b>Of</b> | 5 | | <b>Date</b> | 4/4/2023 | <b>Time</b> | 0953 |

| <b>Description</b> | Leachate leaks observed on the west slope of the landfill. | | | | | | | |
