# ARKANSAS

**RE: Inspection conducted on May 10, 2023**  
**AFIN 60-01071**  
**Permit Number 0266-S1**

**Office of Land Resources  
Regulated Waste Operations  
Class 1 Landfill Inspection Form**

<b>Site Name</b>	City of Little Rock Class 1 Landfill	<b>County</b>	Pulaski	<b>AFIN</b>	60-01071
<b>Facility Address</b>	10803 Ironton Cutoff, Little Rock, AR 72206	<b>Phone #</b>	501-888-4493	<b>Permit #</b>	0266-S1
<b>Permittee Address</b>	10803 Ironton Cutoff, Little Rock, AR 72206	<b>Email Address</b>	<a href="mailto:ncharles@littlerock.gov">ncharles@littlerock.gov</a>	<b>PDS #</b>	
<b>Date</b>	5/10/2023	<b>Entry Time</b>	1152	<b>Exit Time</b>	1455

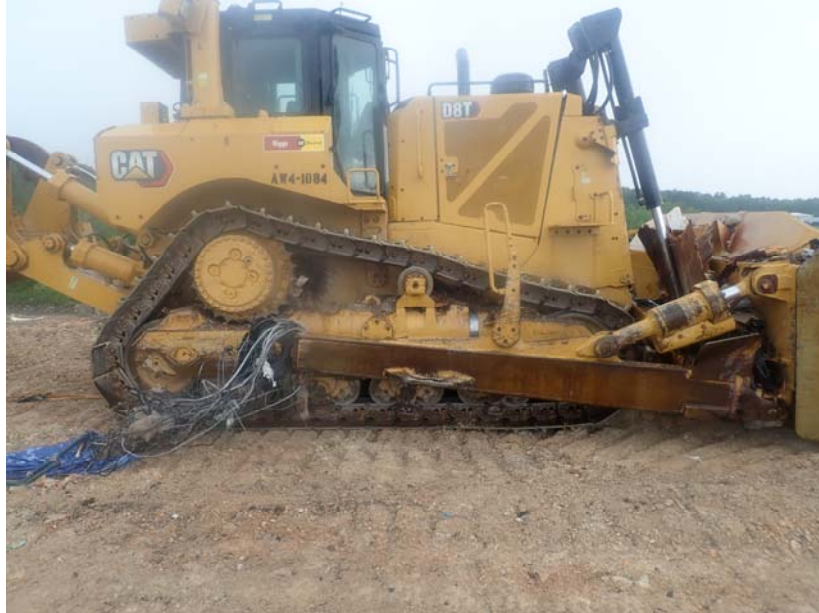
<b>Regulation</b>	<b>Item Description</b>	<b>Comments</b>
	417	Access Requirements	
	411(j)	Adequate Provision for Backup Equipment	Multiple pieces of equipment were observed non-functional with no time-line for repair. (Refer to Photos #1 & #2.)
	423(b)	Annual Compliance Inspection by Registered Engineer

<b>Location</b>	City of Little Rock Class 1			<b>Permit</b>	0266-S1	<b>AFIN</b>	60-01071
<b>Photographer</b>	Kim Davenport, Inspector	<i>KD</i>		<b>Witness</b>	N/A		
<b>Photo #</b>	1	<b>Of</b>	22	<b>Date</b>	5/10/2023	<b>Time</b>	1344
<b>Description</b>	A piece of non-functional equipment was observed. No timeline for repair was provided.

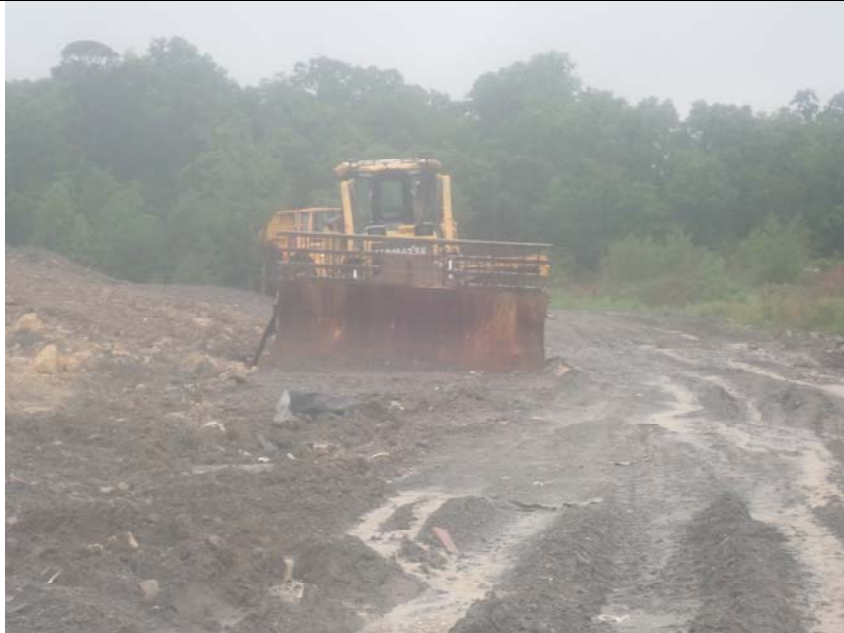
<b>Location</b>	City of Little Rock Class 1			<b>Permit</b>	0266-S1	<b>AFIN</b>	60-01071
<b>Photographer</b>	Kim Davenport, Inspector	<i>KD</i>		<b>Witness</b>	N/A		
<b>Photo #</b>	2	<b>Of</b>	22	<b>Date</b>	5/10/2023	<b>Time</b>	1446
<b>Description</b>	An example is provided of another piece of non-functional equipment observed with no timeline for repair.

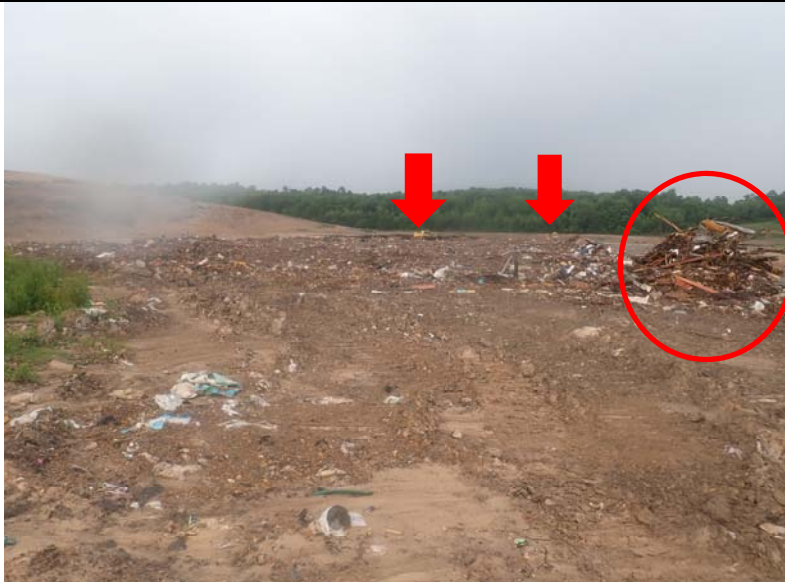
411(h)(1)	Contouring Prevents Surface Water Flowing Into or Through Waste	
X	418(a) & (b)	Run-on/off Control System Present and Adequate	Run-on /Run-off controls were not in place to control the water volume resulting from the storm observed during the inspection. (Refer to Photos #3 - #12.)
	411(h)(2)	Surface Water Control Prevents Off-site Sediment Accumulation	
X	411(i)	Adequate Maintenance of Intermediate/Final Cover Vegetation	Woody vegetation was observed on the northern slope of Cell 2. (Refer to Photo #18.)
	415(a)(1)(2)	Gas Monitoring Program	
X	411(o)	Leachate Leaks or Evidence of Leachate Seepage	Runoff containing waste (leachate) from the active area was observed entering the stormwater ditches and the stormwater pond. (Refer to Photos #3 - #12.) In addition, dark colored water with an oily sheen (leachate) was observed along the western slope of the stormwater pond. (Refer to Photos #13 & #14.)

429	Leachate Collection System	
X	411(d)	Waste spreading and compacting	Waste placed in the 2 <sup>nd</sup> approved working face was not spread or compacted. (Refer to Photo #3 & 4.)

<b>Regulation</b>	<b>Item Description</b>	<b>Comments</b>
X	413(a)	Satisfactory Daily	The 2 <sup>nd</sup> approved working face has received no daily cover since they began accepting the FEMA waste, as confirmed by the Operator, Raymond Bell, and Nathan Charles. (Refer to Photos #3 & #4.) The approval document in the database is dated April 26, 2023. (Refer to

<b>Location</b>	City of Little Rock Class 1			<b>Permit</b>	0266-S1	<b>AFIN</b>	60-01071
<b>Photographer</b>	Kim Davenport, Inspector	<i>KD</i>		<b>Witness</b>	N/A		
<b>Photo #</b>	3	<b>Of</b>	22	<b>Date</b>	5/10/2023	<b>Time</b>	1342
<b>Description</b>	A view of active Cell 5W is observed, looking south from the top of Cell 2. Two (2) pieces of equipment (red arrows) observed working there. The FEMA working face is shown in the foreground, measuring approximately 400' x 300'. Waste was observed that had not been spread or compacted (red circle). No daily cover requirements have been met since the facility started taking FEMA waste. No stormwater or litter controls were observed in place in or around the active areas.

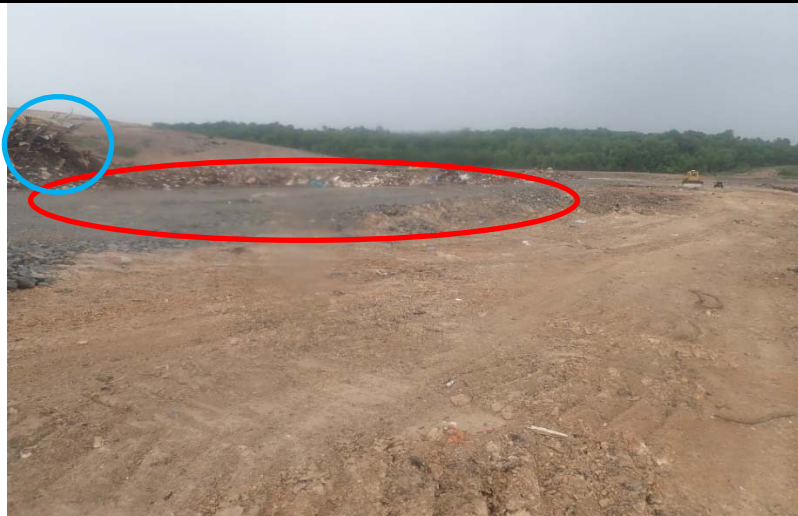
<b>Location</b>	City of Little Rock Class 1			<b>Permit</b>	0266-S1	<b>AFIN</b>	60-01071
<b>Photographer</b>	Kim Davenport, Inspector	<i>KD</i>		<b>Witness</b>	N/A		
<b>Photo #</b>	4	<b>Of</b>	22	<b>Date</b>	5/10/2023	<b>Time</b>	1343
<b>Description</b>	Another view of the active Cell 5W and the 2 <sup>nd</sup> approved working face for FEMA waste (red circle). No daily cover has been placed upon the 2 <sup>nd</sup> working face since they began accepting it. Waste placed in the 2 <sup>nd</sup> working face was not spread or compacted (blue circle). No stormwater or litter controls were in place in or around the active area.

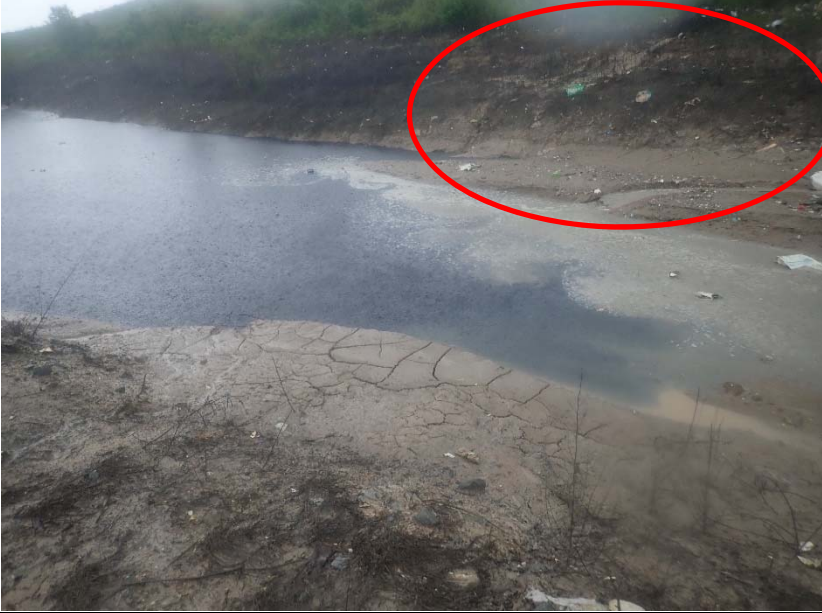
<b>Location</b>	City of Little Rock Class 1			<b>Permit</b>	0266-S1	<b>AFIN</b>	60-01071
<b>Photographer</b>	Kim Davenport, Inspector	<i>KD</i>		<b>Witness</b>	N/A		
<b>Photo #</b>	11	<b>Of</b>	22	<b>Date</b>	5/10/2023	<b>Time</b>	1359
<b>Description</b>	The pond from Photo #10 was observed black in color. Active rainfall during the inspection was observed introducing waste and sediment into the unlined pond. Litter was also observed on the west slope of Cell 2 (red circle).

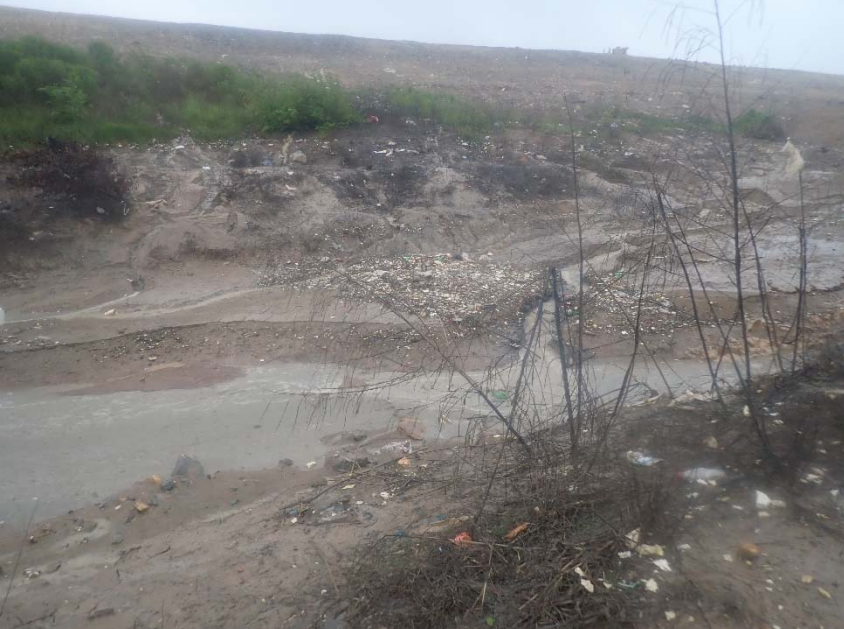
<b>Location</b>	City of Little Rock Class 1			<b>Permit</b>	0266-S1	<b>AFIN</b>	60-01071
<b>Photographer</b>	Kim Davenport, Inspector	<i>KD</i>		<b>Witness</b>	N/A		
<b>Photo #</b>	12	<b>Of</b>	22	<b>Date</b>	5/10/2023	<b>Time</b>	1359
<b>Description</b>	A view of the south end of the unlined pond is provided to show the eroded west slope of Cell 2 and solid waste entering the pond. No stormwater or litter controls were observed in place.

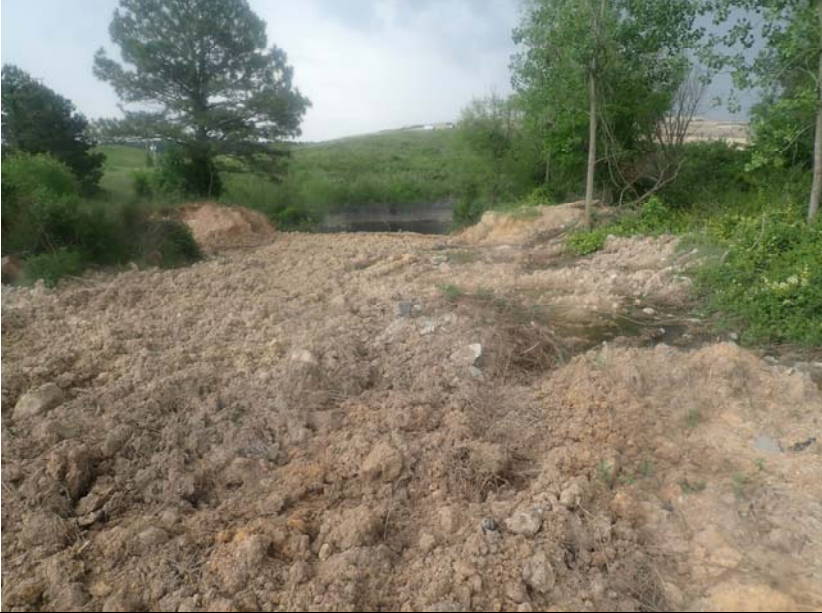
<b>Location</b>	City of Little Rock Class 1			<b>Permit</b>	0266-S1	<b>AFIN</b>	60-01071
<b>Photographer</b>	Kim Davenport, Inspector	<i>KD</i>		<b>Witness</b>	N/A		
<b>Photo #</b>	13	<b>Of</b>	22	<b>Date</b>	5/10/2023	<b>Time</b>	1311
<b>Description</b>	A dirt path leading to the pond shown in Photos #10 - #12 was observed on the western side of the pond.

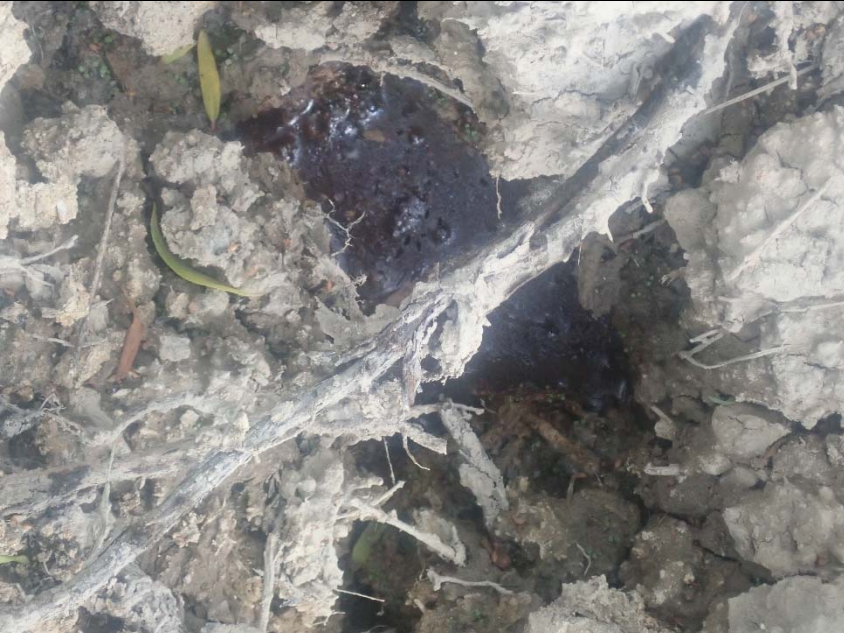
<b>Location</b>	City of Little Rock Class 1			<b>Permit</b>	0266-S1	<b>AFIN</b>	60-01071
<b>Photographer</b>	Kim Davenport, Inspector	<i>KD</i>		<b>Witness</b>	N/A		
<b>Photo #</b>	14	<b>Of</b>	22	<b>Date</b>	5/10/2023	<b>Time</b>	1312
<b>Description</b>	A view of discolored water with an oily sheen (leachate) was observed in the soil shown in Photo #13.

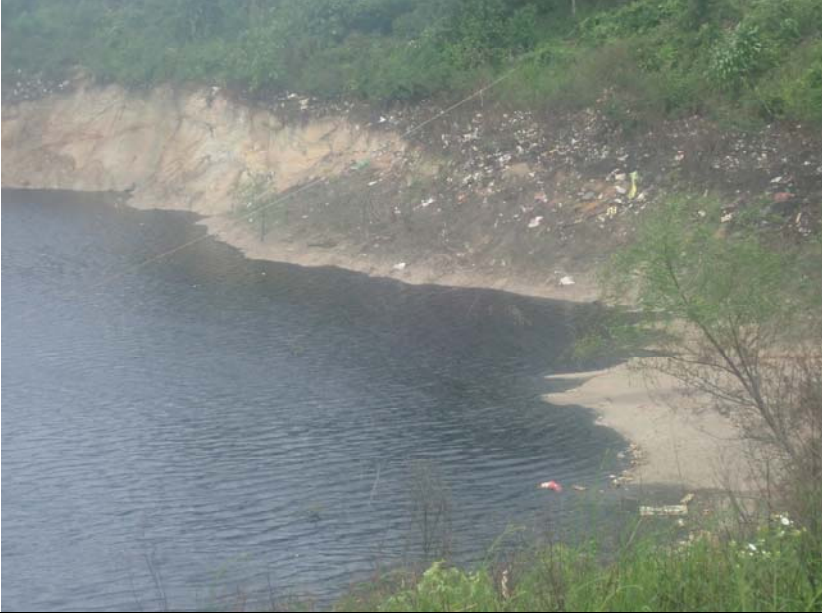
<b>Location</b>	City of Little Rock Class 1			<b>Permit</b>	0266-S1	<b>AFIN</b>	60-01071
<b>Photographer</b>	Kim Davenport, Inspector	<i>KD</i>		<b>Witness</b>	N/A		
<b>Photo #</b>	15	<b>Of</b>	22	<b>Date</b>	5/10/2023	<b>Time</b>	1315
<b>Description</b>	An overview is provided of the pond shown in Photos #10 - #13. The pond is located in an unlined area. Solid waste was observed on the banks of the pond and in the water (leachate).

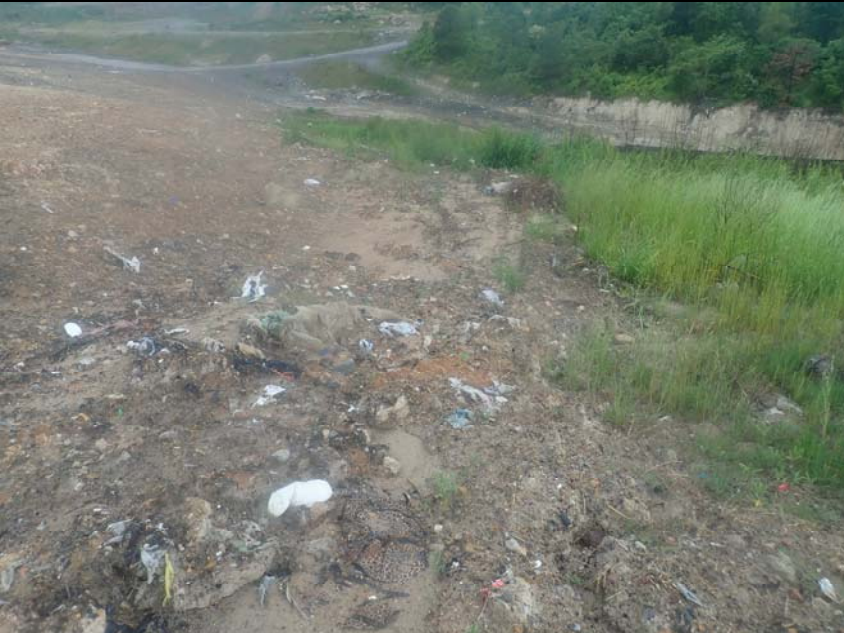
<b>Location</b>	City of Little Rock Class 1			<b>Permit</b>	0266-S1	<b>AFIN</b>	60-01071
<b>Photographer</b>	Kim Davenport, Inspector	<i>KD</i>		<b>Witness</b>	N/A		
<b>Photo #</b>	16	<b>Of</b>	22	<b>Date</b>	5/10/2023	<b>Time</b>	1344
<b>Description</b>	Erosion with exposed waste at the west slope of Cell 2, looking southwest.

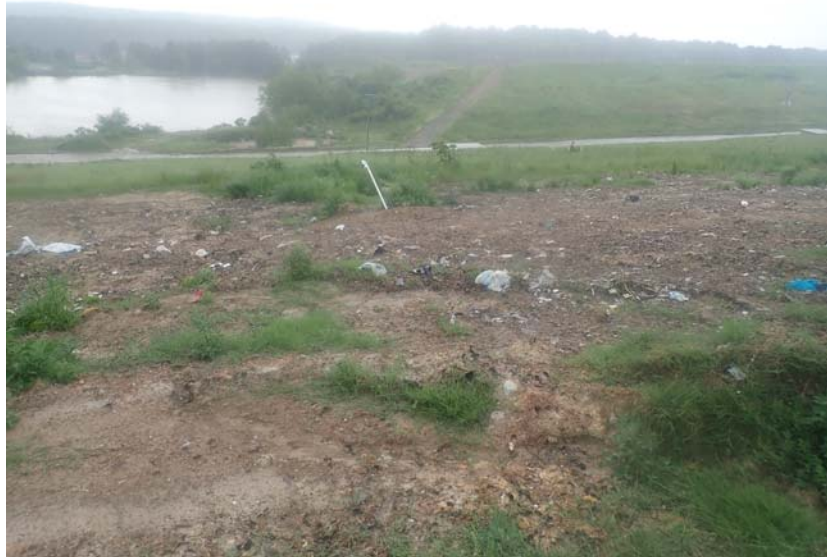
<b>Location</b>	City of Little Rock Class 1	<b>Permit</b>	0266-S1	<b>AFIN</b>	60-01071
<b>Photographer</b>	Kim Davenport, Inspector	<i>KD</i>	<b>Witness</b>	N/A	
<b>Photo #</b>	17	<b>Of</b>	22	<b>Date</b>	5/10/2023
<b>Description</b>	Erosion with exposed waste was observed on the north slope of Cell 2.

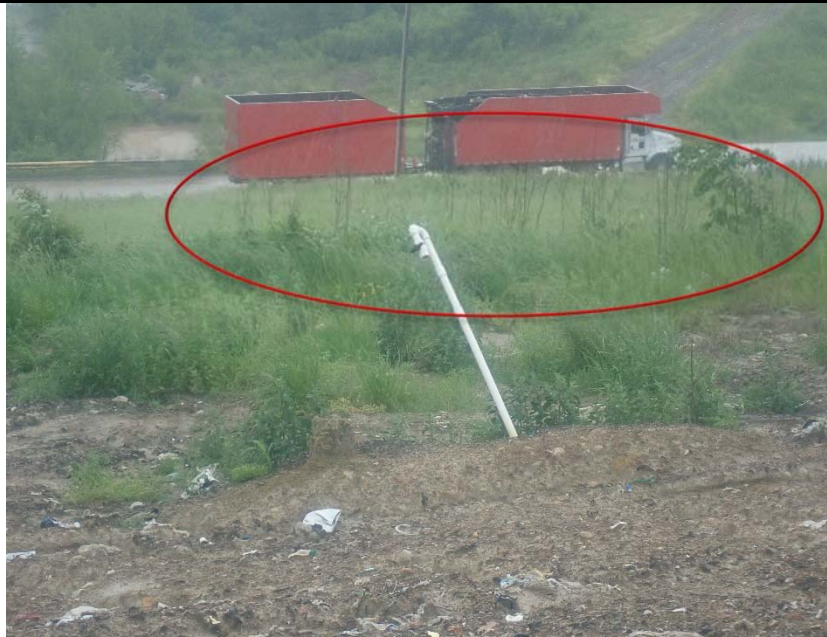
<b>Location</b>	City of Little Rock Class 1	<b>Permit</b>	0266-S1	<b>AFIN</b>	60-01071
<b>Photographer</b>	Kim Davenport, Inspector	<i>KD</i>	<b>Witness</b>	N/A	
<b>Photo #</b>	18	<b>Of</b>	22	<b>Date</b>	5/10/2023
<b>Description</b>	Exposed waste and woody vegetation (red circle) was observed on the north slope of Cell 2.

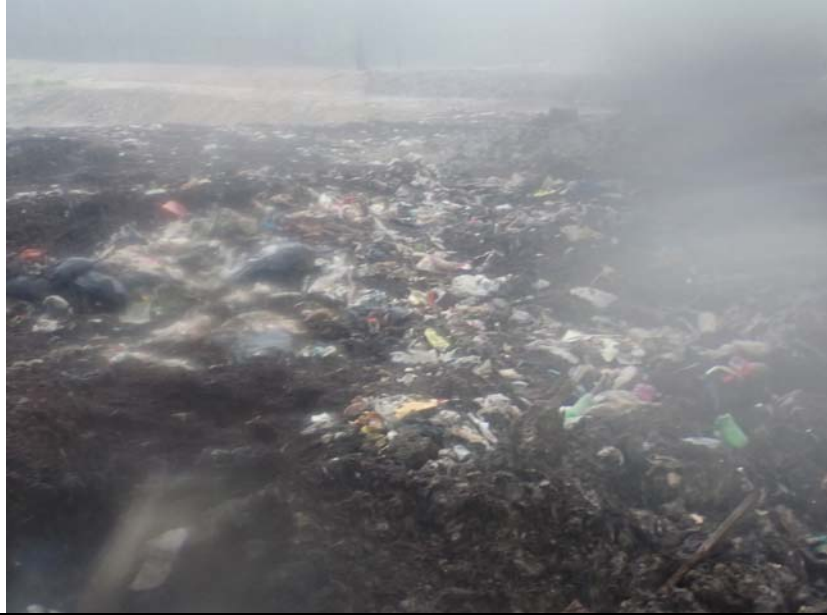
Doc #83935.)			
X	413(b)	Alternate Cover Materials	The previous days' working face working face was observed with insufficient cover. They were using an approved ADC. (Refer to Photo #19.)			
X	419(a)(5)	Cause Discharge/Leachate Leaving Landfill	Leachate was observed pooling in the unlined area referenced as the stormwater pond. (Refer to Photo #10 - #15.)			
	411(f)(3)	Depositing Waste in Standing Water Prohibited				
X	411(o)	Erosion or Other Cover Defects Resulting in Exposed Refuse	Erosion with exposed waste was observed on the west and north slopes of Cell 2. (Refer to Photo #11, #12, #16 - #18.)			
X	309(c)	Overfill/Off Lined Area	Partially buried waste was observed in the truck cleanout area, located north of the fueling station, which is off the lined area and is not permitted for waste disposal. (Refer to Photos #20 - #22.)			
<b>Records</b>						
<b>Date of Last Annual Report</b>		3/30/2023	<b>Date of Last Quarterly Methane Monitoring</b>		3/28/2023

<b>Location</b>	City of Little Rock Class 1			<b>Permit</b>	0266-S1	<b>AFIN</b>	60-01071
<b>Photographer</b>	Kim Davenport, Inspector	<i>KD</i>		<b>Witness</b>	N/A		
<b>Photo #</b>	19	<b>Of</b>	22	<b>Date</b>	5/10/2023	<b>Time</b>	1404
<b>Description</b>	The previous days' working face working face was observed with insufficient cover. They were using an approved ADC.

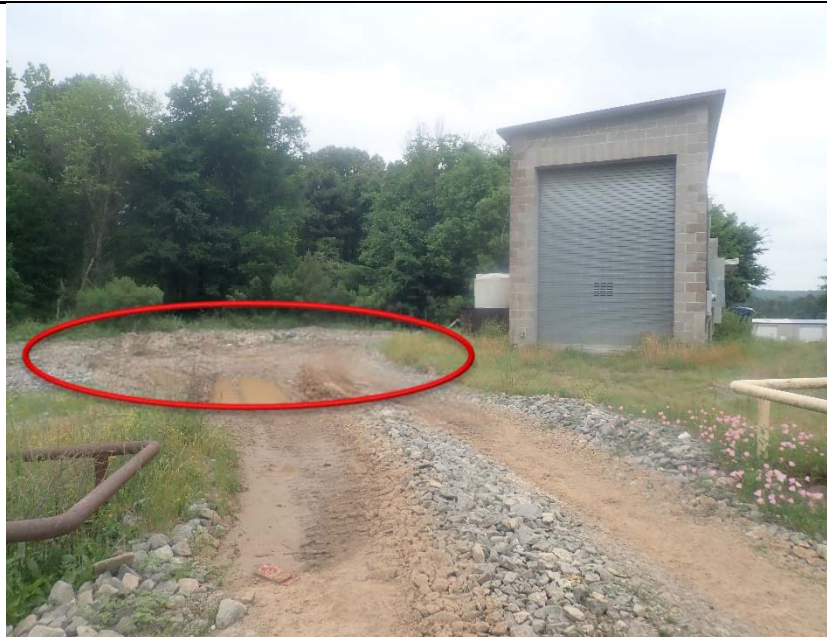
<b>Location</b>	City of Little Rock Class 1			<b>Permit</b>	0266-S1	<b>AFIN</b>	60-01071
<b>Photographer</b>	Kim Davenport, Inspector	<i>KD</i>		<b>Witness</b>	N/A		
<b>Photo #</b>	20	<b>Of</b>	22	<b>Date</b>	5/10/2023	<b>Time</b>	1224
<b>Description</b>	An overview of the truck cleanout area is provided for location reference. The area of concern is circled in red.

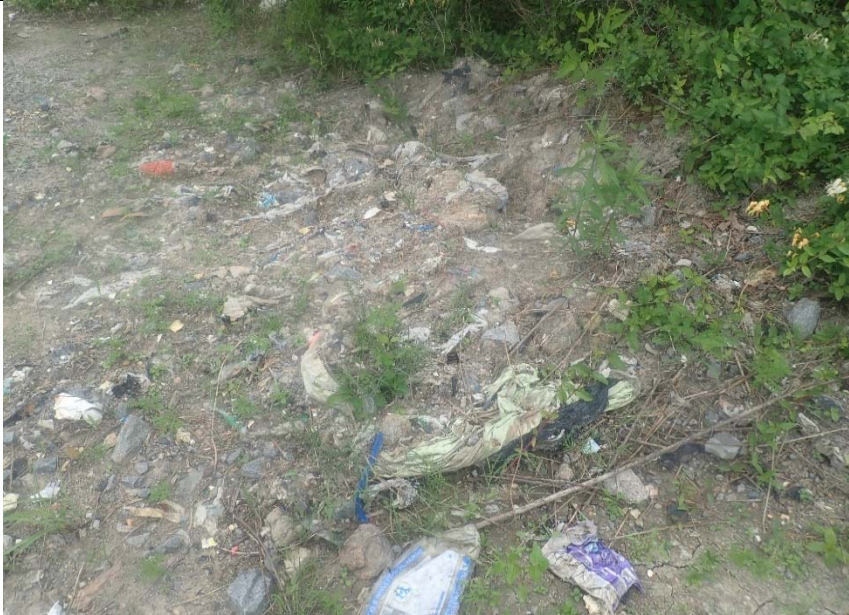
<b>Location</b>	City of Little Rock Class 1			<b>Permit</b>	0266-S1	<b>AFIN</b>	60-01071
<b>Photographer</b>	Kim Davenport, Inspector	<i>KD</i>		<b>Witness</b>	N/A		
<b>Photo #</b>	21	<b>Of</b>	22	<b>Date</b>	5/10/2023	<b>Time</b>	1226
<b>Description</b>	An example is provided of partially buried waste located in the area of concern shown in Photo #20.
