DIVISION OF
ENVIRONMENTAL QUALITY

RE: Inspection conducted on June 27, 2023
AFIN 03-00051
Permit Number 0249-S1-R2

**Office of Land Resources
Regulated Waste Operations
Class 1 Landfill Inspection Form**

Site Name	NABORS Class 1 Landfill	County	Baxter	AFIN	03-00051
Facility Address	Hwy 5 N to CR 16 to site entrance - Three Brothers	Phone #	870-688-3822	Permit #	0249-S1-R2
Permittee Address	P.O. Box 1669 Harrison, AR 72602	Email Address	cwsautomotiveandconsulting@gmail.com judge@baxtercounty.org	PDS #	126487
Date	6/27/2023	Entry Time	1057	Exit Time	1235

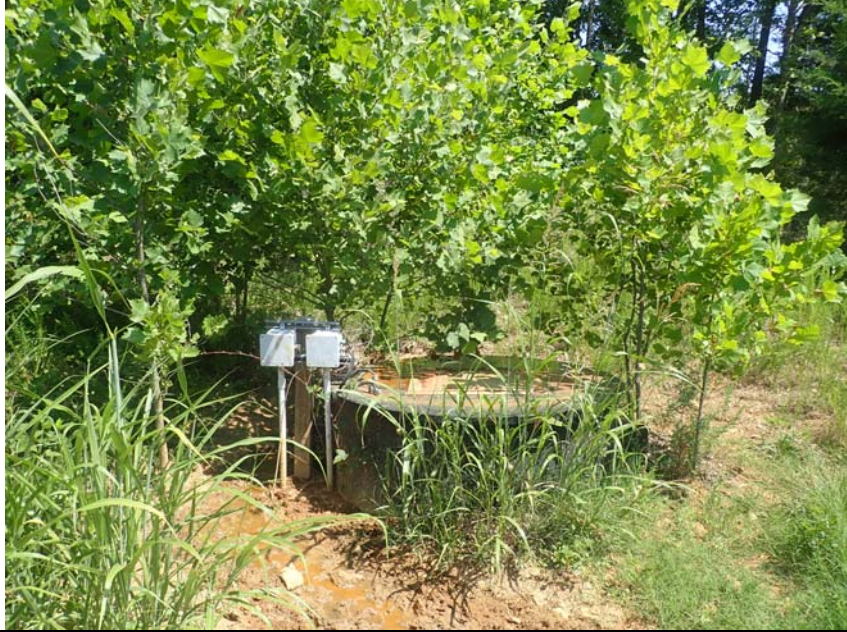
Regulation	Item Description	Comments
	413(a)(b)(c) Satisfactory Daily/Alternate/Intermediate Cover	
X	419(a)(5) Cause Discharge/Leachate Leaving Landfill	VLCS-1 sump observed overflowing. (Refer to Photos #1 and #2.)
	411(f)(3) Depositing Waste in Standing Water Prohibited	
	411(o) Erosion or Other Cover Defects Resulting in Exposed Refuse	
	309(c) Overfill/Off Lined Area

Location	NABORS Class 1 Landfill			Permit	0249-S1-R2	AFIN	03-00051
Photographer	Darrell Norton, Inspector		<i>DN</i>	Witness	n/a		
Photo #	1	Of	4	Date	6/27/2023	Time	1057
Description	Vegetative growth around VLCS-1 sump. VLCS-1 appears to be failing with leachate overflow visible.

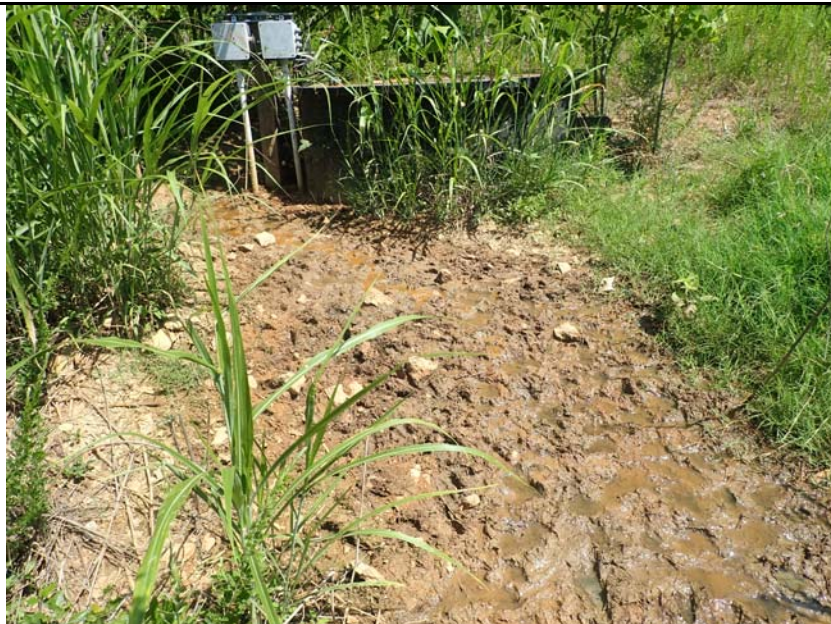
Location	NABORS Class 1 Landfill			Permit	0249-S1-R2	AFIN	03-00051
Photographer	Darrell Norton, Inspector		<i>DN</i>	Witness	n/a		
Photo #	2	Of	4	Date	6/27/2023	Time	1057
Description	A closer view of the overflow from VLCS-1 sump observed in Photo #1.

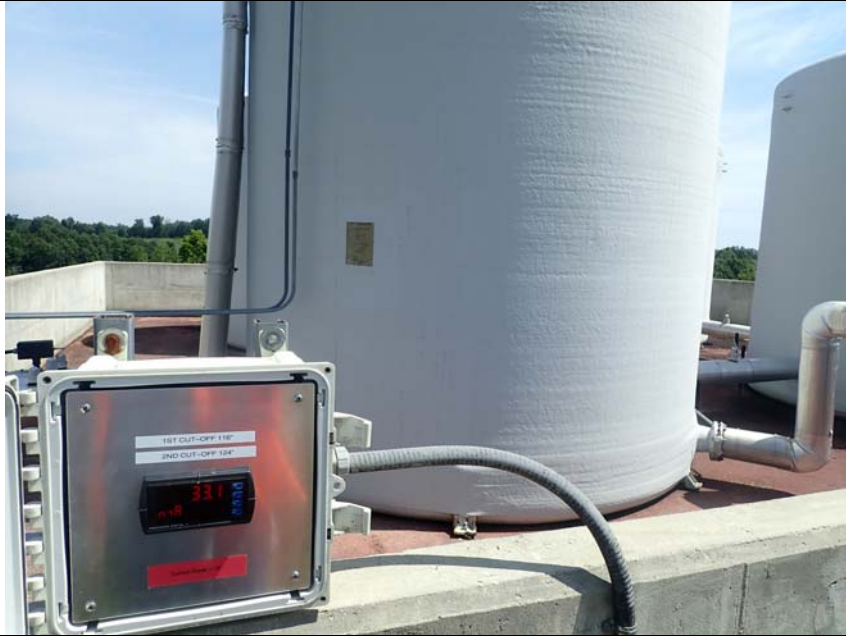
Location	NABORS Class 1 Landfill			Permit	0249-S1-R2	AFIN	03-00051
Photographer	Darrell Norton, Inspector		<i>DN</i>	Witness	n/a		
Photo #	3	Of	4	Date	6/27/2023	Time	1100
Description	Tank farm and secondary containment.

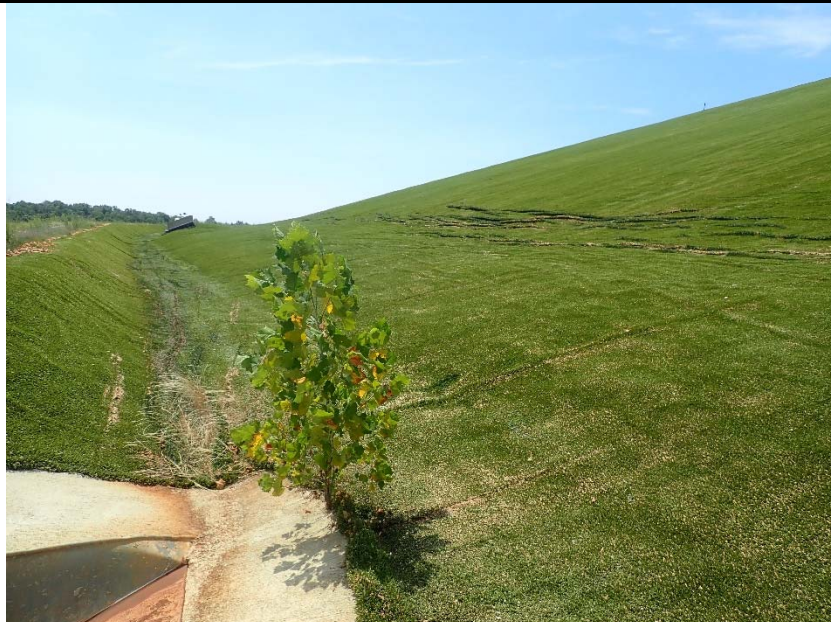
Location	NABORS Class 1			Permit	0249-S1-R2	AFIN	03-00051
Photographer	Darrell Norton, Inspector		<i>DN</i>	Witness	n/a		
Photo #	4	Of	4	Date	6/27/2023	Time	1122
Description	Turf roll and damage observed in multiple areas on the final cover system. Woody vegetation was also observed in the final cover system between LCS-6 and LCS-7.
