**RE: Inspection conducted on July 18, 2023  
AFIN 16-00199  
Permit Number 0254-S1-R4**

**Division of Environmental Quality  
Office of Land Resources  
Class 1 Landfill Inspection Form**

| <b>Site Name</b> | Craighead County SWDA Class 1 | <b>County</b> | Craighead | <b>AFIN</b> | 16-00199 |

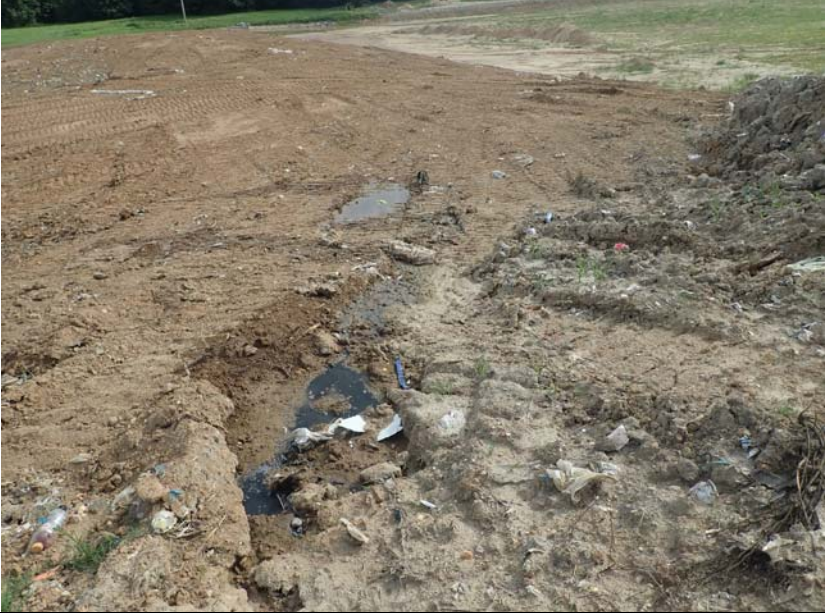
| <b>Photo #</b> | 1 | <b>Of</b> | 3 | | <b>Date</b> | 7/18/2023 | | <b>Time</b> | 0919 | | |

| <b>Regulation</b> | <b>Item Description</b> | <b>Comments</b> |
|---|---|---|
| X | 411(o) Leachate Leaks or Evidence of Leachate Seepage | Leachate leaks observed on the west and north slopes of the landfill. (Refer to Photo #1 & #2.) |

| <b>Description</b> | | Leachate leaks observed on the north slope of the landfill. | | | | | | | | | |

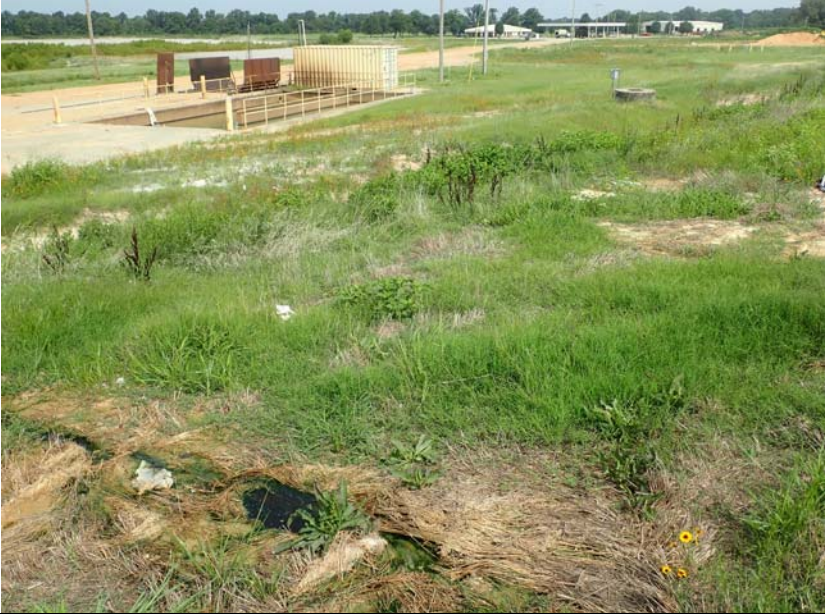
| <b>Photo #</b> | 2 | <b>Of</b> | 3 | | <b>Date</b> | 7/18/2023 | | <b>Time</b> | 1013 | | |

| <b>Description</b> | | Leachate leaks observed on the west slope of the landfill. | | | | | | | | | |
