RE: City of Decatur WWTP Inspection (Benton Co)
AFIN: 04-00052 **NPDES Permit No.: AR0022292**

ENVIRONMENTAL QUALITY	OFFICE OF WATER QUALITY		
	INSPECTION REPORT		
	AFIN: 04-00052	PERMIT #: AR0022292	DATE: 7/27/2023
	COUNTY: 04 Benton	PDS #: 126876	MEDIA: WN
GPS LAT: 36.343294 LONG: -94.471183 LOCATION: Entrance			
FACILITY INFORMATION		INSPECTION INFORMATION	
NAME: City of Decatur WWTP LOCATION: 985 Austin Ave. CITY: Decatur		FACILITY TYPE: 1 - Municipal INSPECTOR ID#: 142257 S - State FACILITY EVALUATION RATING: 1 - Unsatisfactory INSPECTION TYPE: Reconnaissance	
RESPONSIBLE OFFICIAL		DATE(S): 7/27/2023 ENTRY TIME: 22:06 EXIT TIME: 22:12 PERMIT EFFECTIVE DATE: 11/30/2020 7/27/2023 23:20 23:26 PERMIT EXPIRATION DATE: 11/30/2025	
NAME: / TITLE Robert Tharp / Mayor COMPANY: City of Decatur MAILING ADDRESS: P.O. Box 247 CITY, STATE, ZIP: Decatur AR 72722 PHONE & EXT: / FAX: 479-752-3912 / EMAIL: james.boston@decaturarkansas.com		FAYETTEVILLE SHALE RELATED: N FAYETTEVILLE SHALE VIOLATIONS: N INSPECTION PARTICIPANTS NAME/TITLE/PHONE/FAX/EMAIL/ETC.: James Boston, Public Works Director, 479-212-0726, james.boston@decaturarkansas.com William Cody, Area 1 Inspector, 501-944-2569, william.

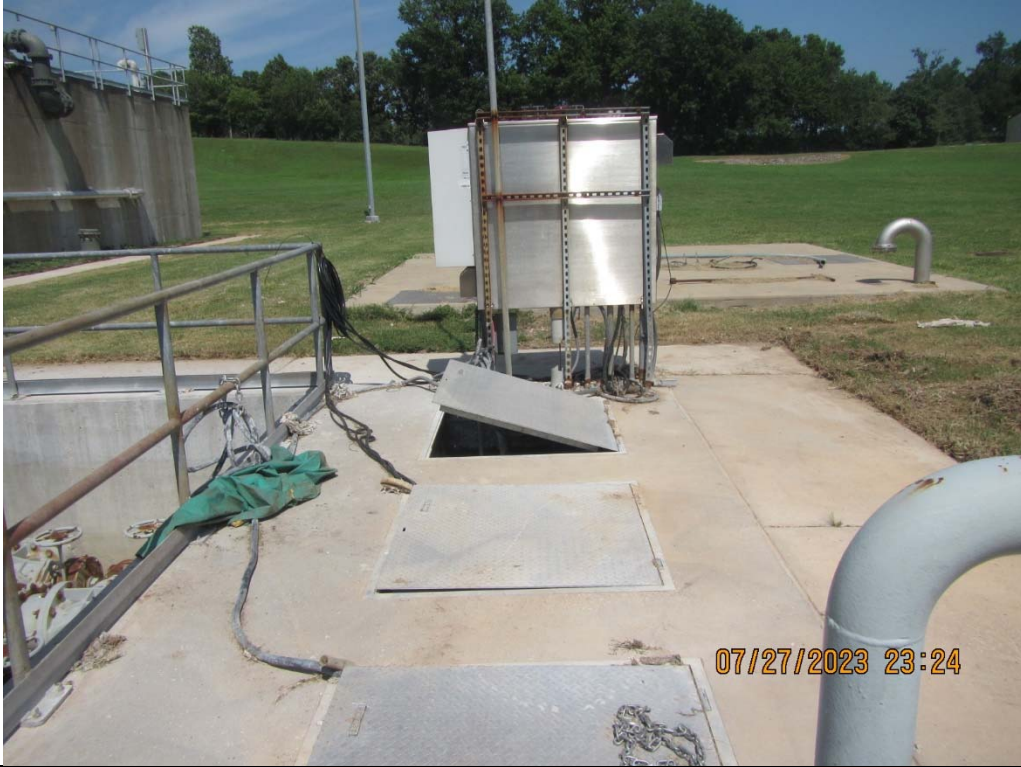
After my site visit with the complainant, I returned to the Decatur WWTP and again met with Mr. Boston. We then looked at the influent lift station as requested by the Inspector Supervisor and Enforcement Branch. The influent lift station had clear indications of overflows, as there is trash on the ground surrounding the lift station. Mr. Boston explained to me that O6 Environmental would be remediating this area the following morning. It is requested that the City of Decatur WWTP provide an update on the remediation efforts made by O6 Environmental. Mr. Boston also explained that overflows will occur at the plant where the overflow will flow over and down the walls of the raised concrete platform onto the ground. I asked how long it has been since a previous overflow and the statement of "it has been a little while" was received. The EQ basin is said to not be in operation and/or not of use currently. Mr. Boston said they have not had any issues with the EQ basin since it has not been of use.

Location:	City of Decatur WWTP		
Photographer:	William Cody	Date:	7/27/2023
Witness:	James Boston	Time:	23:24
		Photo #:	1
Description:	Influent lift station area.

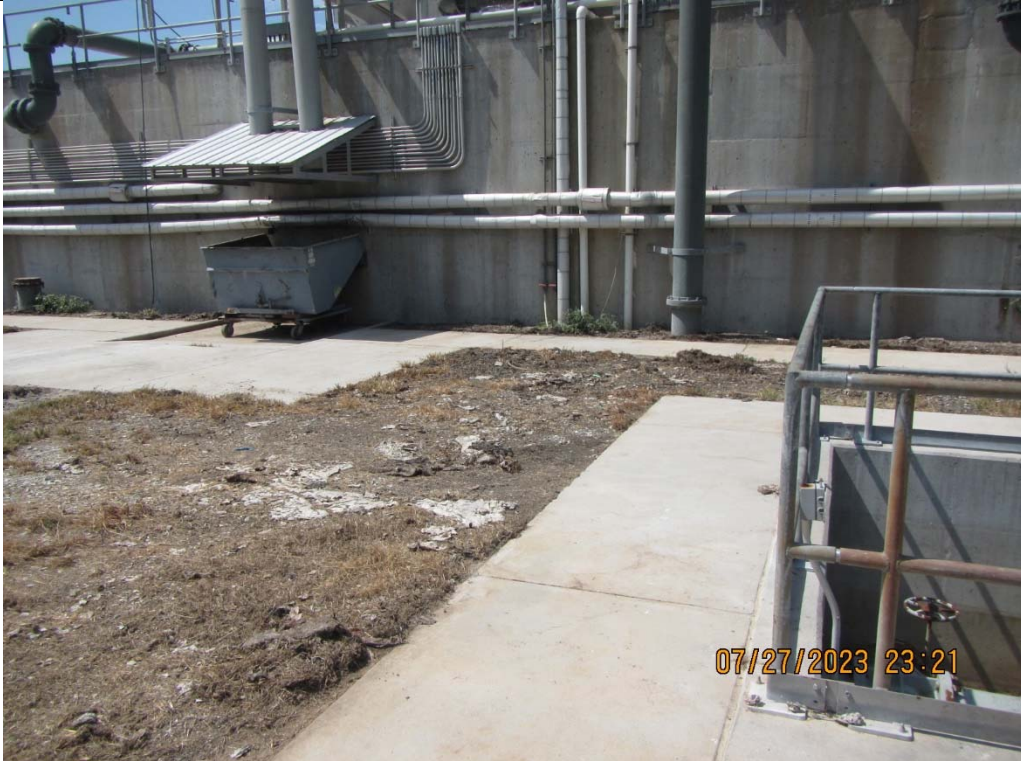
SUMMARY OF FINDINGS	
<p>The following items were noted and require a written and photographic response:</p> <ol style="list-style-type: none"> 1. There is evidence of a recent SSO at the influent lift station. It is required that this overflow be reported to the Enforcement Branch, per Part II, 5.A of the permit. 2. Trash and debris are evident in the area surrounding the influent lift station. It is required that this area be cleaned in order to maintain proper operation and maintenance requirements, per Part III, B.1.A of the permit.

Photographer:	William Cody	Date:	7/27/2023
Witness:	James Boston	Time:	23:21
		Photo #:	2
Description:	Trash, debris, and other evidence of an SSO on the grounds next to the lift station.

These are some of the main reasons water can overflow and get away from treatment. We recently spent a lot of money for grounds clean up. And will do more when necessary.

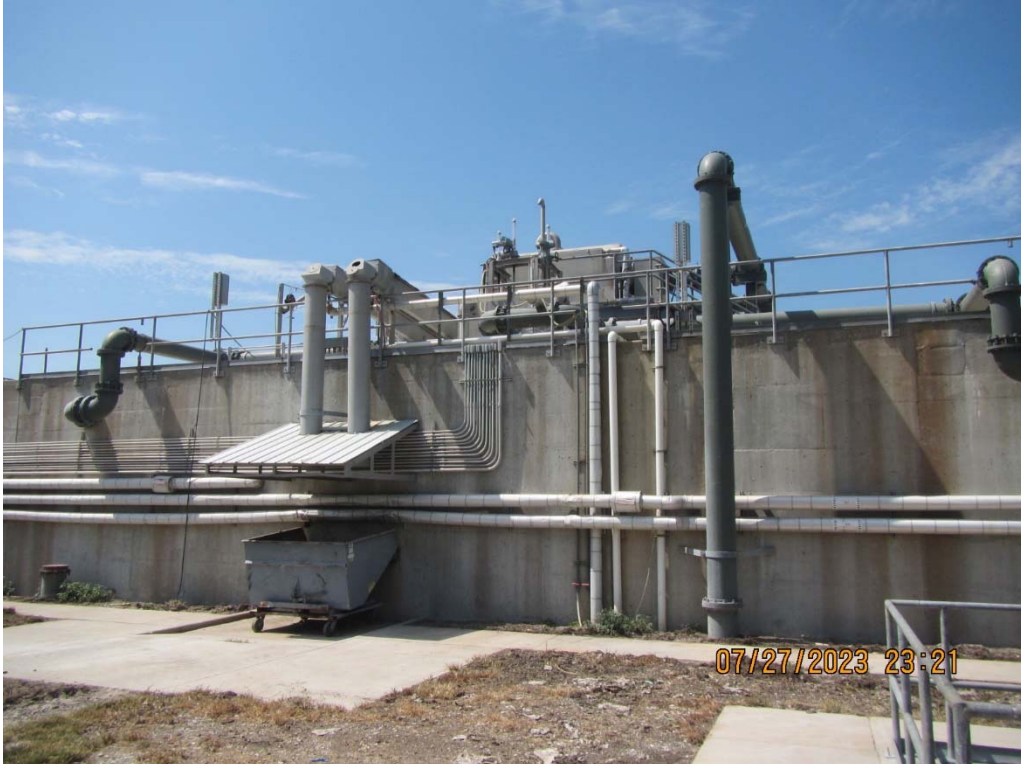
Location:	City of Decatur WWTP				
Photographer:	William Cody	Date:	7/27/2023	Time:	23:21
Witness:	James Boston	Photo #:	3		
Description:	View of treatment units/components on the raised concrete platform.

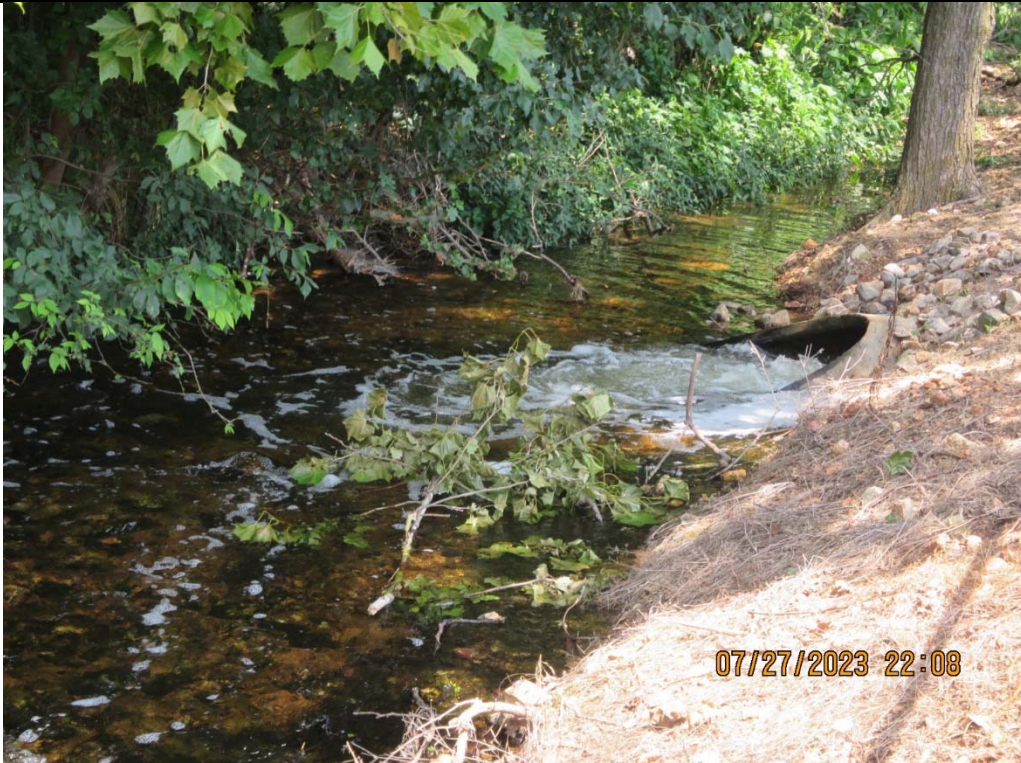
During my initial site visit, I met with Mr. Boston at the Decatur WWTP. Mr. Boston showed me the treatment plant's outfall into Columbia Hollow Creek, approximately just under one mile from the complaint location. The effluent appeared clear and the receiving stream did not appear to have any sludge accumulation or any other indications of an overflow. I then left the facility to meet with the complainant at the reported location of concern downstream.

Photographer:	William Cody	Date:	7/27/2023	Time:	22:08
Witness:	James Boston	Photo #:	4		
Description:	Outfall 001.
